Loss of control and collision with terrain involving Robinson R44 II, registration VH-HOB

near Clare, South Australia, on 22 December 2020

ATSB Transport Safety Report

AO-2020-064

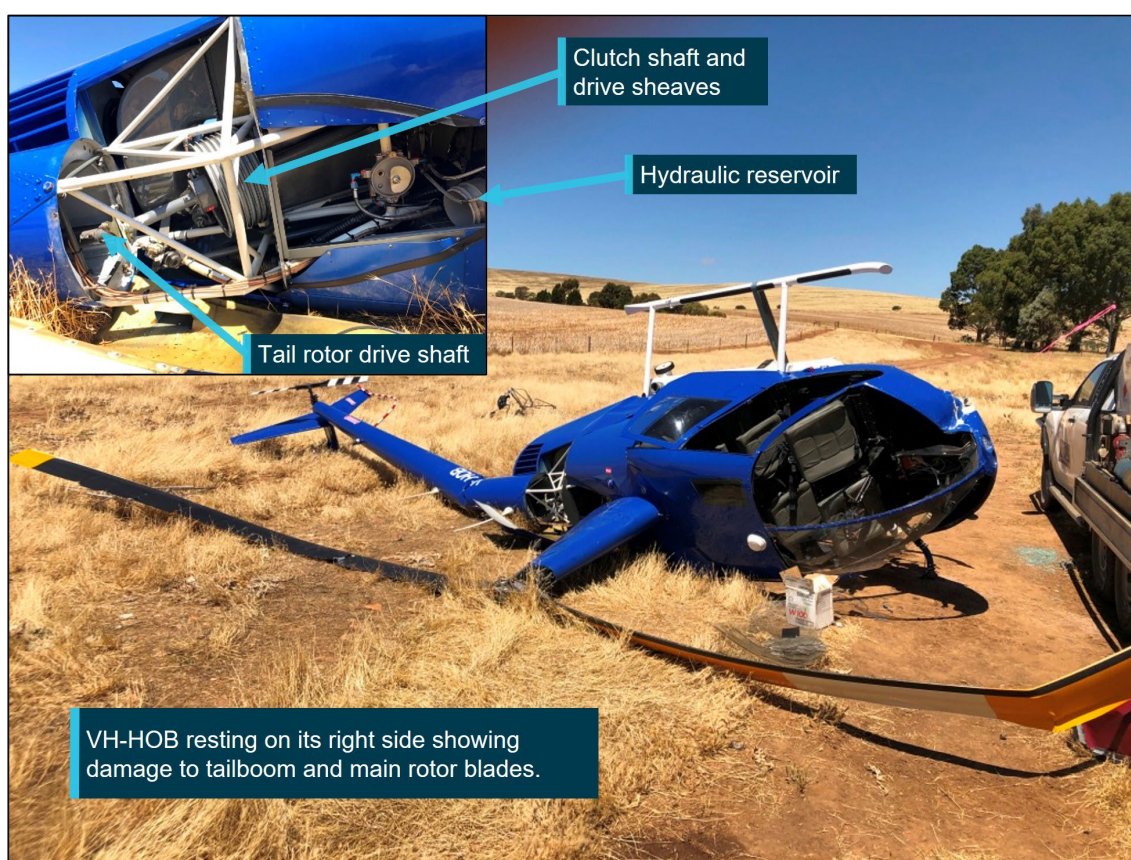
Figure 2: VH-HOB following the collision with inset showing clutch shaft with upper drive sheaves and displaced hydraulic reservoir

The helicopter presented as relatively intact with the tailboom broken aft of its forward mount point. The operator's examination identified that one of the arms of the clutch shaft forward yoke had fractured resulting in loss of drive to the main and tail rotor systems. The tubular steel structure surrounding the shaft was damaged by the rotation of the unrestrained clutch shaft. The hydraulic reservoir was also found displaced from its mounting base and was located within the wreckage (Figure 2).

Following the accident, attending maintenance personnel reported they conducted a functional check of the flight control system and found the cyclic³ and collective⁴ controls had full and free movement. However, one of the tail rotor control tubes exhibited bending damage that was likely the result of contact with the unrestrained clutch shaft.

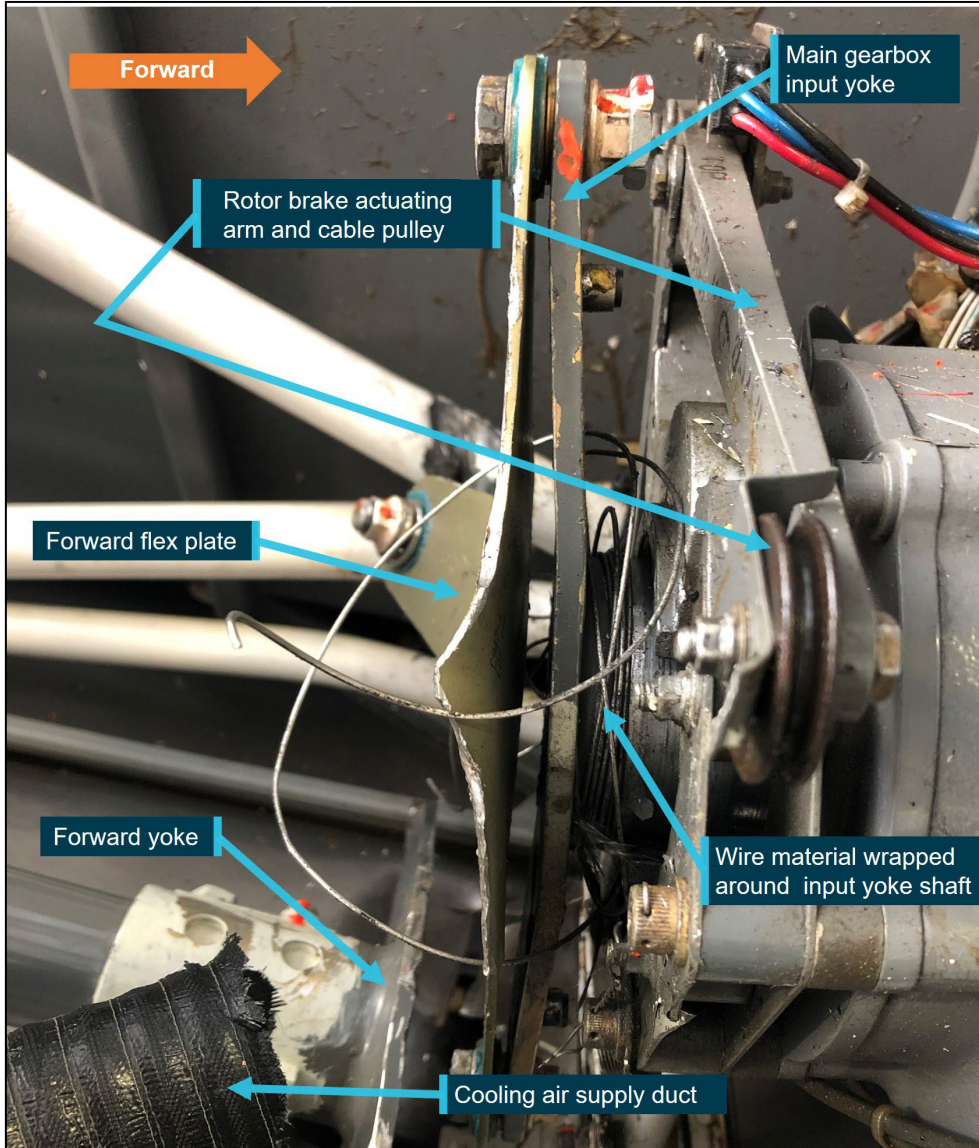
Figure 4: Rotor brake mechanism minus actuating cable attached and trapped wire material around the main gearbox input yoke shaft

cable was displaced from its guide pulley and was disconnected from the braking mechanism (Figure 4).

The action of separating the cable from the braking mechanism likely caused the rotor brake to be momentarily actuated, and while considered minimal, may have affected the speed of the main rotor system.

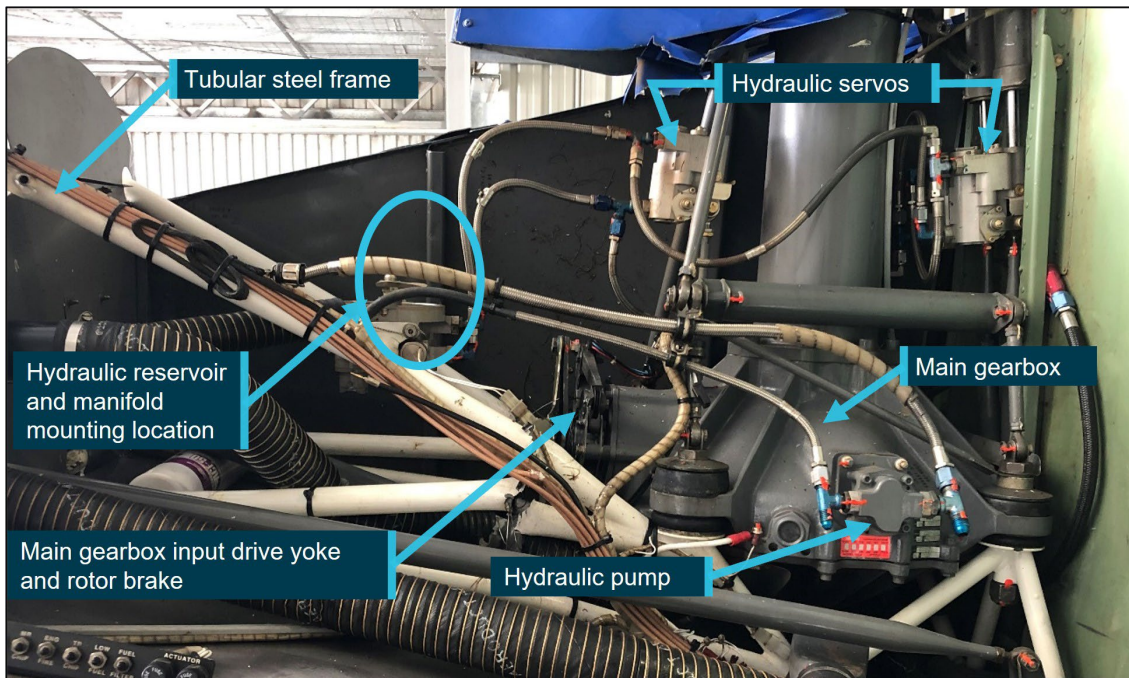
Figure 5: Hydraulic system and main gearbox installation from VH-HOB

The hydraulic reservoir had separated from the hydraulic manifold mounted to the tubular frame likely from the clutch shaft striking the manifold (mounting location circled, Figure 5). This resulted in significant loss of hydraulic fluid. The ATSB’s examination of the hydraulic reservoir revealed multiple impact marks attributed to striking, or being struck repeatedly by a rotating component, likely the main gearbox input yoke.

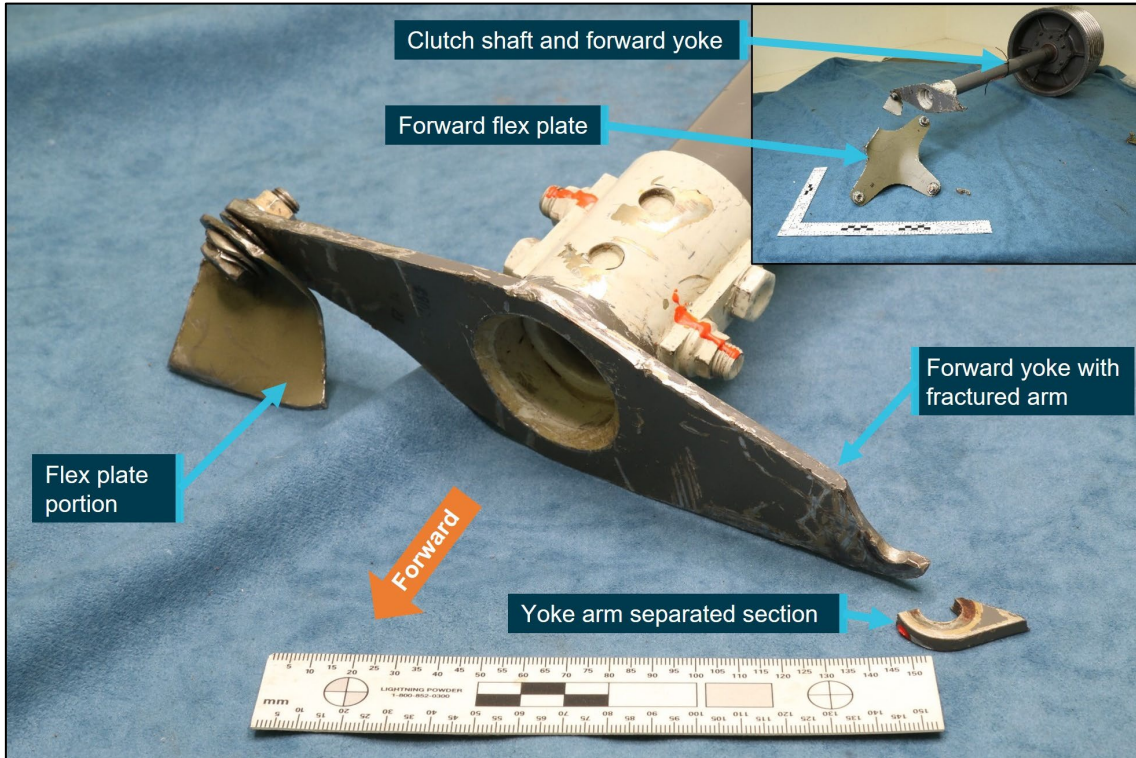
Figure 6: Fractured forward yoke arm with inset showing clutch shaft assembly and flex plate

The clutch shaft with the fractured yoke arm, the forward flex plate and the attaching hardware were provided to the ATSB for detailed examination (Figure 6). A portion of the flex plate that remained connected to the yoke and the separated section of the arm was also provided for examination.

The yoke presented with one arm intact, to which a portion of the forward flex plate and its attaching hardware were present. The opposite arm had fractured at the bolt hole that secured the arm to flex plate.

The surfaces of the yoke presented with scoring marks and indentations to the painted surfaces. Mechanical impact damage and gouging was also present with smearing damage to the arm fracture surfaces obscuring some of the original fracture features.

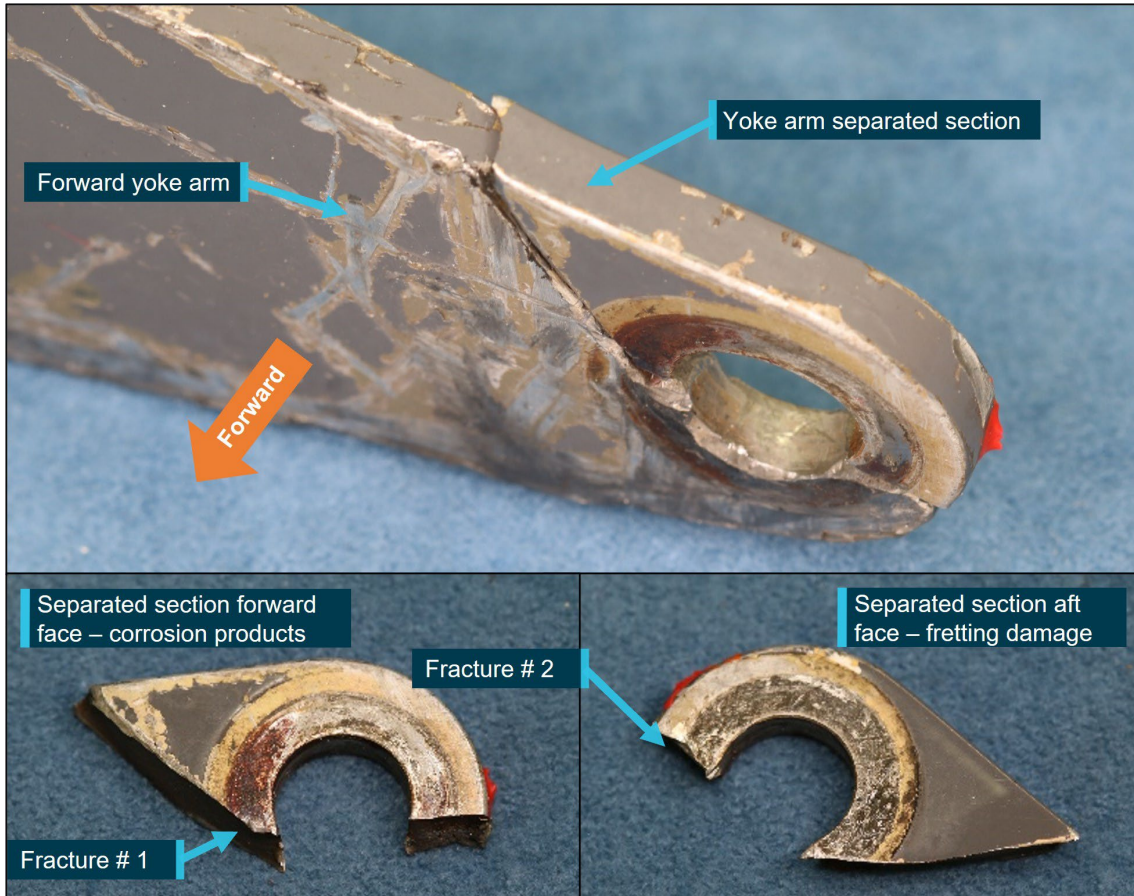
Figure 7: Fractured yoke arm and separated section front and rear surface condition

Red-coloured corrosion products were observed on the forward face of the yoke where it contacted the bonded stainless-steel washer from of the forward flex plate (Figure 7). Fretting damage was present on the aft face that was in contact with the attaching hardware. Microscopic examination of the red-coloured product identified it to have been produced from general corrosion/oxidation of the underlying steel surface. There were no indications of pitting corrosion.

A distinctly corroded region was identified on the forward-most surface of the yoke. A similarly corroded/stained region was identified on the fracture surface. The corroded regions were underneath where the bonded washer from the forward flex plate would normally be clamped. The varying nature of the corrosion within the fatigue crack and the demarcation between the various regions suggested that the crack had existed during an overhaul cycle of the component.

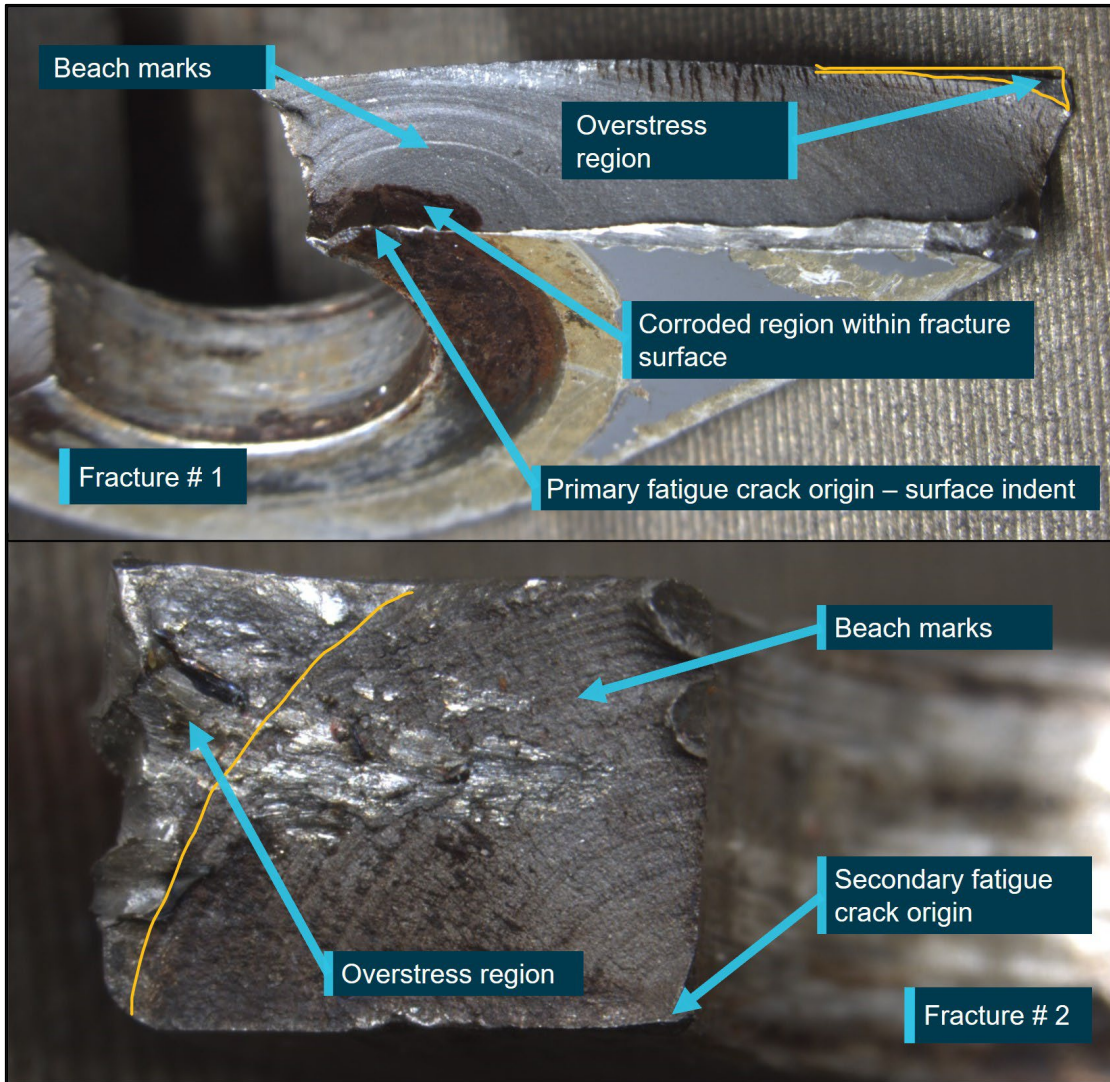
Figure 8: Separated yoke tip with fracture features identified

Visual examination of the fracture surfaces on either side of the bolt hole showed evidence of fatigue fracture. The fracture surface showed concentric beach marks indicative of a progressive crack mechanism, which radiated outwards from the likely origin at the inner bolt hole surface on the front face of the yoke (Figure 8). The fatigue crack had propagated from the front to the aft face, and initially obscured from view by the presence of the attaching hardware.

Crack propagation continued across a substantial portion of the cross section (about 98% of fracture # 1 and about 80% of fracture #2), with a visible portion on the rear face of about 6 mm before final overstress fracture and separation occurred.

The yoke failed as a result of fatigue crack propagation that initiated on the forward face of the yoke arm coincident with the bolt hole. On one side, the crack had initiated from a mechanical surface defect. The fatigue cracking was assessed to have propagated slowly as evidenced by the many hundreds of crack progression bands, with failure of the yoke arm occurring when minimal intact cross-sectional area remained.

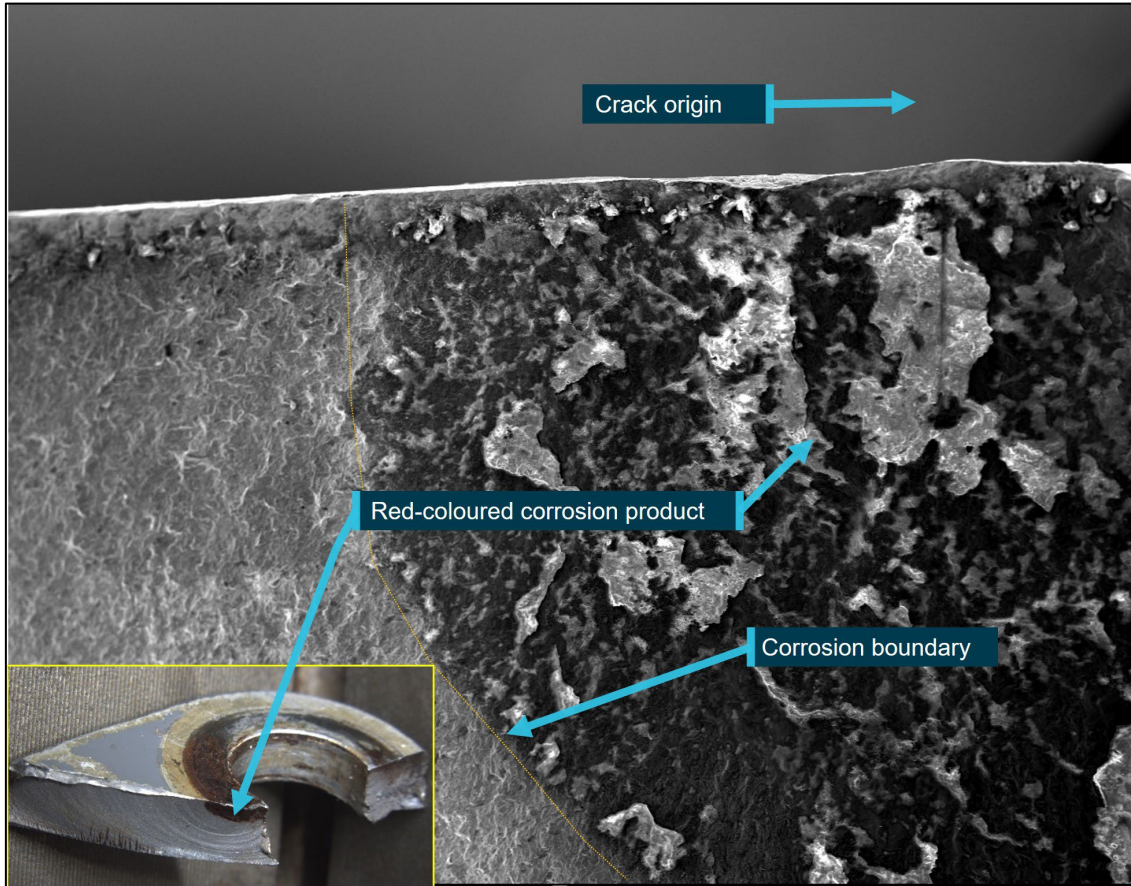
Figure 9: Fracture surface of separated section showing corrosion boundary with inset showing crack surface discoloration

- many hundreds of crack progression bands were observed, which indicated crack growth occurred as a result of high-cycle fatigue⁵
- surface damage (an indent) approximately 0.10 mm in depth at the fatigue crack origin of fracture #1 had likely influenced the initiation of cracking within the yoke arm at the point of fracture
- a clear boundary on the fracture surface existed between the region of corrosion and the region that was not corroded (Figure 9).

The presence of corrosion deposits in part of the cracked region indicated that the crack was likely present at that inspection. Once the yoke arm was re-installed, the forward face was obscured by the flex plate and the crack would not have been visible during the subsequent routine inspections.
