# Aviation Investigation Preliminary Report

| <b>Location:</b> | Owenton, KY | <b>Accident Number:</b> | ERA25FA005 |
| <b>Date &amp; Time:</b> | October 7, 2024, 17:35 Local | <b>Registration:</b> | N230AE |
| <b>Aircraft:</b> | Bell 206L-3 | <b>Injuries:</b> | 3 Fatal |

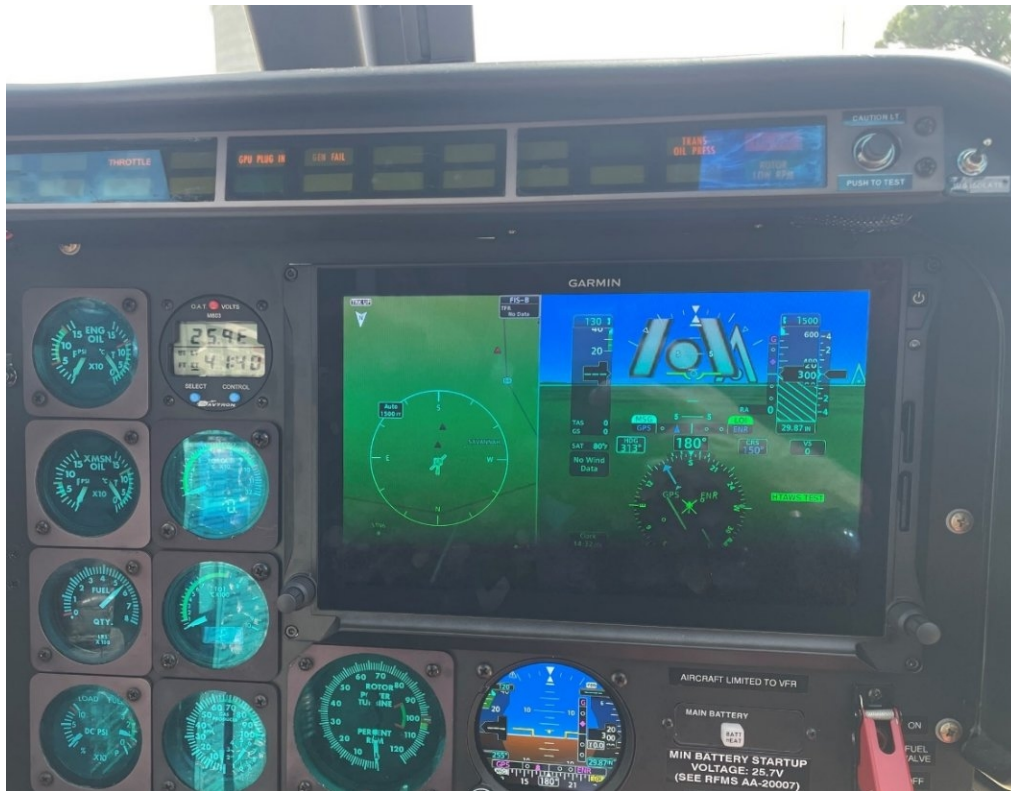
The helicopter was equipped with a two-axis autopilot, a Garmin 650 GPS, a Garmin 500txi cockpit display, synthetic vision, and a Helicopter Terrain Awareness and Warning System (HTAWS). These systems provided both visual and aural terrain and obstacle advisories to the pilot and crew. Figure 2 shows an exemplar instrument panel including terrain and obstacle awareness displays.

Figure 2 - Exemplar of instrument panel as configured in accident helicopter.
