# Aviation Investigation Final Report

<b>Location:</b>	Hochatown, Oklahoma	<b>Accident Number:</b>	CEN24LA004
<b>Date &amp; Time:</b>	October 1, 2023, 12:30 Local	<b>Registration:</b>	N379SH
<b>Aircraft:</b>	ROBINSON HELICOPTER R44	<b>Aircraft Damage:</b>	Substantial
<b>Defining Event:</b>	Loss of engine power (total)	<b>Injuries:</b>	1 None
<b>Flight Conducted Under:</b>	Part 91: General aviation - Personal

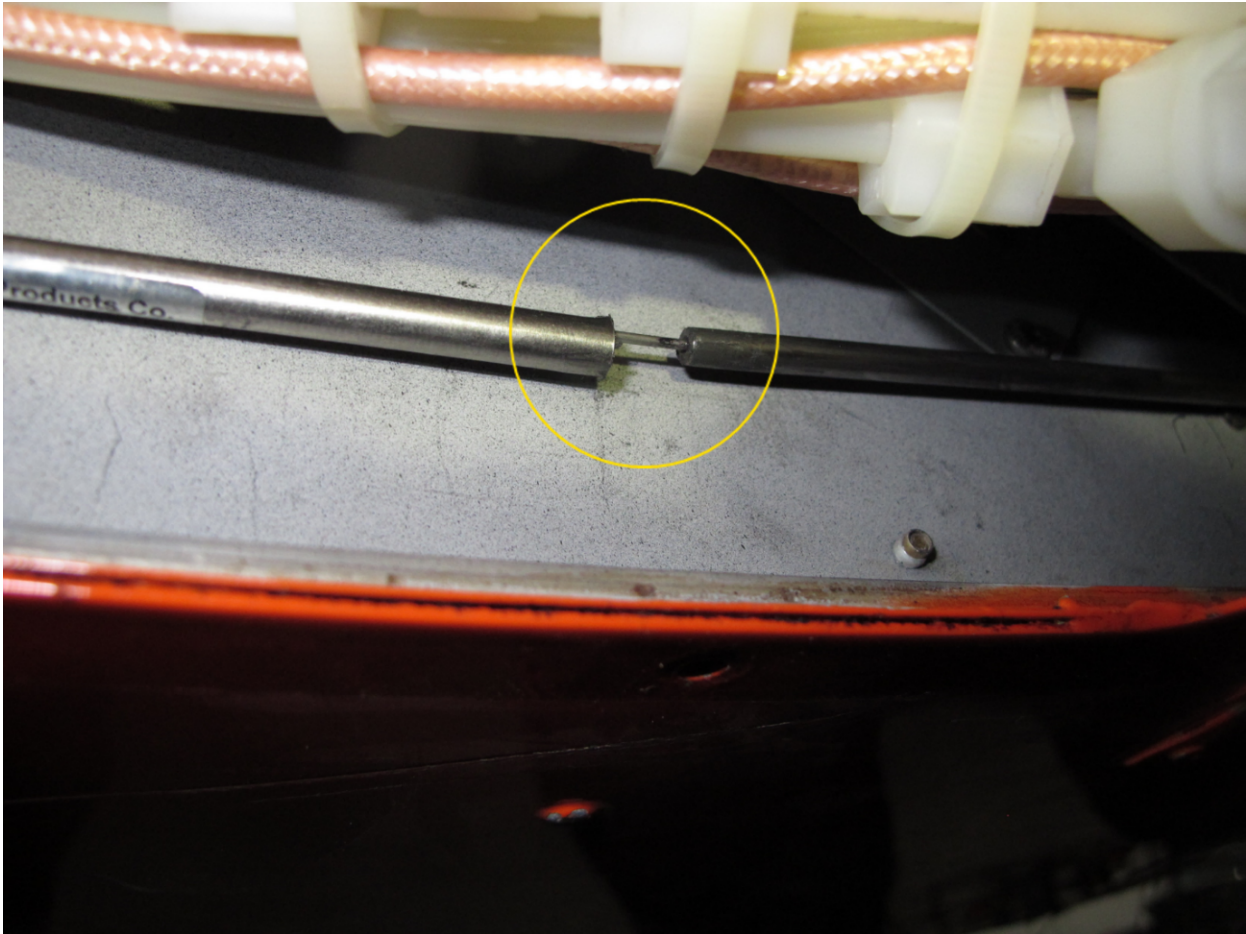
Examination of the engine revealed that the idle speed was set below 50 percent, which was below the manufacturer's recommendation of 60 to 65 percent. Additionally, the carburetor heat control cable was rigged improperly, and therefore, was jammed in the full heat position. The combination of these factors would have likely made the engine more susceptible to losing power, especially with an abrupt power reduction initiated by the pilot during the simulated autorotation.

A total loss of engine power during a practice autorotation due to the improper engine idle setting and rigging of the carburetor heat control which resulted in a hard landing.

The helicopter sustained substantial damage to the tailboom and the main rotor blades. A postaccident examination revealed that the carburetor heat control knob was jammed in the full heat position. Further examination revealed that the carburetor heat control cable was rigged so that the cable was pulled beyond the end of the cable conduit sleeve (figure 1). When the carburetor heat knob was actuated, the control cable would bind with the conduit sleeve.

**Figure 1:** Carburetor heat control cable as found. The cable is free from the conduit sleeve (circled in yellow).

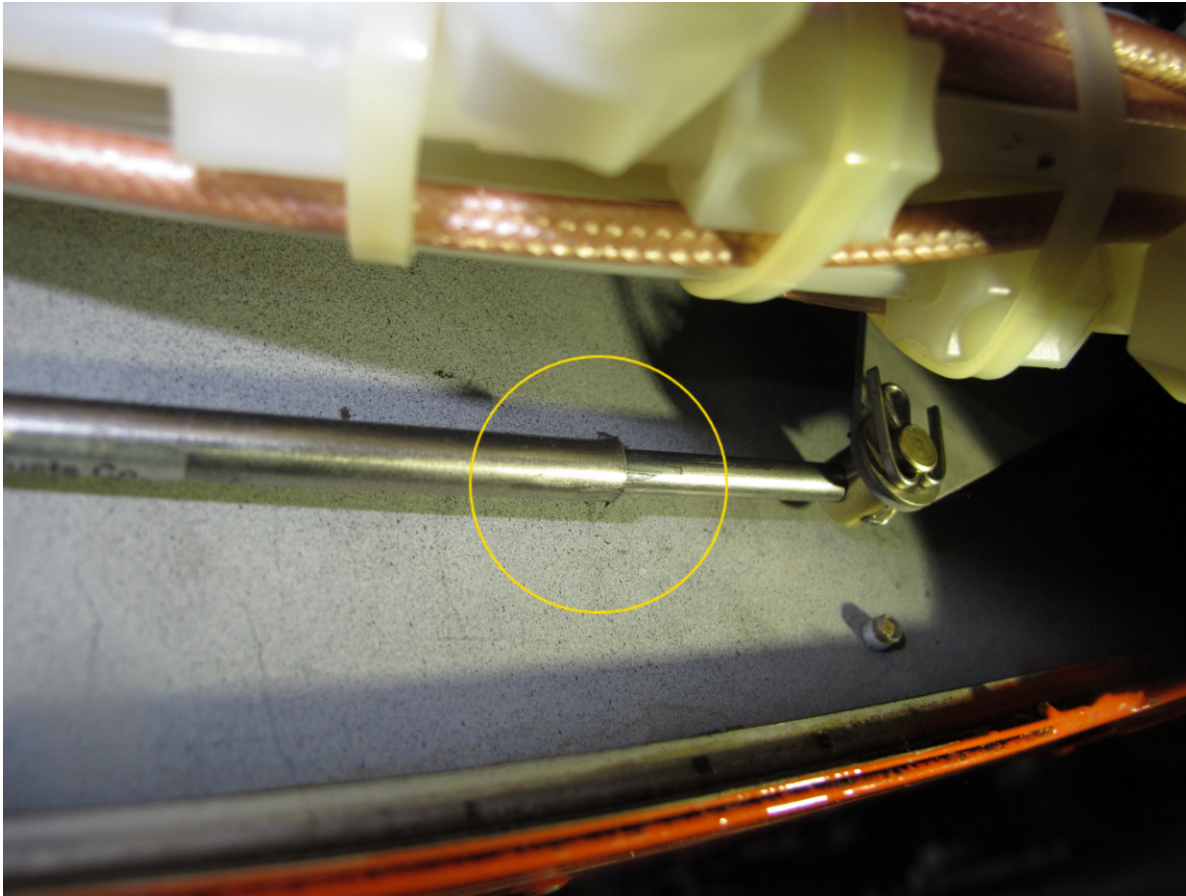
Figure 2 shows a normal engagement of the carburetor heat control cable in the conduit sleeve.

**Figure 2.** The normal engagement of the carburetor heat cable and conduit. Cable is inserted into the conduit sleeve (circled in yellow).
