# Aviation Investigation Final Report

<b>Location:</b>	Las Vegas, Nevada	<b>Accident Number:</b>	WPR23LA041
<b>Date &amp; Time:</b>	November 18, 2022, 10:27 Local	<b>Registration:</b>	N88E (A1); N4050P (A2)
<b>Aircraft:</b>	Cessna 172M (A1); ROBINSON HELICOPTER R44 (A2)	<b>Aircraft Damage:</b>	Substantial (A1); Minor (A2)
<b>Defining Event:</b>	Midair collision	<b>Injuries:</b>	2 None (A1); 1 None (A2)
<b>Flight Conducted Under:</b>	Part 91: General aviation - Instructional (A1); Part 91: General aviation - Instructional (A2)

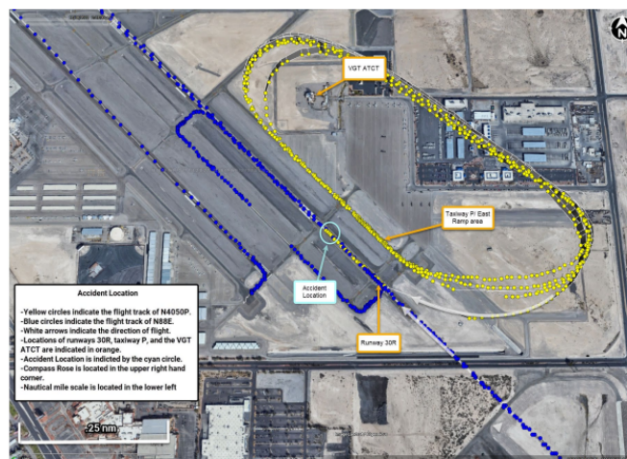
The Cessna had completed 3 approaches to runway 30R, including one full-stop and two touch-and-go landings, and the accident helicopter had completed 4 full-stop landings to taxiway Papa before the accident. (See Figure 1.)

Figure 4. Graphic depicts the flight tracks of N4050P and N88E, and the accident location.

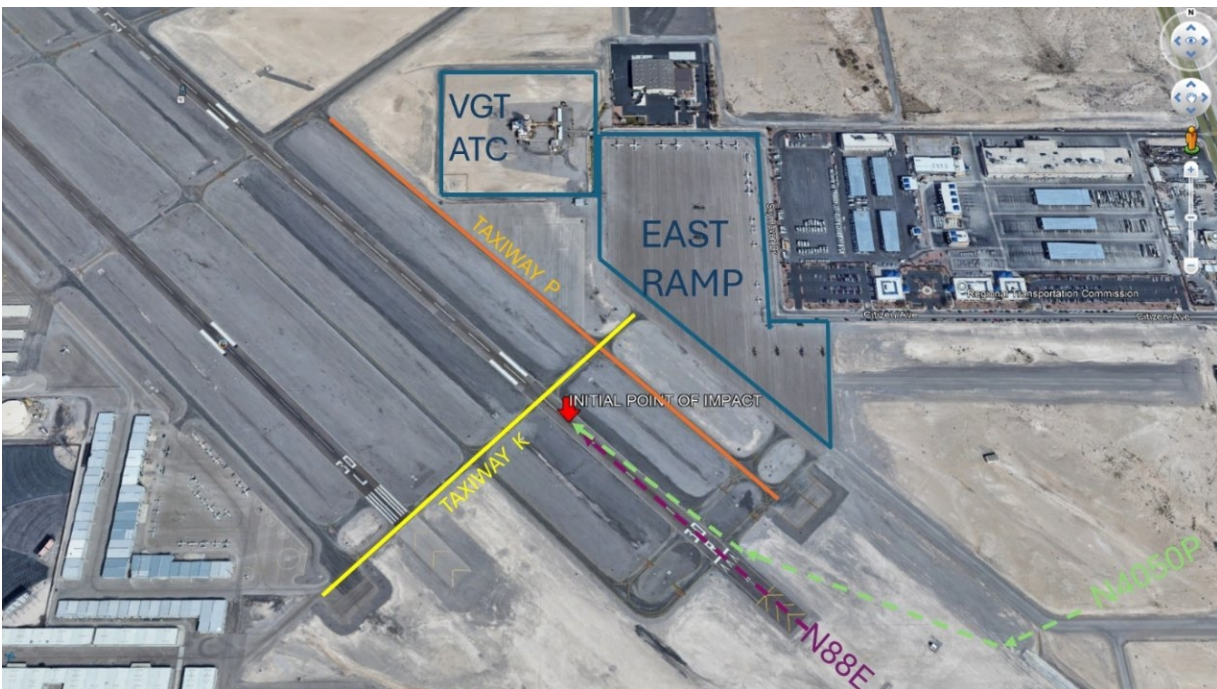
At 10:27, the controller instructed the accident helicopter to, when able, make a right turn on taxiway Kilo, and that landing on the east ramp was at the pilot's own risk. (See Figure 2.) The pilot responded by stating "Las Vegas tower, five zero papa." The controller again instructed the helicopter pilot to make a right turn onto taxiway Kilo. The pilot did not acknowledge the instruction.

Figure 2. View of initial point of impact in relation to Taxiway Papa, Taxiway Kilo, the East Ramp, and ATC.
