Aviation Investigation Final Report

| Location: | Galliano, Louisiana | Accident Number: | CEN23FA071 |
| Date & Time: | December 29, 2022, Local | Registration: | N595RL |
| Aircraft: | Bell 407 | Aircraft Damage: | Substantial |

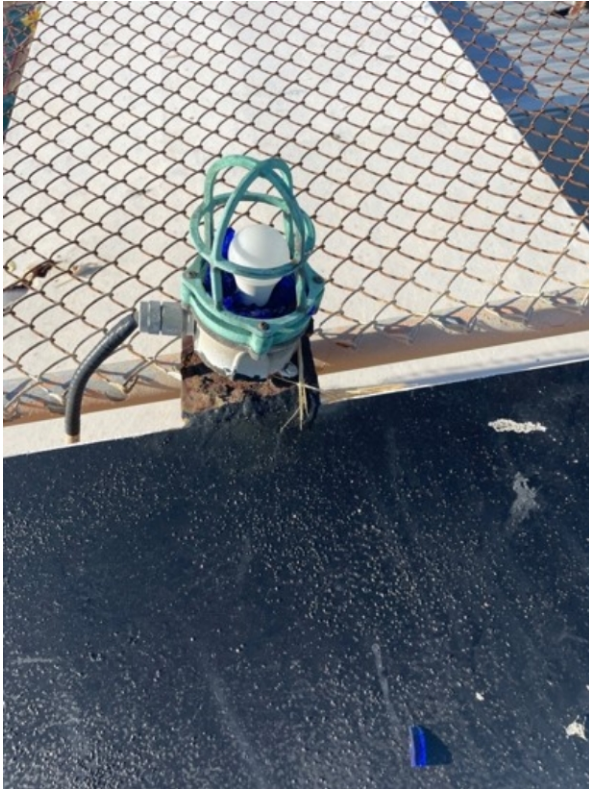
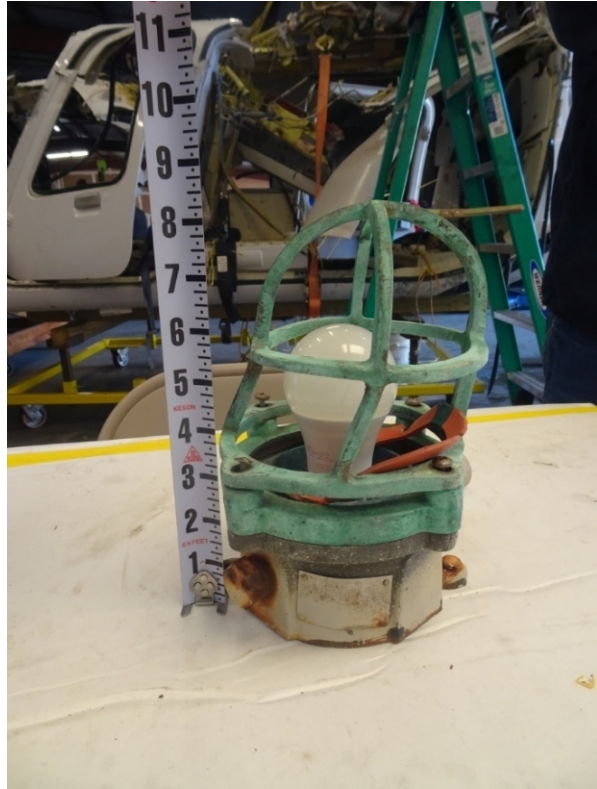
Further examination of the helideck revealed that the center blue light assembly on the northwest elevation of the helideck was damaged but still attached to its 6 inch by 6 inch light mount. Although the light remained installed on the mount, its blue glass globe was fragmented and the metal protective guard for the globe was significantly deformed and bent toward the stairwell, as shown in Figure 2. After the accident, a platform employee removed the damaged light assembly from the mount out of concern for safety during future use of the helideck. The amber light, located on the west corner of the helideck, near the stairwell, separated from its mount and was not recovered. The remaining perimeter lights appeared undamaged.

Figure 2. Photo (left) of the damaged center perimeter light shortly after the accident (Source: Walter Oil and Gas). Photo (right) of the same light assembly after it was removed from the helideck (Source: NTSB).

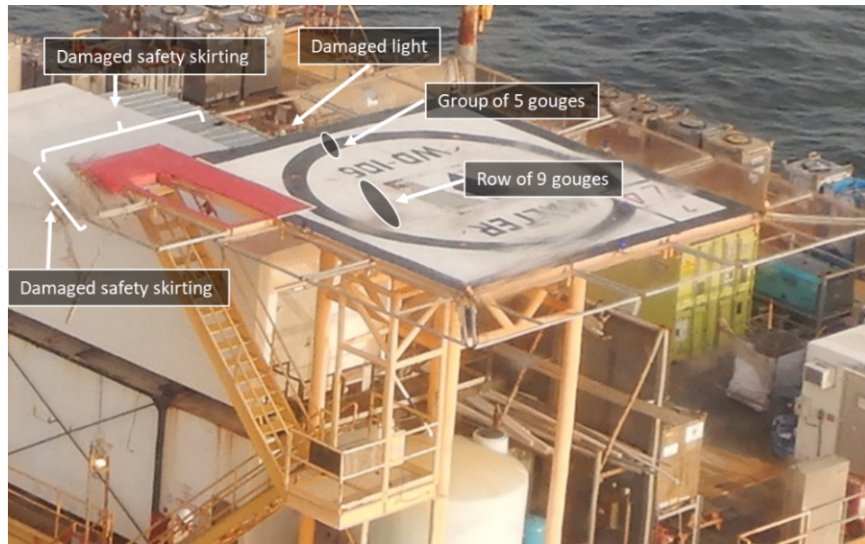
Two areas of gouges in the paint on the helideck were present. The first area was a row of nine irregularly spaced but inline gouges, as depicted in Figure 3, located inside the aiming circle and adjacent to the "W" icon logo painted on the helideck. The second area was a group of five irregularly spaced gouges, found in the black paint of the aiming circle, near the northeast side and near the damaged center light. Figure 4 is an illustration showing the location of the two areas of paint gouges and the damaged light assembly.

Figure 3. Image identifying some of the damage to the helideck.

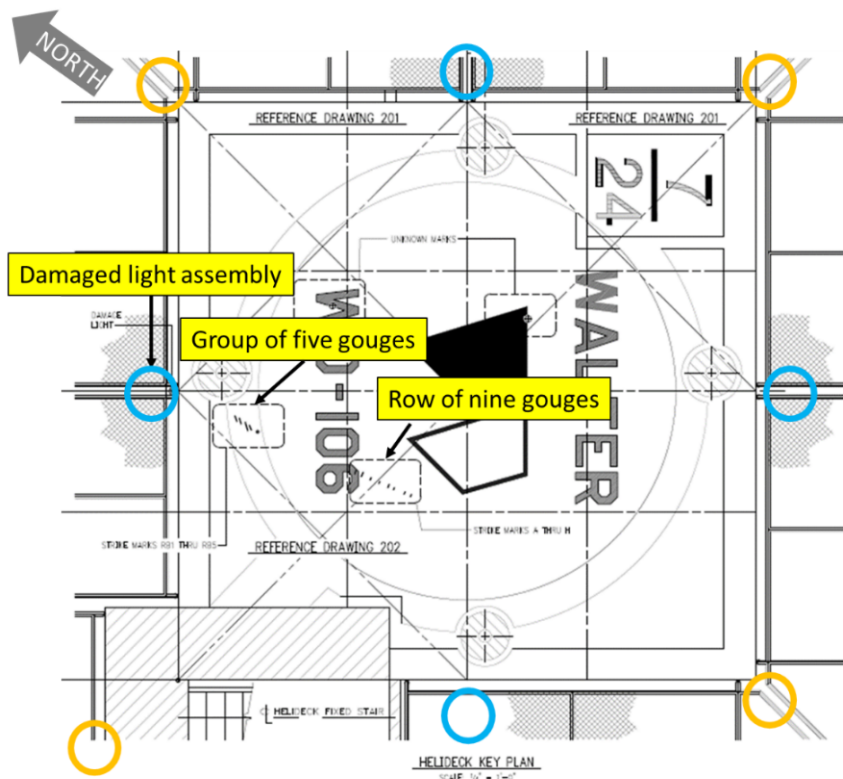
Figure 4. Illustration depicting the location of the two groups of gouges in the helideck paint and the location of the damaged perimeter light assembly.

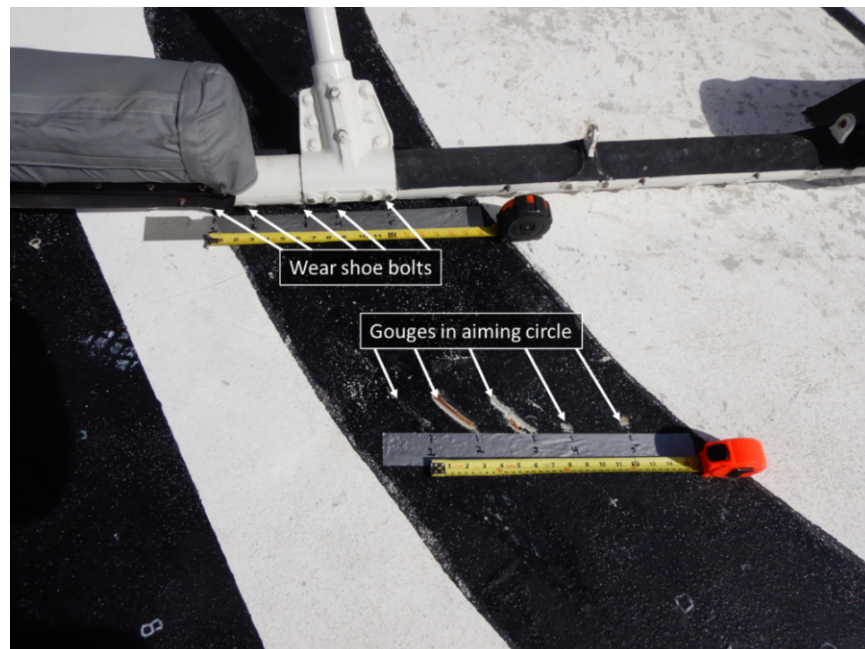
When compared to the group of five gouges in the aiming circle, the exemplar helicopter’s five wear shoe mounting bolts were near the gouges and matched the spacing between the gouges, as shown in Figure 8.

Figure 8. Photo of an exemplar helicopter's right skid showing the five wear shoe mounting bolts that matched the spacing of the group of five irregularly spaced gouges in the helideck paint.
