Aviation Investigation Final Report

Location:	Port Allen, Louisiana	Accident Number:	CEN23FA142
Date & Time:	March 26, 2023, 02:38 Local	Registration:	N441PD
Aircraft:	ROBINSON HELICOPTER COMPANY R44 II	Aircraft Damage:	Destroyed
Defining Event:	VFR encounter with IMC	Injuries:	2 Fatal
Flight Conducted Under:	Part 91: General aviation - Aerial observation

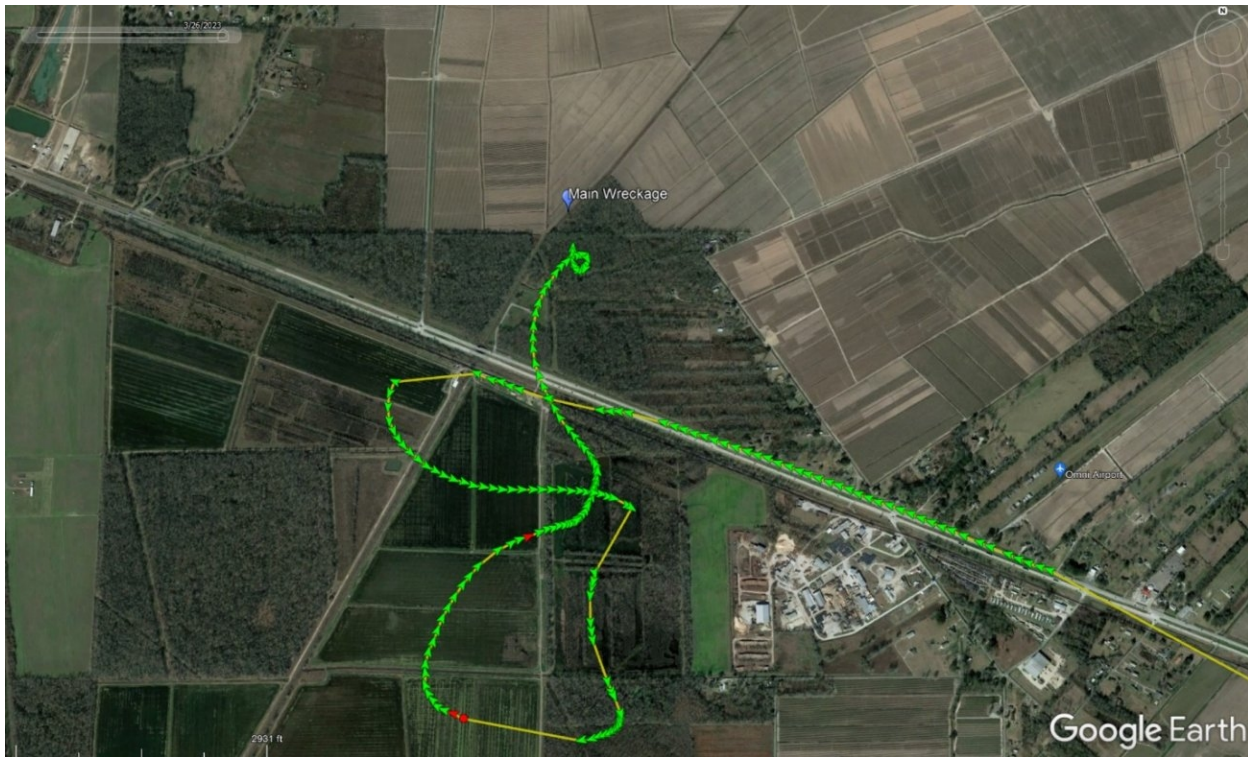
Figure

According to Baton Rouge Police Department (BRPD) personnel and ADS-B data, the BRPD helicopter, call sign Air 1, departed the Baton Rouge Metropolitan Airport (BTR), Baton Rouge, Louisiana, about 0226, to provide aerial support to BRPD ground units that were conducting a high-speed pursuit of a fleeing vehicle. Air 1 advised dispatch and ground units via radio that they were assisting and requested updates to the vehicle movement and location. ADS-B data showed the helicopter depart BTR to the south, turned west, then overfly Highway 190, west of Baton Rouge. Unable to maintain a safe pursuit of the vehicle, BRPD dispatch terminated the pursuit to all BRPD units, including the helicopter, via radio at 0235. There were no further communications received from the helicopter. About that time, the data showed the helicopter executed a shallow left deviation to the south of Highway 190. Following the deviation, a left turn was initiated and the turn rate increased. The initial turn was followed by a series of turns and altitude changes (see Figures 1 and 2). The ADS-B data ended at 0238 at an altitude of about 1,450 agl. There were no witnesses to the accident.

1. ADS-B data overlaid on Google Earth.

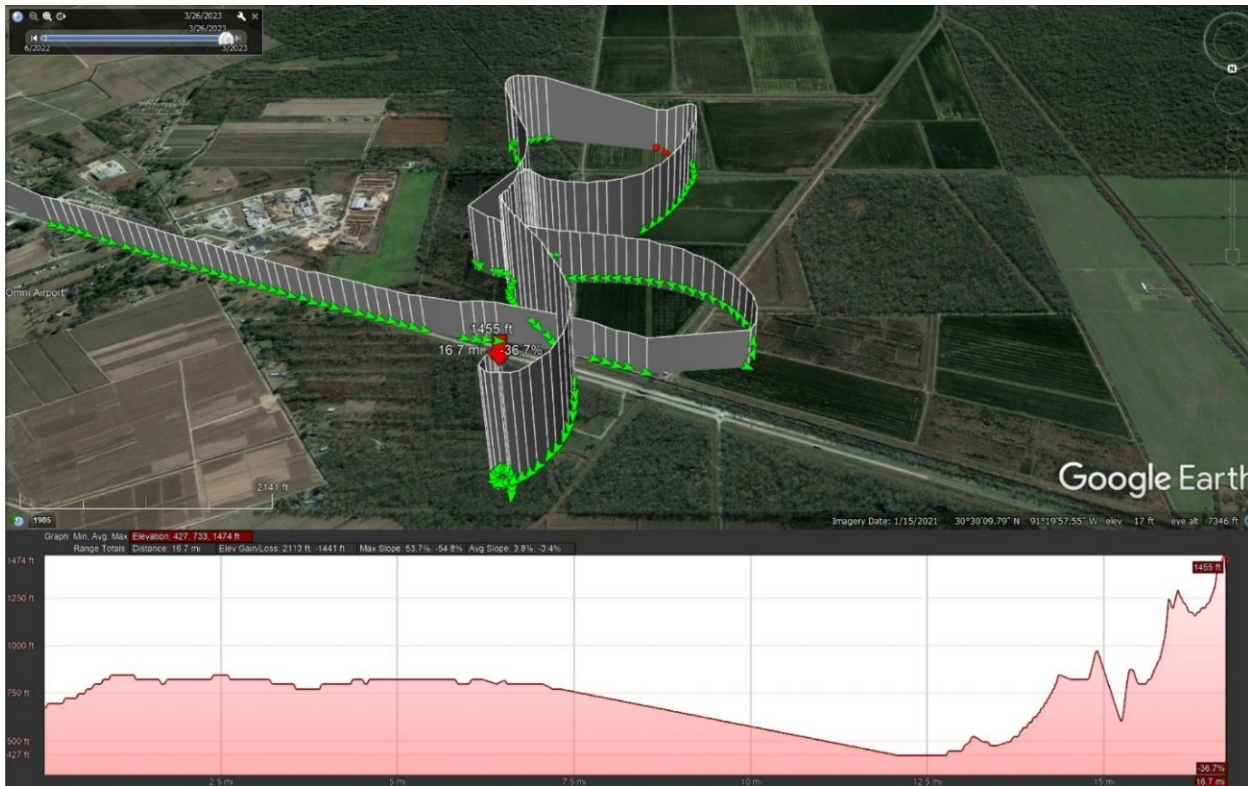
Based on available flight data and weather information, it is likely that the pilot continued the vehicle pursuit into deteriorating weather conditions. After termination of the pursuit, the helicopter's erratic maneuvers are consistent with the pilot experiencing spatial disorientation, a loss of control in flight, and inability to recover the helicopter.

Figure 2. ADS-B data overlayed on Google Earth with an altitude profile.

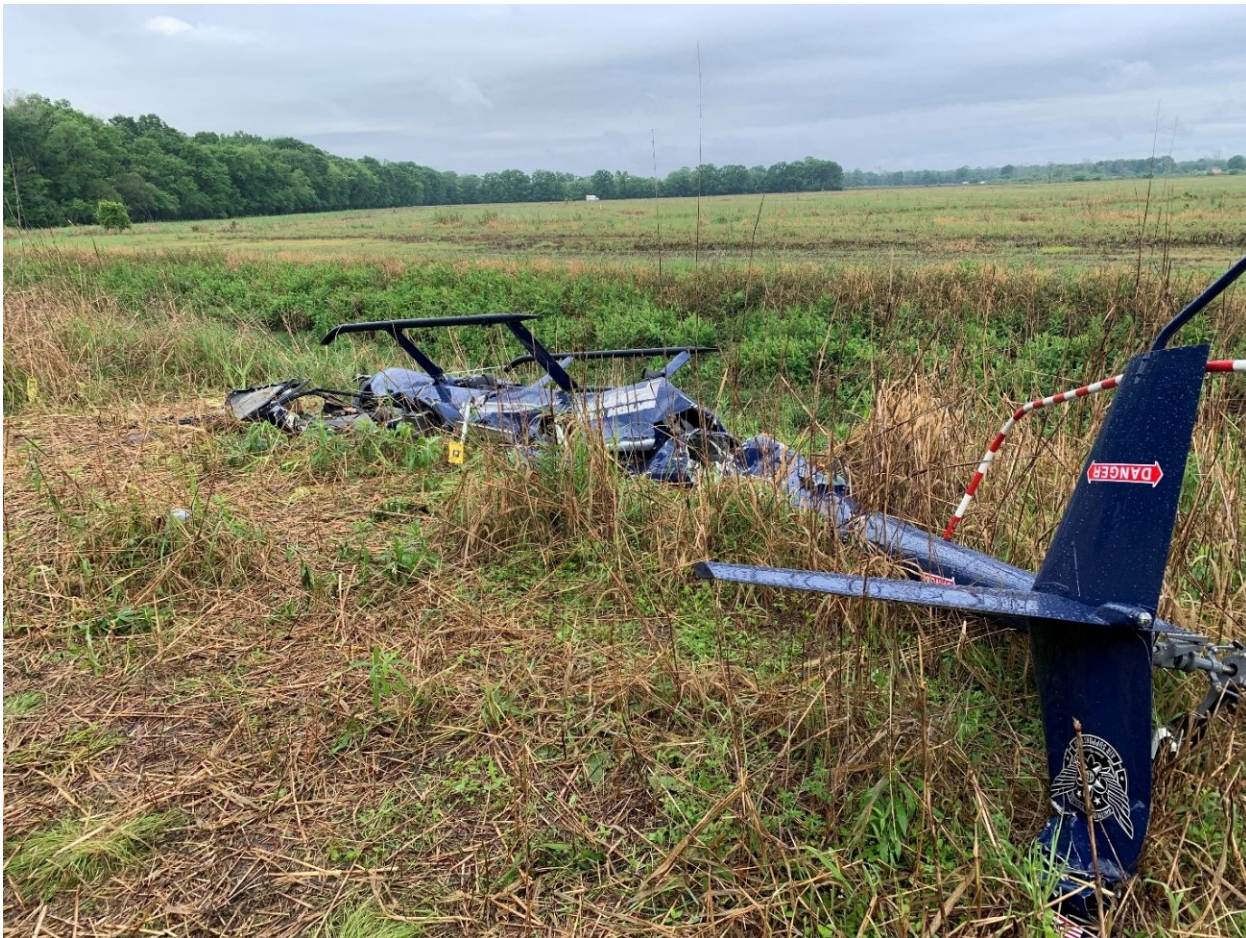
The main wreckage, which consisted of the cockpit, fuselage, and tailcone, came to rest inverted next to an irrigation ditch at the edge of a sugar cane field (see Figure 3).

Figure 3. Main wreckage at accident site.

Examination of the helicopter structure revealed impact signatures consistent with main rotor blade contact to the cabin structure above the forward looking infrared (FLIR) gimbal, to the top of the windshield bow and left seat passenger door frame. Main rotor blade leading edge damage and blade separation locations corresponded to the impact signatures on the cabin structure. Both elastomeric teeter stops were split horizontally through the middle. One main rotor blade spindle appeared to be straight or undamaged, and the other blade spindle was torn open at the coning bolt. The main rotor gearbox rotated one full revolution when it was manually rotated. The tail rotor gearbox was intact and free to rotate.
