AIR TRANSPORTATION SAFETY INVESTIGATION REPORT A23W0082

ENGINE POWER LOSS AND COLLISION WITH TERRAIN

Valhalla Helicopters Inc.
Bell Textron Inc. 205A-1 (helicopter), C-GRUV
Peace River Aerodrome, Alberta, 55 NM NE
19 July 2023

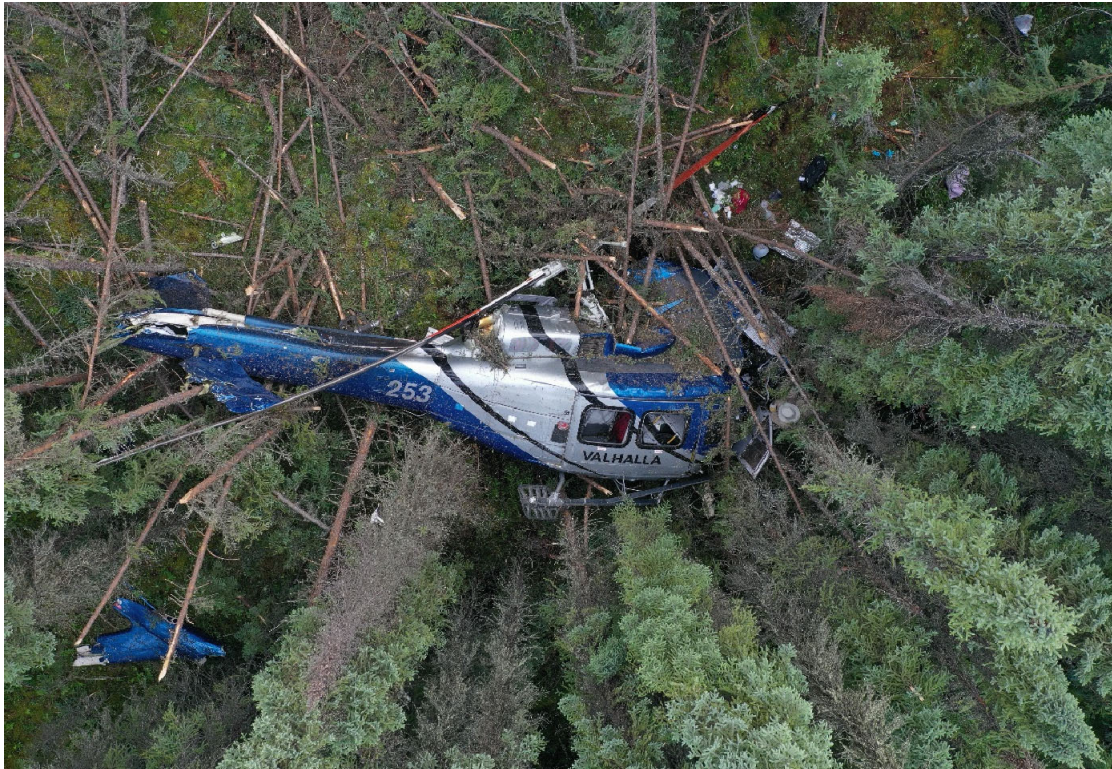
Figure 2. Accident site (Source: Royal Canadian Mounted Police)

The aircraft was substantially damaged by the significant impact forces when it collided with the terrain in a nose-down, left-banked attitude (Figure 2). The tail boom was hit by

the main rotor blade. The condition of the main rotor blade is consistent with low rotor rpm at the time of impact.

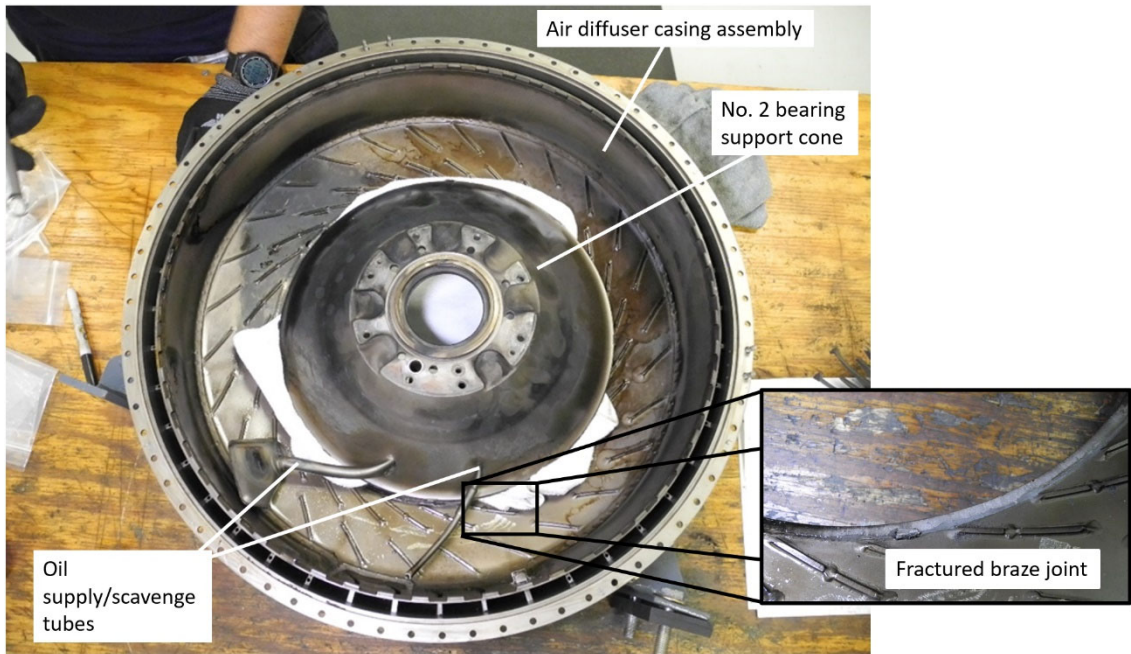
Figure 4. Air diffuser assembly, showing the No. 2 bearing support cone, oil supply/scavenge tubes, with a close-up view of the fractured braze joint in inset (Source of main and inset images: National Transportation Safety Board of the United States)

Examination of the air diffuser's components revealed that the No. 2 bearing support cone was brazed to the air diffuser casing assembly and that the entire circumference of the braze had failed in addition to the non-structural oil pressure and scavenge tubes at their outer extremities. The 2 separated components appeared to show no marks of previous disassembly or repair, such as grinding, chiselling, or other mechanical means that would have marred the surfaces. The intermittent fillet welds appeared to be the original OEM welds, consistent with the other welds on the air diffuser casing assembly.

The brazed surfaces did not show signs of liquation, porosity, or unevenness. The brazing appeared to have complete coverage of both surfaces over most of the circumference. The separation of the braze centreline (cohesive zone) was consistent throughout the circumference on both faces with only a few small, scattered areas of apparent loss of bonding between the air diffuser casing assembly and the support cone.

Examination of the support cone brazing did show 1 area where the braze failed at or near the air diffuser casing assembly surface. This indicates a possible localized contamination in this area. Since the air diffuser casing assembly material is made from stainless steel, it is also possible there was some interfacial corrosion. However, the exact cause of this failed brazing is unknown.

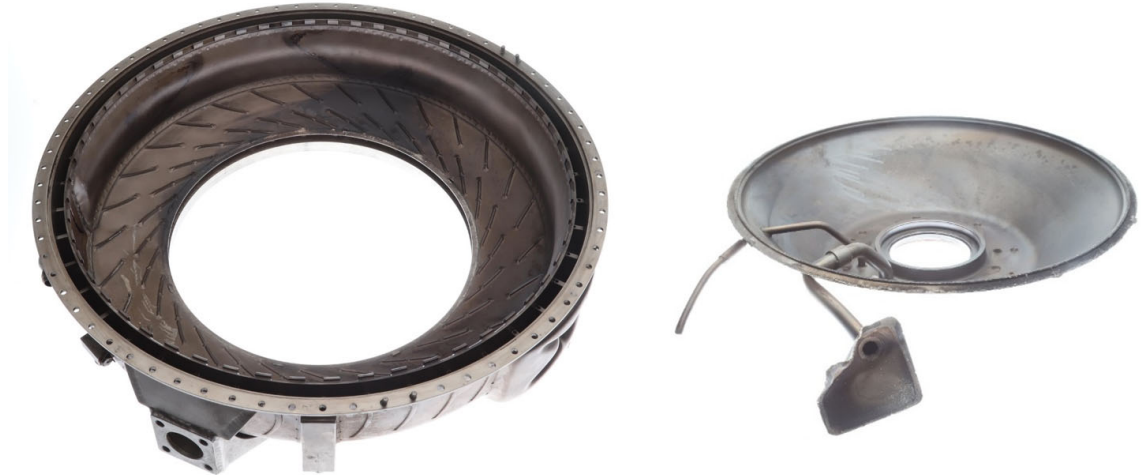
The distribution of these 8 failed fillet welds suggests that the braze weld failed first around most, or all, of the circumference of the support cone. The pounded appearance of the 5 fillet welds that each failed in the weld throat suggests that they failed before the 3 welds that were torn away, and these 5 were subsequently pounded due to repeated movement and contact between the support cone and air diffuser casing assembly. The 3 remaining fillet welds most likely failed due to overstress, after the braze and other fillet welds failed, because they do not exhibit the same impact (pounding) damage.

Evidence of impact damage was noted at the fitment lip around the entire circumference of the air diffuser casing assembly and support cone, again suggesting repeated movement between the support cone and air diffuser casing assembly. This means that the failure of this braze was a progressive failure with repeated movement between the support cone and air diffuser casing assembly over some length of time, most likely due to a deteriorating brazing bond.

Figure 5. Air diffuser casing assembly (left) and No. 2 bearing support cone (right) separated at the braze joint (Source: TSB)

A teardown of the occurrence aircraft's engine was completed as part of the investigation. It was determined that the failure of the air diffuser's No. 2 bearing support cone brazing resulted in an unsupported No. 2 bearing and air diffuser casing assembly, and the compressor rotor made contact with the power shaft. In addition, the loss of support experienced by the gas producer nozzles and cylinder allowed contact with the rotating gas producer components. The failure of the brazing was precipitated by an undetermined defect at the time of manufacture.

A defect in a braze bond in the engine's air diffuser, which occurred for an undetermined reason at the time of manufacture, created a localized stress concentration that, over time, resulted in the progressive failure of the braze bond and led to an engine failure.

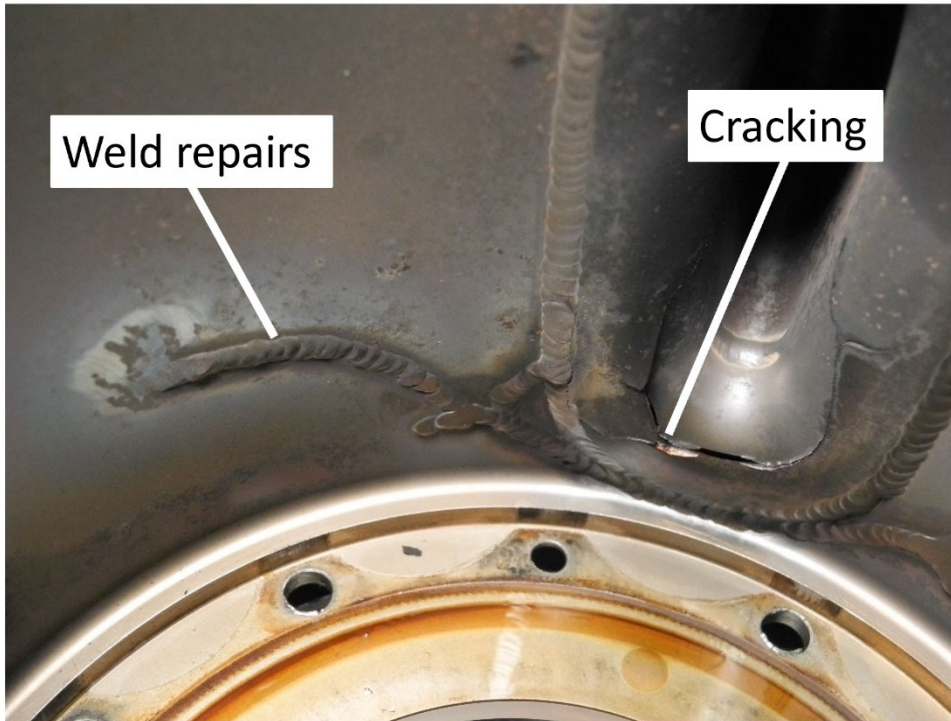
The occurrence exhaust diffuser was observed to have several welding repairs and cracks. Several cracks were noted in every power turbine bearing housing inner support strut (Figure 6).

Figure 6. Welding repairs and cracks on the occurrence exhaust diffuser (Source: National Transportation Safety Board of the United States)

Discussions with the OEM revealed that the cracking observed on the bearing housing supports are commonly found on exhaust diffusers due to normal engine operation. The investigation determined that the occurrence exhaust diffuser had been in use for approximately 933 hours since overhaul/repair at the time of the accident.

It was also indicated that there were no limitations as to the length of cracking that can be repaired. However, if there are cracks greater than 2 inches in length in the parent metal, then the repair does require post-weld heat treatment. In the occurrence aircraft, the repaired cracks were greater than 2 inches in length and were heat-treated post-weld.

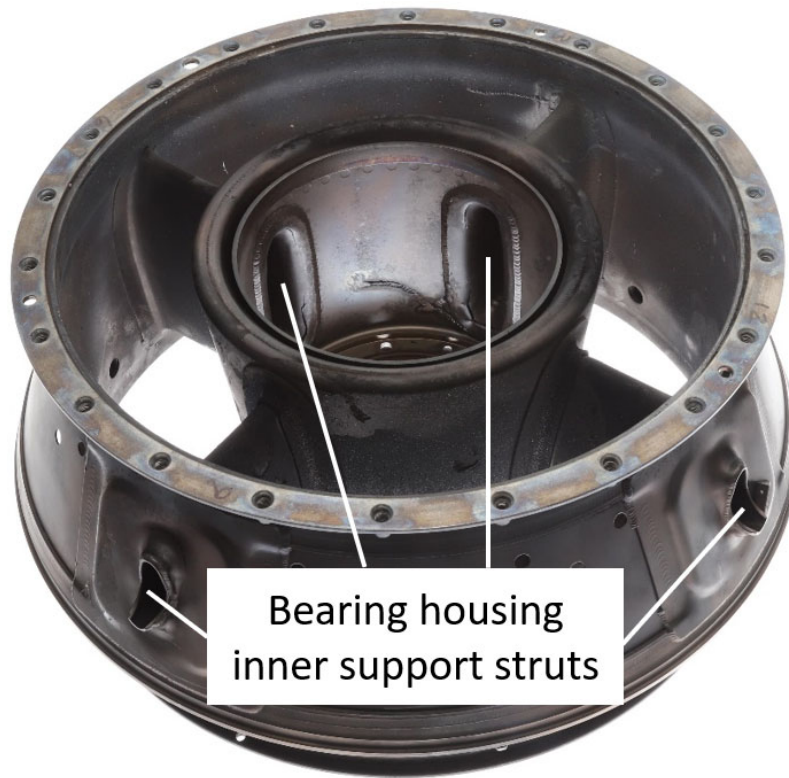
However, in this occurrence, the extensive cracking found in the exhaust diffuser was related to the loss of the No. 2 bearing support at the air diffuser. This would have added additional loading on the exhaust diffuser's power turbine bearings (No. 3 and No. 4) housing inner support struts (Figure 7).

Figure 7. Exhaust diffuser showing the bearing housing inner support struts (Source: TSB)

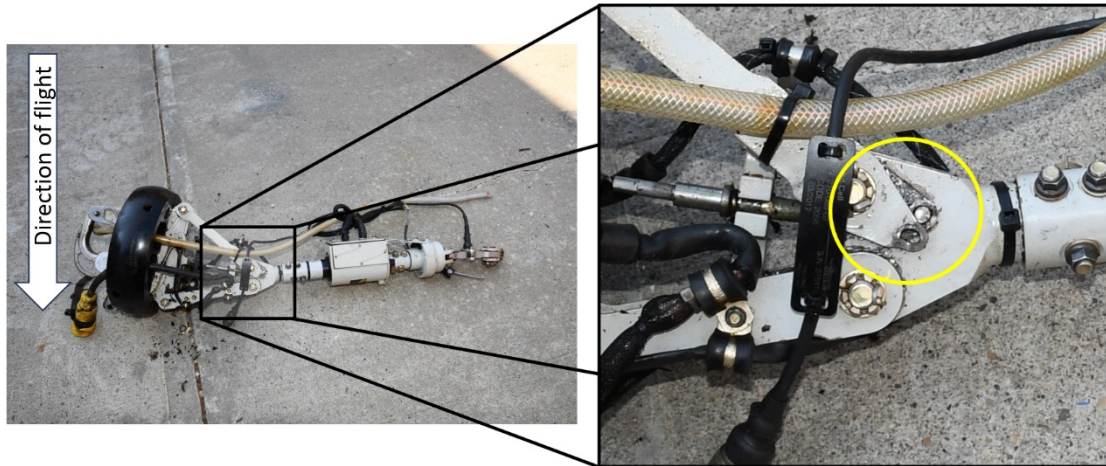
The occurrence suspension system showed signs of deformation consistent with a strong aft-ward force being applied (Figure 9).

Figure 9. Suspension system with close-up view (right image) of deformation (Source: TSB)

Post-accident, the cargo hook showed no damage and still functioned as designed with the manual release.

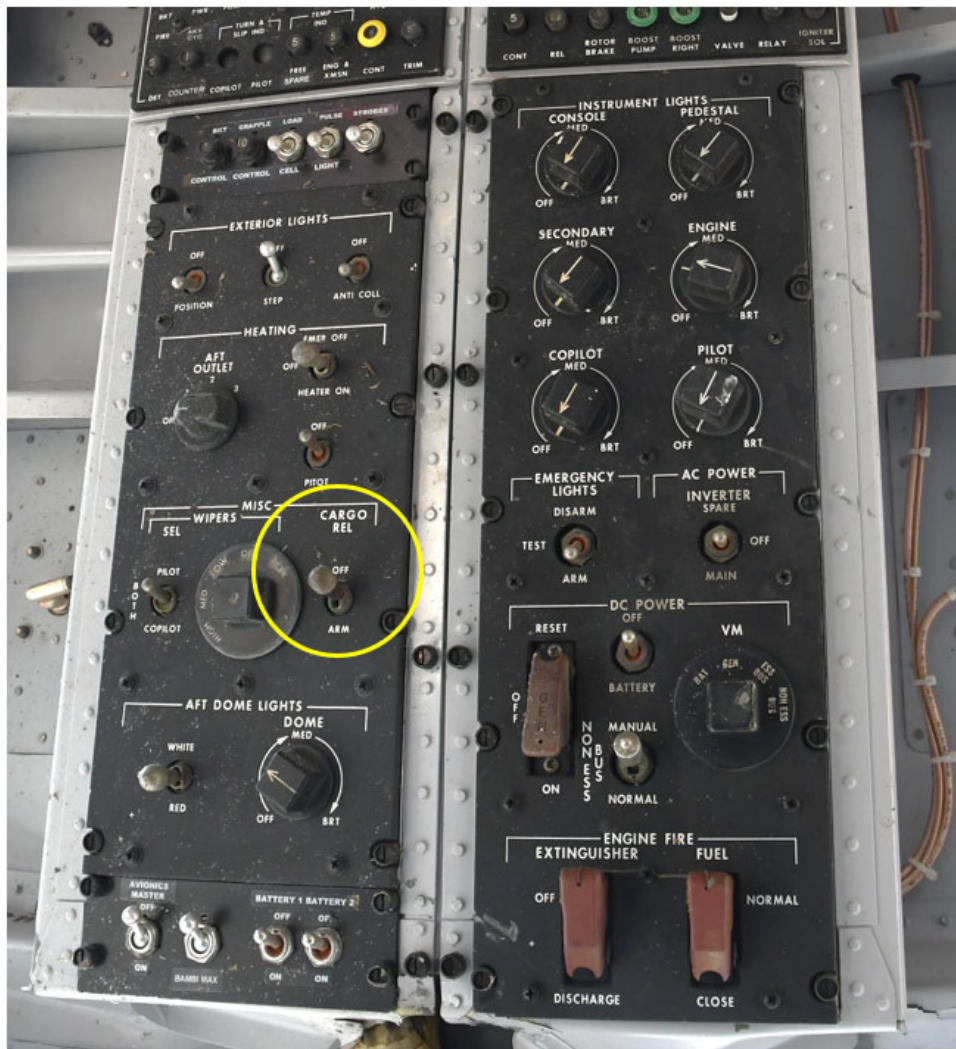
In the occurrence aircraft, the CARGO REL switch was found in the OFF position. The investigation determined that it was common for pilots at Valhalla Helicopters Inc. to conduct external cargo⁸ operations with the CARGO REL switch in the OFF position.

Figure 11. CARGO REL [cargo release] switch, as found post-accident, on the overhead panel of the occurrence helicopter. DC Power and Battery switches were selected OFF, post-accident, for safety reasons. (Source: TSB)

Given that the CARGO REL switch was in the OFF position, it would have been very difficult to jettison the load using this switch in the short time between the engine failure and the impact with terrain.

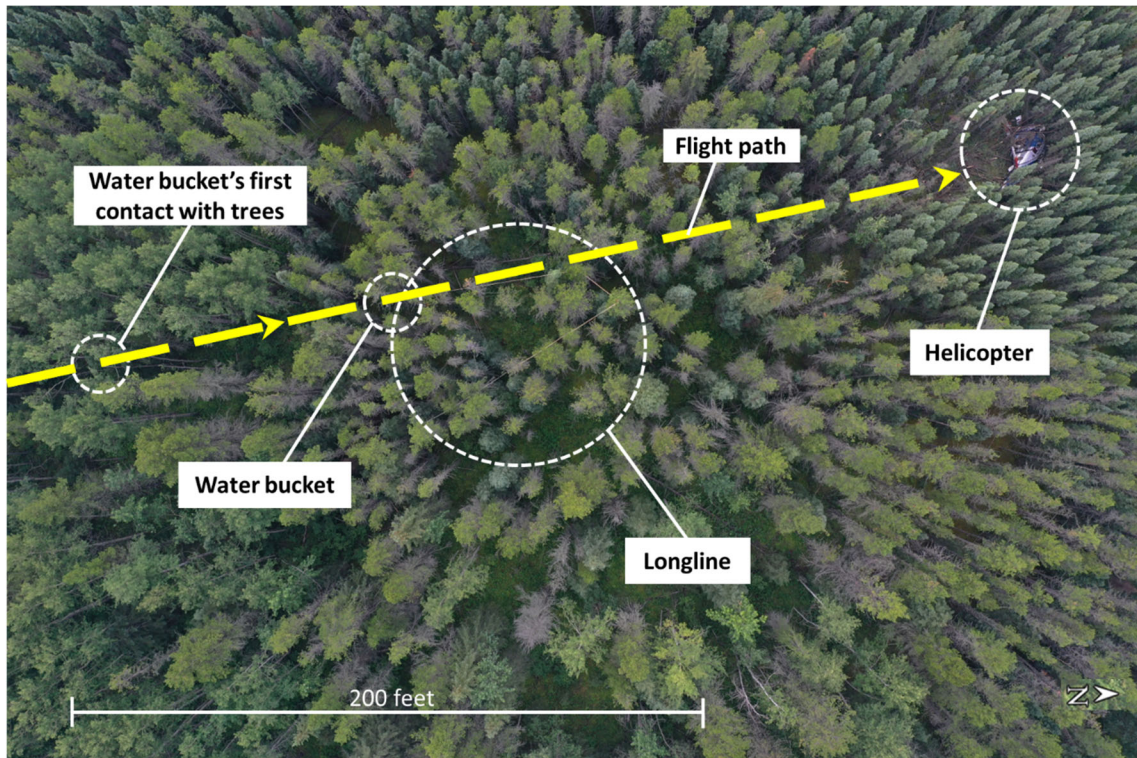
A 150-foot longline was attached to the helicopter's cargo suspension system. Investigators found the line wrapped around treetops in the vicinity of the impact site. The longline was stretched with enough force to melt¹⁴ and subsequently solidify portions of the Kevlar line.

Several patches of trees were missing treetops along the helicopter's final approach flight path, near where the water bucket was located.

Figure 13. Overhead view of the wreckage trail, showing the locations of the water bucket, longline, and helicopter in relation to the flight path (Source: Royal Canadian Mounted Police, with TSB annotations)
