Aviation Investigation Final Report

Location:	Nuevo, California	Accident Number:	ANC23FA031
Date & Time:	March 24, 2023, 12:17 Local	Registration:	N14Z
Aircraft:	BELL HELICOPTER TEXTRON 407	Aircraft Damage:	Destroyed
Defining Event:	Low altitude operation/event	Injuries:	2 Fatal
Flight Conducted Under:	Part 91: General aviation - Personal

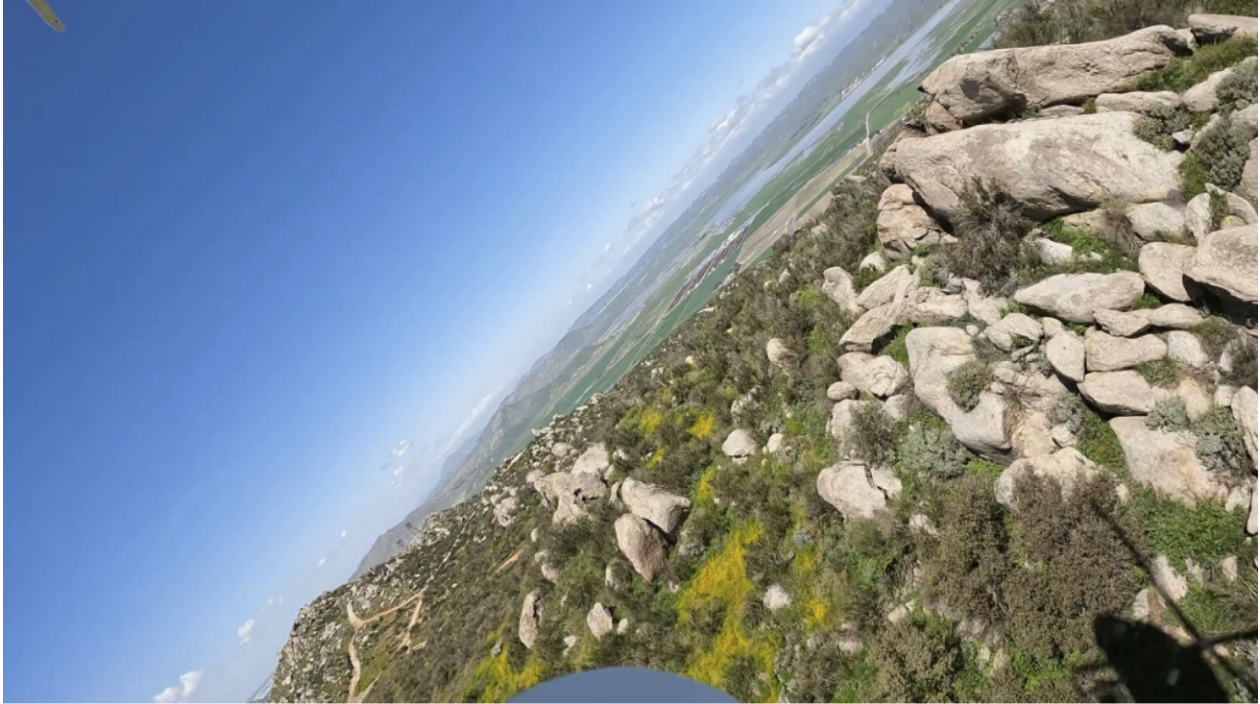
About 3 minutes later, the pilot flew over the next line of hills at an altitude of about 30 ft agl, then turned left and flew low-level along a ridgeline. As the pilot approached the crest of the ridgeline, he initiated a steep right turn in a bank of about 60°. See figure 1.

Figure 1. Video frame from on board Go-Pro camera seconds before impact, with main rotor blade seen in upper left of photo.

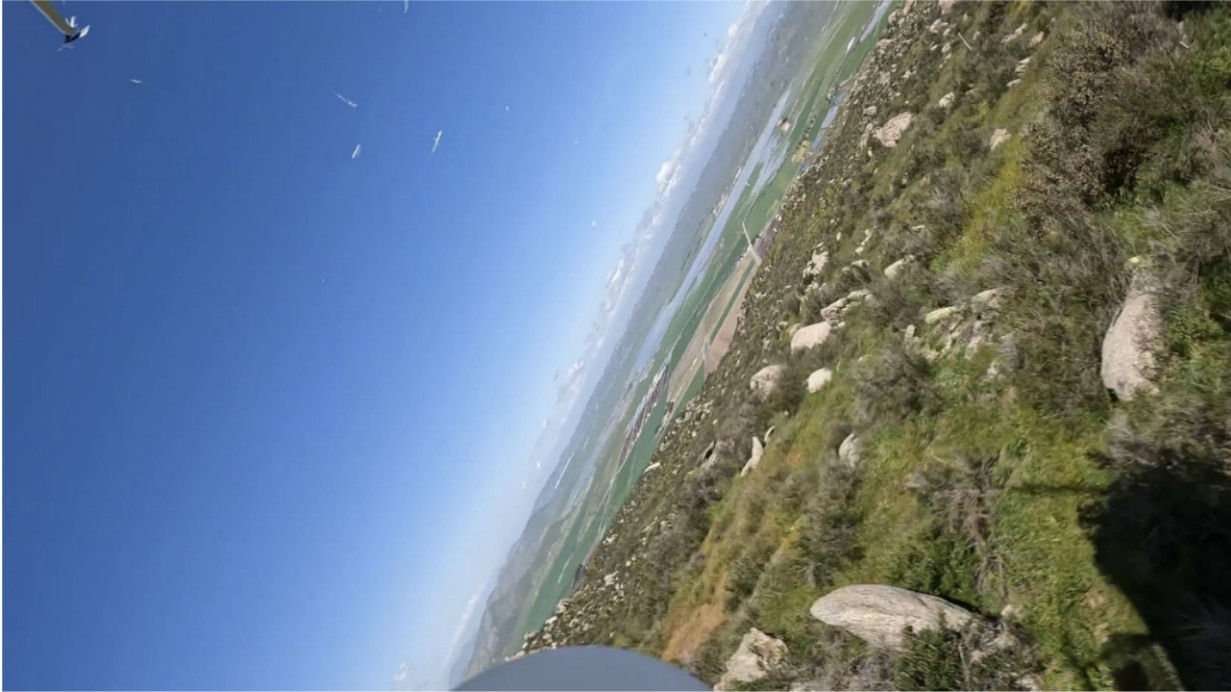
The pilot's decision to maneuver in a steep bank at a low altitude, which resulted in his failure to maintain clearance with terrain.

Moments later, as the helicopter passed over a rocky outcropping at the top of the hill, the main rotor blade contacted terrain and shards of main rotor blades can be seen on the video. See figure 2.

Figure 2. Video frame from on board Go-Pro camera at point of impact, with portions of fragmented main rotor blade seen in upper left of photo.
