Aviation Investigation Preliminary Report

Location:	Washington, DC	Accident Number:	DCA25MA108
Date & Time:	January 29, 2025, 20:48 Local	Registration:	N709PS (A1); UNREG (A2)
Aircraft:	BOMBARDIER INC CL-600-2C10 (A1); Sikorsky UH60 (A2)	Injuries:	64 Fatal (A1); 3 Fatal (A2)
Flight Conducted Under:	Part 121: Air carrier - Scheduled (A1); Armed Forces (A2)

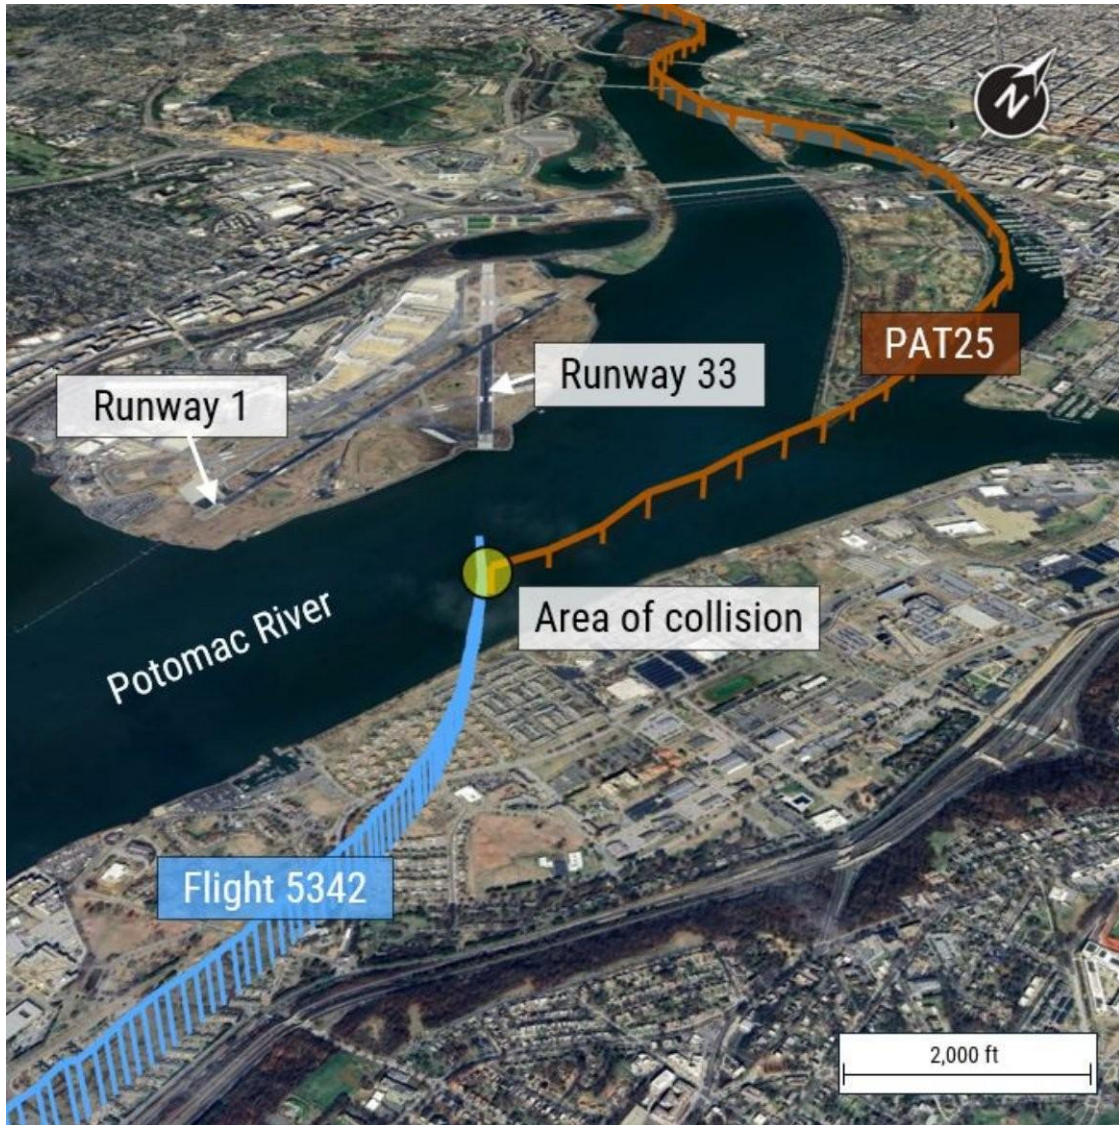
Figure 1. Google Earth image with preliminary ADS-B data for flight 5342 (blue line) and radar data for PAT25 (orange line).

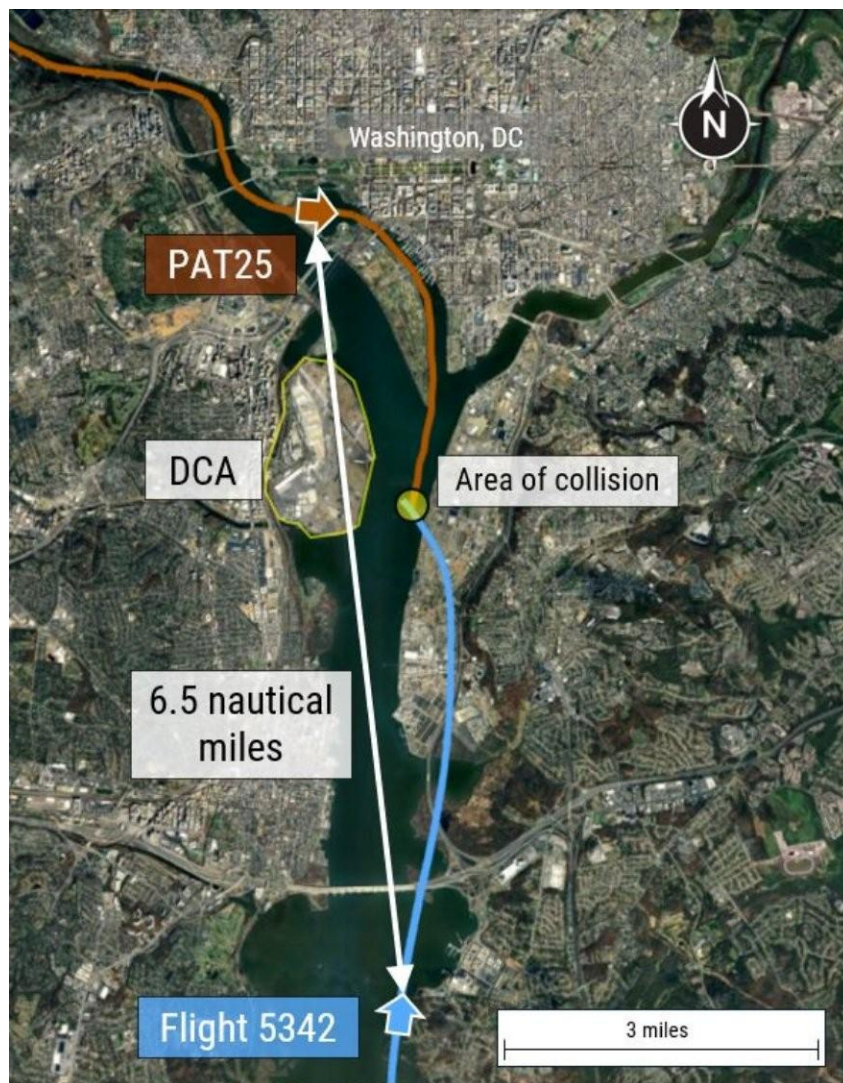
At 2046:08, the PAT25 crew reported that they had the traffic in sight and requested to maintain visual separation. The controller approved the request. At this time, the distance between the two aircraft was about 6.5 nm. Figure 2 shows each aircraft's approximate position at 2046:02, when the controller first advised the crew of PAT25 of flight 5342.

Figure 2. Google Earth image with airplane and helicopter preliminary flight tracks overlaid, and each aircraft's approximate position shown at 2046:02.

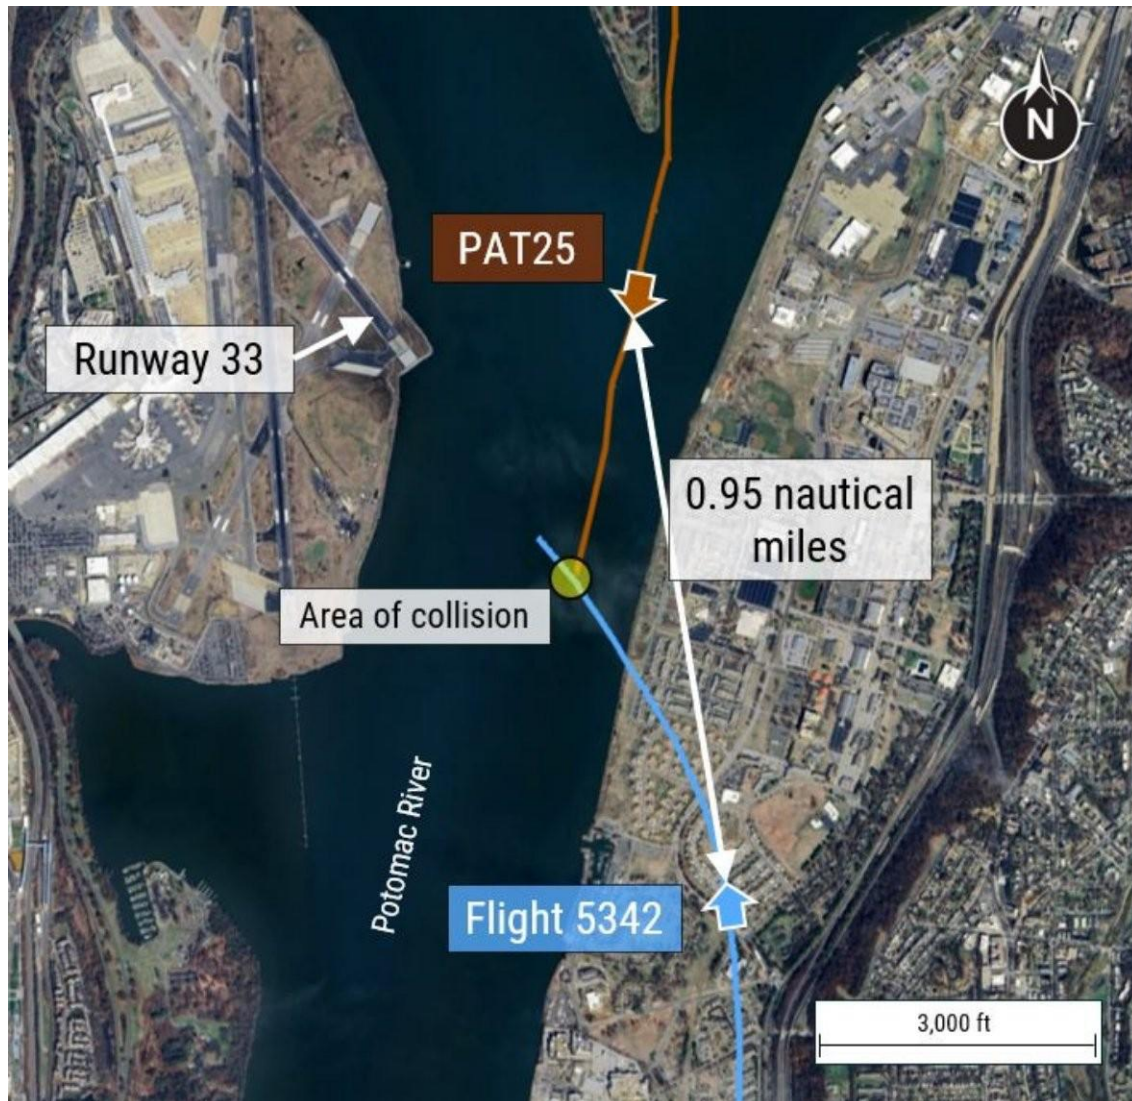
At 2047:40, the crew of flight 5342 received an automated traffic advisory from the airplane's traffic alert and collision avoidance system (TCAS) system stating, "Traffic, Traffic." At this time, the aircraft were about 0.95 nm apart, as shown in Figure 3.

Figure 3. Google Earth image showing the approximate positions of both aircraft at 2047:40.

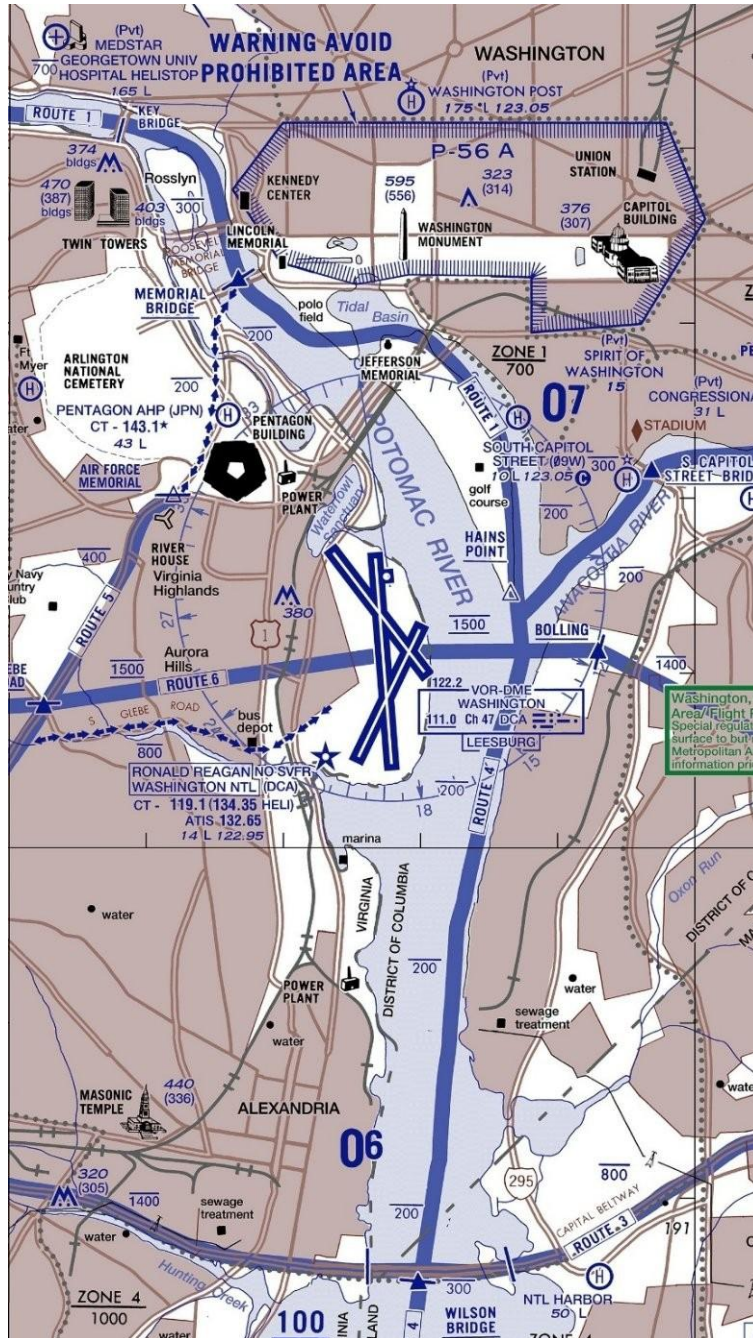
The Baltimore-Washington Helicopter Route Chart contains the helicopter routes for the Washington, DC area; the area immediately surrounding DCA is excerpted below (see figure 4). PAT25’s route on the night of the accident included Route 1, which begins in Cabin John, Maryland, and follows the western shore of the Potomac River southeast toward Washington, DC. After crossing Key Bridge, the route follows the eastern shore of the Potomac with the Kennedy Center and Lincoln Memorial to the east and Roosevelt Island to the west, crossing Memorial Bridge (a compulsory reporting point). After Memorial Bridge, the maximum allowable altitude on Route 1 is 200 ft above mean sea level (msl).

Figure 4. Excerpt of FAA Baltimore-Washington Helicopter Chart showing the area surrounding DCA. (Source: FAA.)

Route 1 then continues south of the Washington Monument, crossing West Potomac Park and the Tidal Basin before following the Washington Channel along East Potomac Park. Hains Point, the southernmost tip of East Potomac Park and located at the confluence of the Potomac and Anacostia rivers, is identified as a non-compulsory reporting point and the area where Route 4 intercepts Route 1. Route 4 continues south to the Woodrow Wilson Bridge

along the Potomac River's eastern shore, with DCA to the west. South of Wilson Bridge, the maximum allowable altitude along Route 4 increases from 200 ft msl to 300 feet msl.

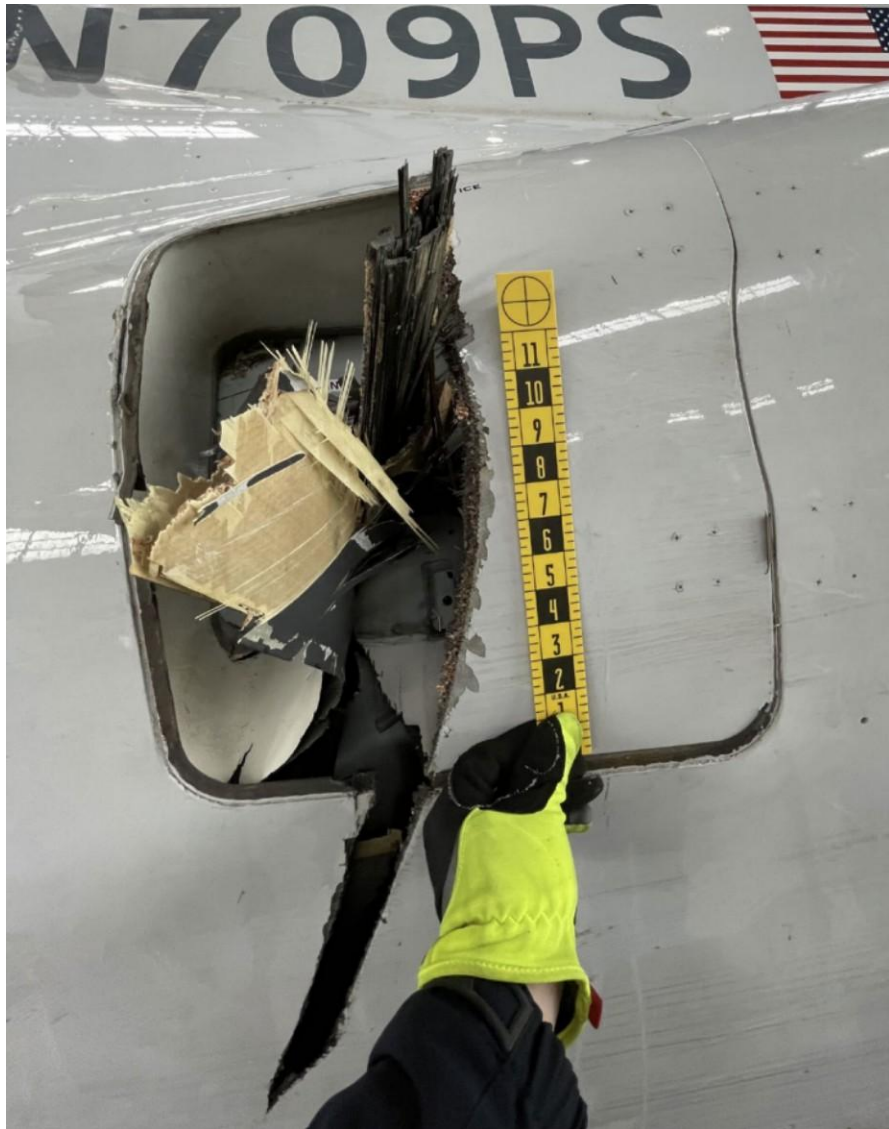
The airplane sustained extensive water impact damage to most of its structure. The fuselage was recovered in 13 major sections comprising the entire length of the airplane, from the radome in the nose to the aft fuselage and tail cone. Two areas of damage were noted to the lower right side aft fuselage wing-to-body fairing. There was a puncture in the right side of the fairing about 10 inches (in) by 8 in, and a slash through the lower surface of the fairing, internal structure, and lavatory access door about 29 in long by 2 in wide. An approximate 2-ft-long section of one of the helicopter's tail rotor blades was embedded in the slash (see figure 5).

Figure 5. Damage to aft fuselage with tail rotor blade.

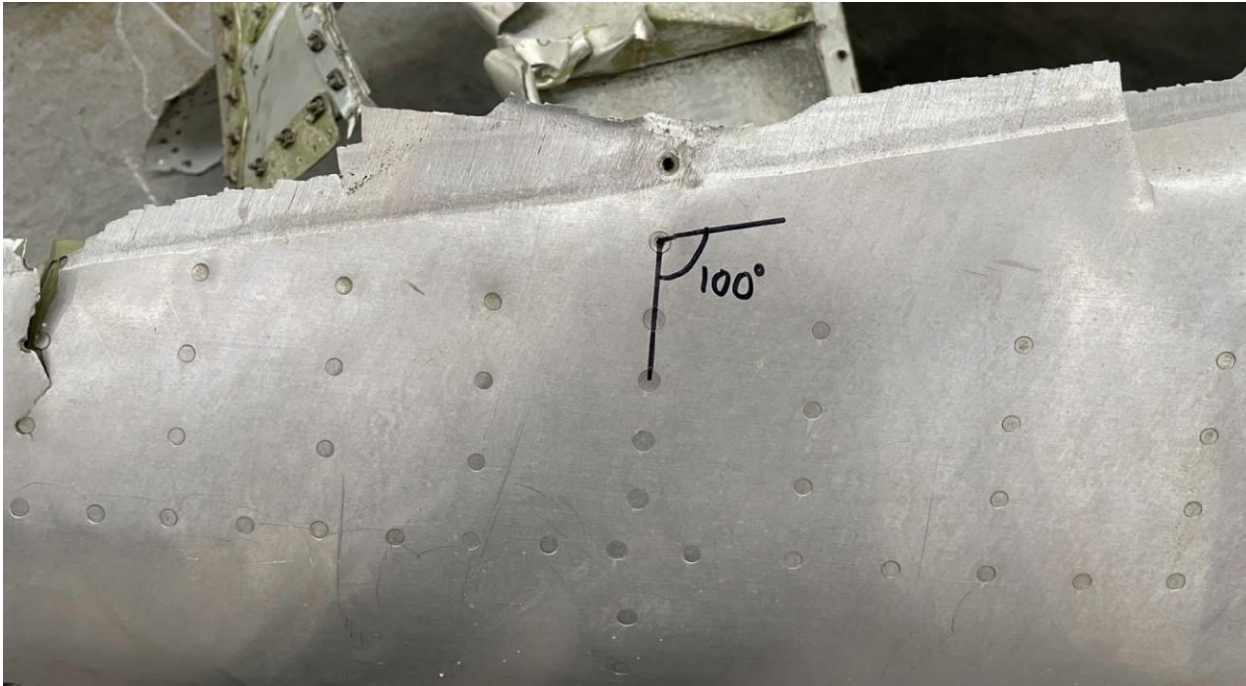
The inboard left wing between the airplane's centerline and wing station (WS) 178 was significantly fragmented. The upper portion of the left main landing gear remained attached to the left wing and the lower portion was separated; the outboard tire displayed a diagonal slash through all its layers. The outboard left wing from WS 178 to the wingtip was separated and recovered in the debris field. The inboard end of the left center slat displayed a linear slash mark about 52 inches long (see figure 6). The slat skin aft of the leading edge of the slash was

gouged and abraded linearly aftward. The left wing forward spar aft of the slat was also cut along the same diagonal line, and the interior wing structure was damaged and deformed aft and inboard. There was some black paint transfer on the interior wing structure.

Figure 6. Close up view of slash mark displayed on left outboard slat.

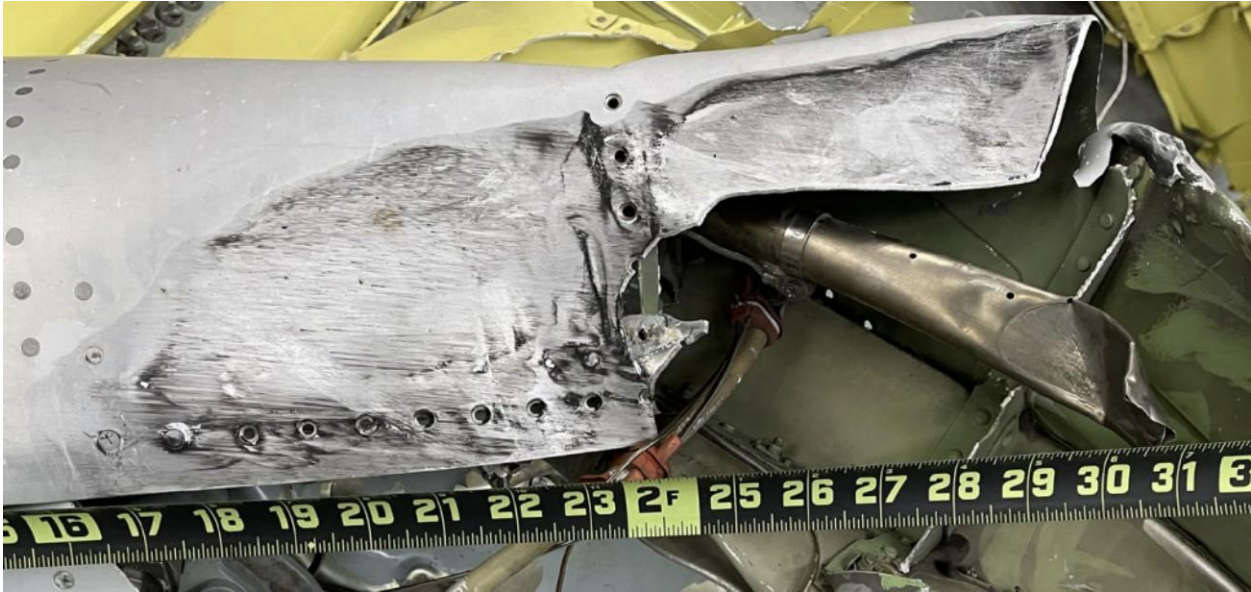
Two other sections of the inboard left slat displayed impact/denting and associated black paint transfer (see figure 7). Various pieces of fibrous materials were found in multiple sections of the airplane, including the left wing and vertical stabilizer. Samples of the fibrous material were collected for documentation and identification at the NTSB Materials Laboratory.

Figure 7. Close up view of impact mark on left inboard slat.
