Aviation Investigation Final Report

Location:	Hydro, Oklahoma	Accident Number:	CEN24FA094
Date & Time:	January 20, 2024, 23:23 Local	Registration:	N295AE
Aircraft:	Bell 206	Aircraft Damage:	Destroyed
Defining Event:	Birdstrike	Injuries:	3 Fatal
Flight Conducted Under:	Part 135: Air taxi & commuter - Non-scheduled - Air Medical (Discretionary)

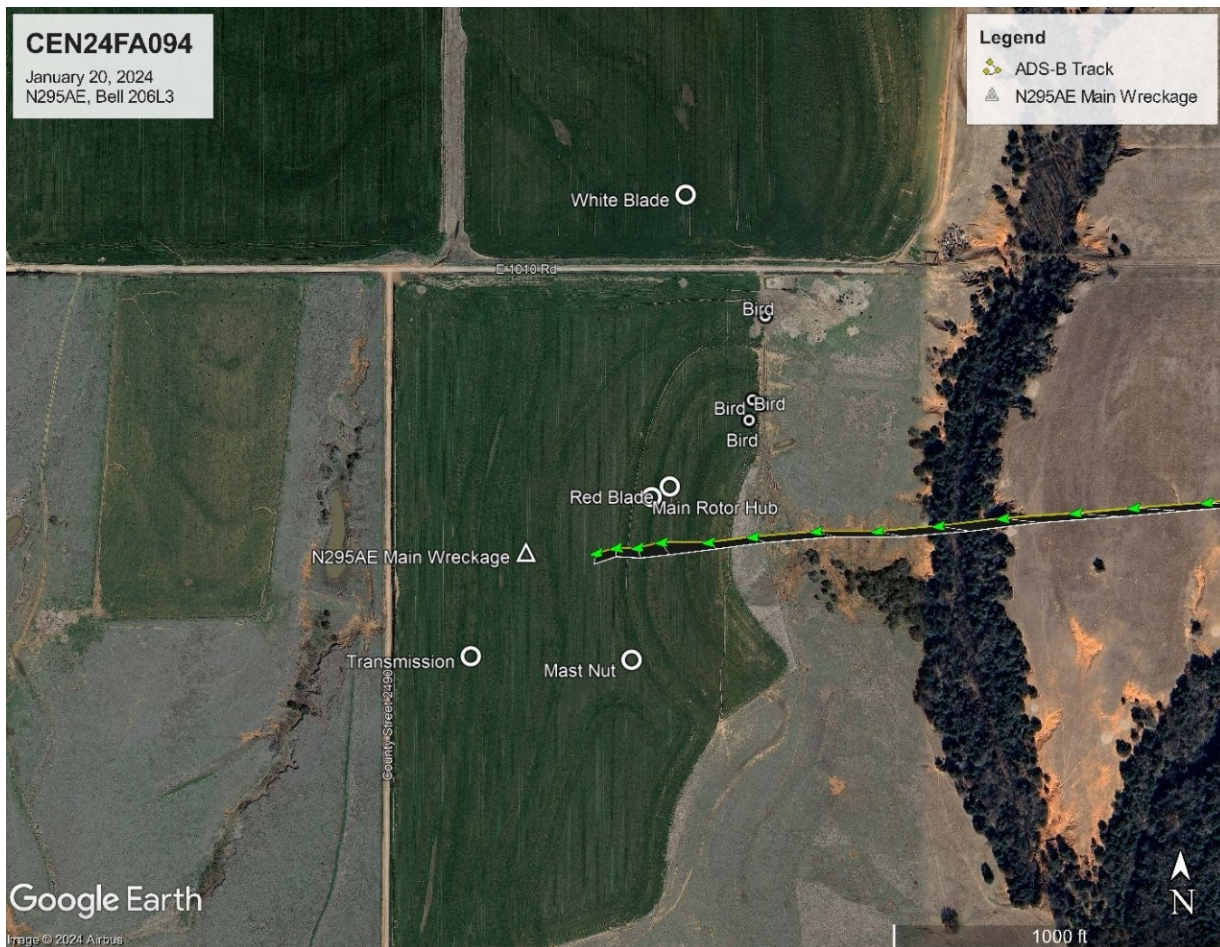
ADS-B data captured the accident flight as it departed OL16 and flew west towards OL16 between 500 ft and 600 ft above ground level and about 110 knots groundspeed. The last ADS-B point was at 2323:39 about 210 ft east of the main wreckage location (see Figure 1).

Figure 1. ADS-B Flight Track with Wreckage and Bird Locations

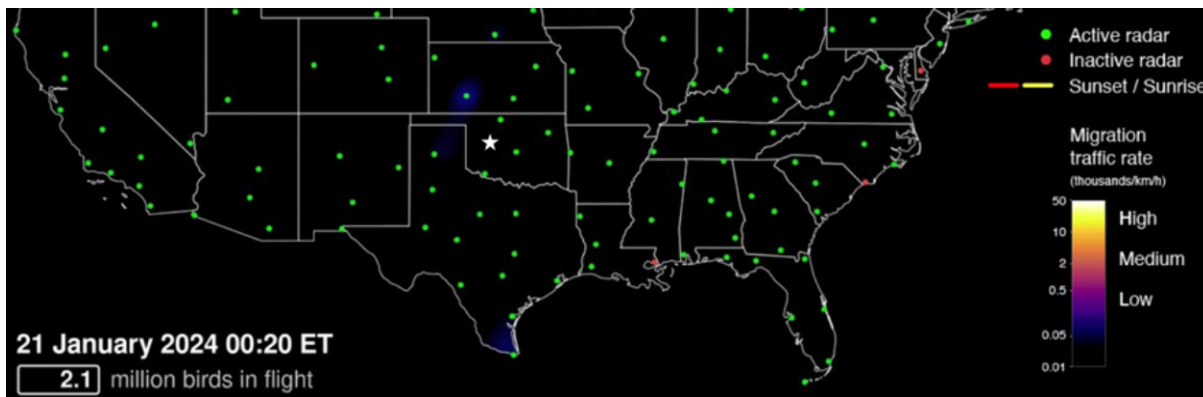
In addition, another bird avoidance resource, BirdCast, uses a collaboration of radar and spotter information to provide near-real-time models of bird activity. A review of historic data contained on their website showed no significant bird activity in the vicinity of the accident (see Figure 2)

Figure 2. BirdCast Information – Accident location annotated by a white star.
