# Aviation Investigation Final Report

| <b>Location:</b> | Hildale, Utah | <b>Accident Number:</b> | WPR24LA161 |
| <b>Date &amp; Time:</b> | May 27, 2024, 08:00 Local | <b>Registration:</b> | N57948 |
| <b>Aircraft:</b> | Aerospatiale SA315B | <b>Aircraft Damage:</b> | Substantial |

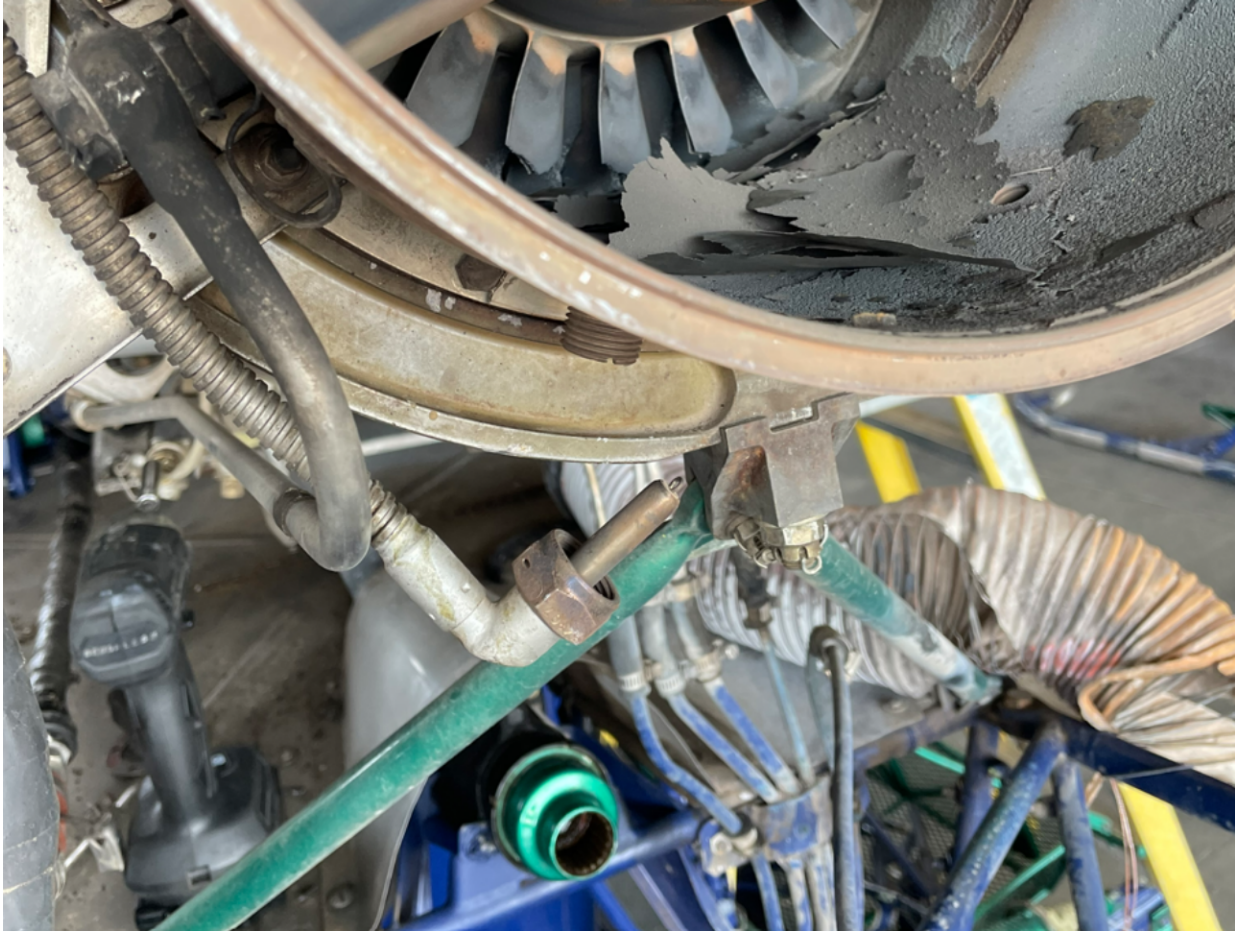
Figure 1 – Loose Thermocouple

Although the mechanic stated that he checked the thermocouples after maintenance, the accident is consistent with maintenance personnel not securing the thermocouples properly. This resulted in lower EGT temperatures being presented to the pilot than what were being generated by the engine during operation. It is therefore likely that the pilot unknowingly exceeded the engine’s operating temperature limits, resulting in a catastrophic overtemperature event and total loss of engine power.

The engine uses two thermocouples to provide a signal to the EGT gauge in the cockpit. Upon external examination of the engine, the lower thermocouple was found to be hanging loose from its boss on the exhaust section (Figure 1). A review of photographs taken onsite showed that the lower thermocouple was in the same loose condition immediately following the accident (Figure 2). The upper thermocouple was found tight but not safety wired. The engine maintenance manual states that the thermocouple retention nut should be secured using stainless steel wire during installation. The upper probe was found with thermal damage that melted the probe wire in the gas path. The lower probe did not exhibit any damage. No additional preimpact anomalies were noted with the engine or airframe.
