Aviation Investigation Preliminary Report

Location:	Mountain Home Park, WA	Accident Number:	WPR25FA114
Date & Time:	March 19, 2025, 12:28 Local	Registration:	N23SD
Aircraft:	Bell 206B II	Injuries:	1 Fatal
Flight Conducted Under:	Part 137: Agricultural

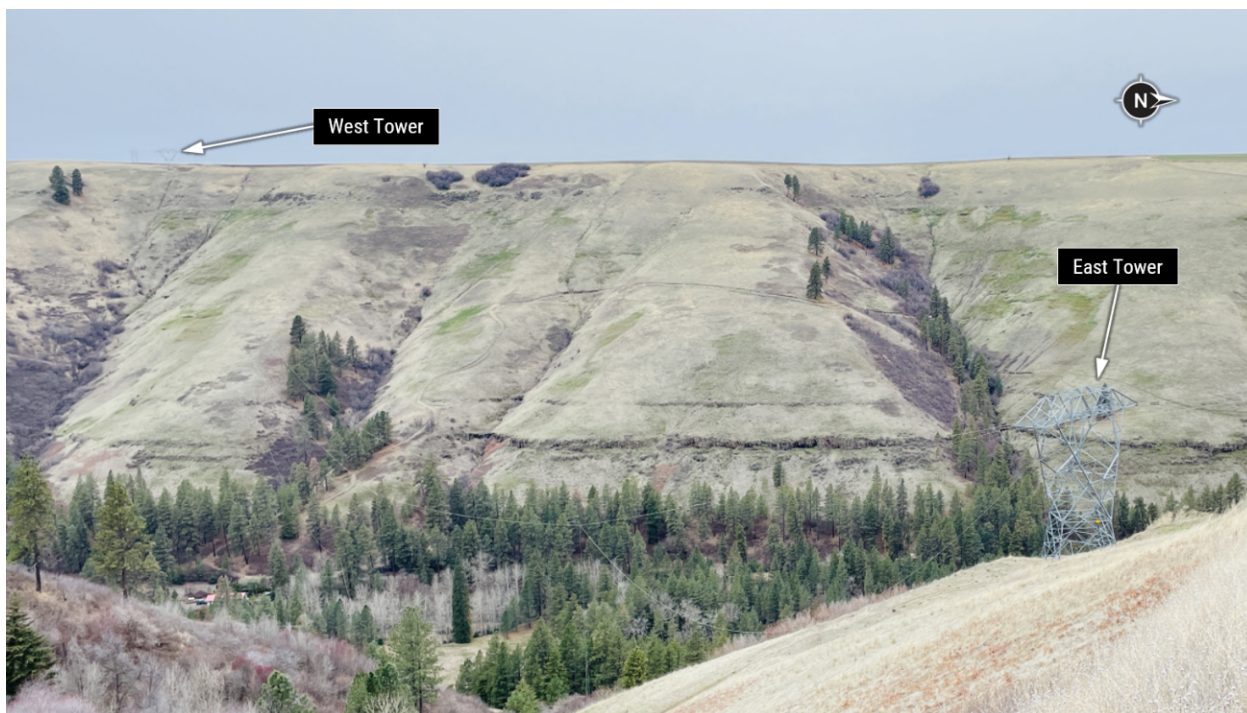
The accident site was located within a canyon that was about 1,000 ft deep, about one mile wide, and oriented generally north/south. Three electrical cables crossed the canyon near the accident site, supported by two steel electrical towers that were about 4,200 ft apart. One steel tower was located on the west edge of the canyon, and the other tower was about 500 ft below the east rim of the canyon. The southern cable displayed frayed wires, and the center cable was severed. (Fig. 1)

Figure 1: The electrical towers and cables, viewed from the east side of the canyon.
