# Aviation Investigation Preliminary Report

<b>Location:</b>	Mountain Home Park, WA	<b>Accident Number:</b>	WPR25FA114
<b>Date &amp; Time:</b>	March 19, 2025, 12:28 Local	<b>Registration:</b>	N23SD
<b>Aircraft:</b>	Bell 206B II	<b>Injuries:</b>	1 Fatal
<b>Flight Conducted Under:</b>	Part 137: Agricultural

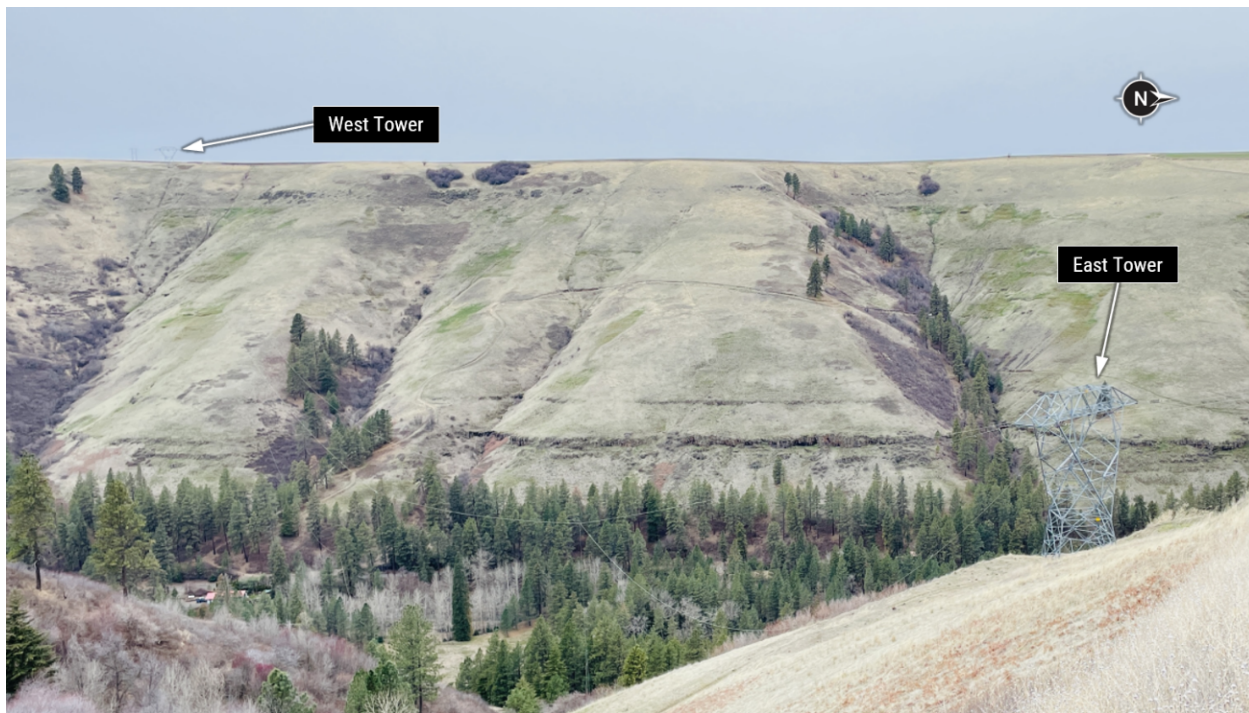
The accident site was located within a canyon that was about 1,000 ft deep, about one mile wide, and oriented generally north/south. Three electrical cables crossed the canyon near the accident site, supported by two steel electrical towers that were about 4,200 ft apart. One steel tower was located on the west edge of the canyon, and the other tower was about 500 ft below the east rim of the canyon. The southern cable displayed frayed wires, and the center cable was severed. (Fig. 1)

Figure 1: The electrical towers and cables, viewed from the east side of the canyon.

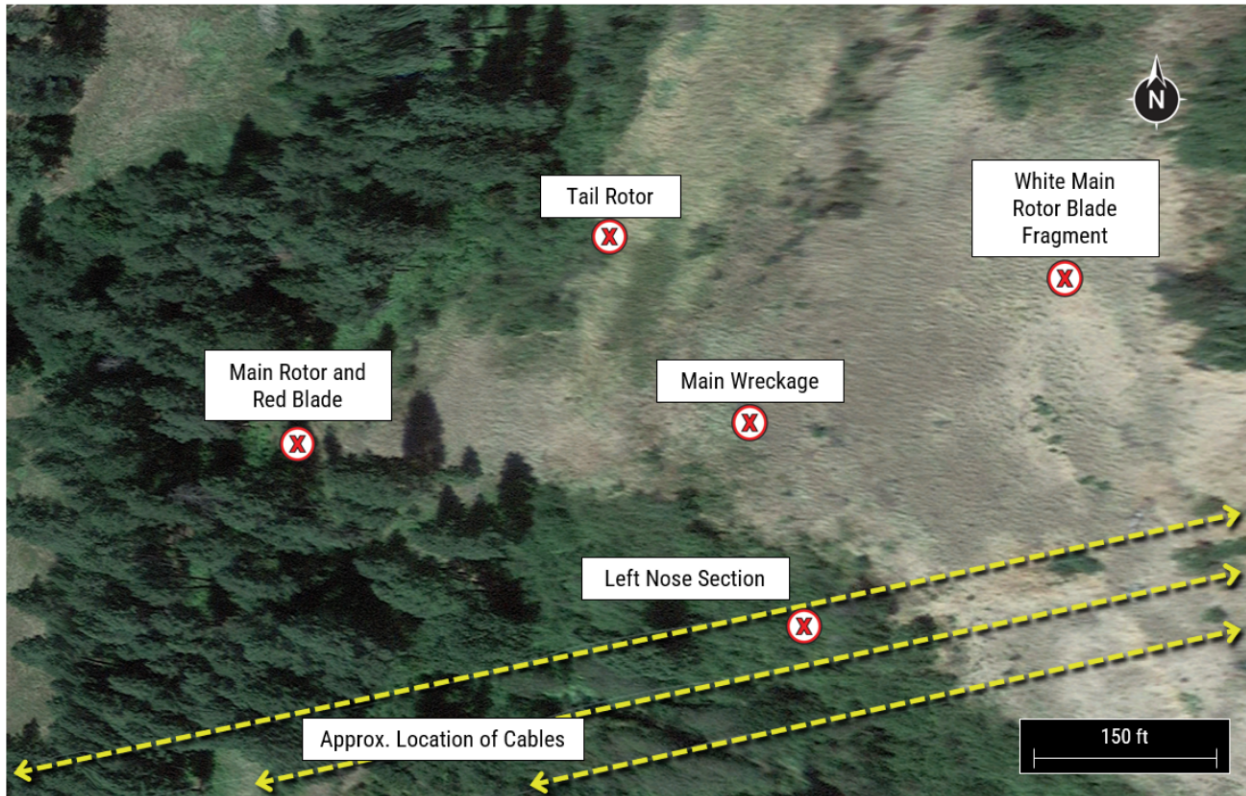
The accident site was situated on the east wall of the canyon, with the debris field below and north of the electrical cables. (Fig. 2) The helicopter main wreckage, which consisted of the majority of the fuselage, engine, and main rotor transmission, came to rest about 150 ft north of the wires on the east slope of the canyon. The front windscreens and chin bubbles were shattered. The left side of the nose and left forward door had separated and was found beneath the power cables. The right side of the nose section was fragmented and came to rest near the main wreckage.

Figure 2: The helicopter wreckage distribution.

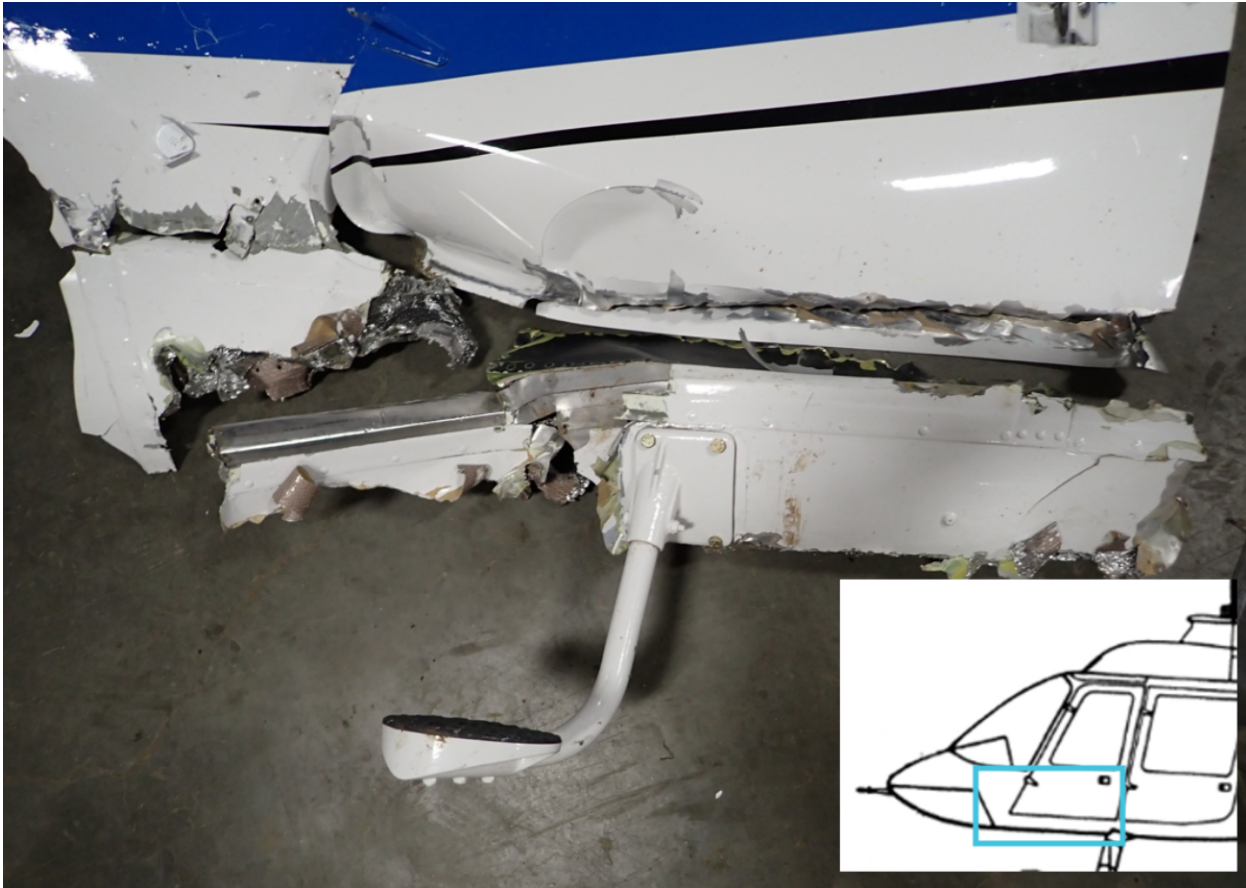
Impact signatures were observed on the left nose section and fuselage consistent with contact with an electrical cable. Damage consistent with cable tearing was observed along the aft frame of the left chin bubble, extending aft through the forward lower door frame to the aft left cabin doorframe. (Fig. 3)

Figure 3: Tearing on the lower left fuselage. The inset depicts the area of damage on a model, with the damage area shown in the blue box.
