Aviation Investigation Final Report

Location:	Caldwell, Ohio	Accident Number:	ERA23LA309
Date & Time:	July 23, 2023, 14:20 Local	Registration:	N482TJ
Aircraft:	Bell 206-L4	Aircraft Damage:	Substantial
Defining Event:	Unknown or undetermined	Injuries:	1 Serious
Flight Conducted Under:	Part 133: Rotorcraft ext. load

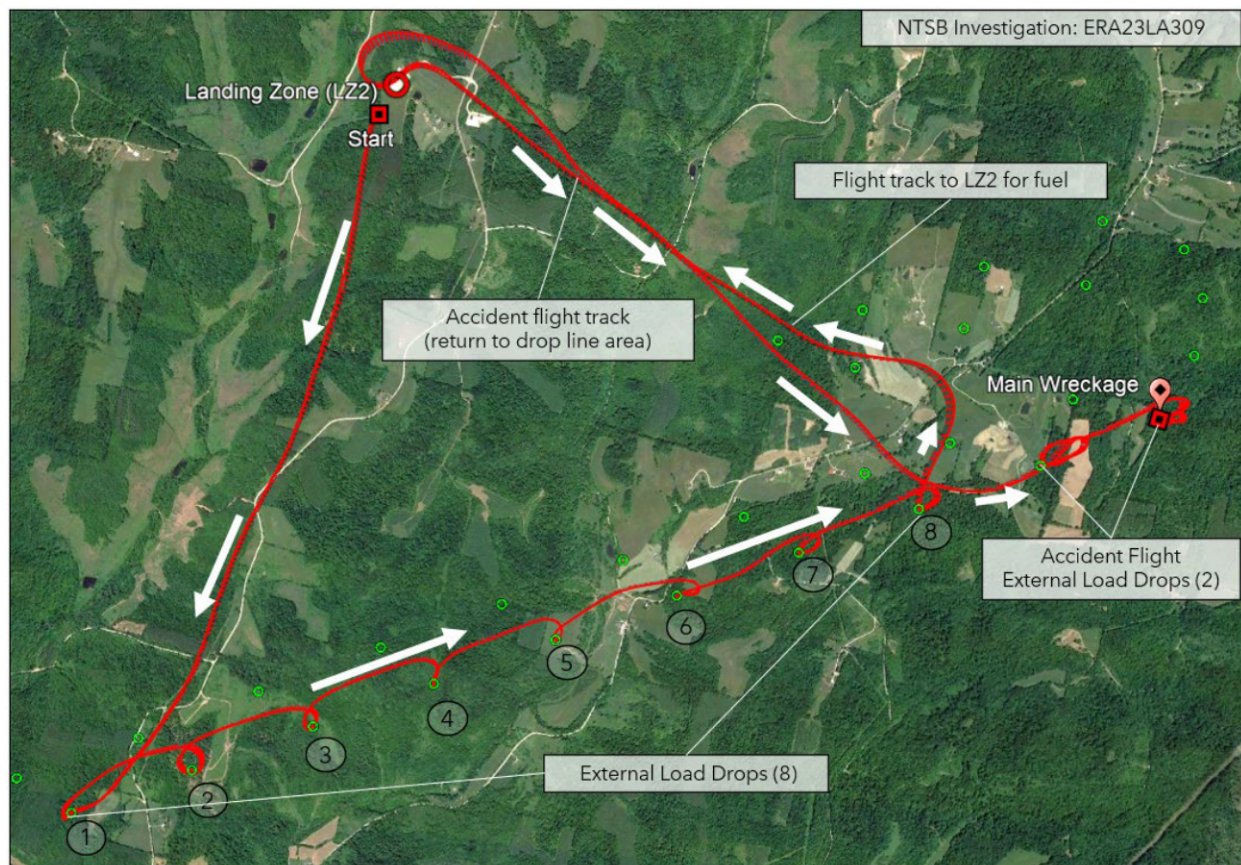
Flight track data indicated that the pilot maneuvered the helicopter southeast of LZ2 for about 45 minutes. The pilot completed one cargo load drop involving a bag that weighed 130 pounds, resulting in a helicopter external load weight of 940 pounds after the drop. The pilot then maneuvered toward the next drop zone. The flight track showed that the helicopter circled over the area of the accident site before descending through trees in a near-vertical (straight-down) path and impacting terrain. Figure 1 shows the helicopter's path over the drop zones and the locations of LZ2 and the accident site.

Figure 1. Flight track (red line), drop zones (green dots), and location of main wreckage at accident site. Note: The drop zones from the morning flights are number 1 through 8. The drop zones for the afternoon flights are labeled on the right side of the figure.

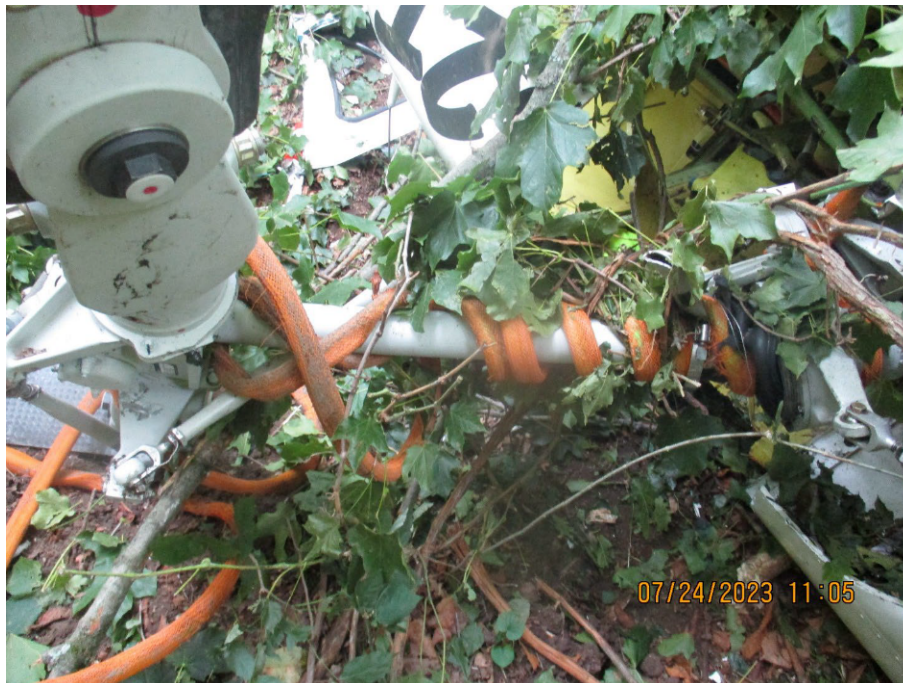
Postaccident examination of the helicopter found no anomalies that would have precluded normal operation. Additionally, the long line used for the external load operation was found partially wrapped around the main rotor mast and tangled in trees surrounding the wreckage. The cargo and emergency release hooks remained attached to the helicopter and the load, and the load was found near the wreckage. It could not be determined at what point during the accident sequence the long line became wrapped around the main rotor mast. Postaccident performance calculations indicated that the accident helicopter would have had sufficient capability to perform an out-of-ground-effect hover. Thus, the reason for the helicopter's uncontrolled vertical descent and impact with terrain could not be determined.

The long line used for external load operations was found partially wrapped around the main rotor mast, as shown in figure 2, and partially tangled in trees surrounding the main wreckage. The cargo hook (attached to the underside of the fuselage) was found closed with the long-line hook attached. The emergency hook release was also found closed. The cargo hook was tested, and when actuated the hook opened and the long line separated from the helicopter. The long line was measured and found to be 122 ft in length. The line exhibited tearing and abrasions about 14 ft below the point where it was connected with the cargo hook, consistent with where it had been wrapped around the main rotor mast. The eight cargo hooks on the external load carrier were found closed, and the cargo load to be dropped at the second drop zone was located about 20 to 30 ft from the main wreckage.

Figure 2. Long line wrapped around the helicopter main rotor driveshaft at the accident site. (Source: FAA)
