# Aviation Investigation Preliminary Report

| <b>Location:</b> | Kaparuk, AK | <b>Accident Number:</b> | ANC25FA044 |
| <b>Date &amp; Time:</b> | June 4, 2025, 10:55 Local | <b>Registration:</b> | N962MD |
| <b>Aircraft:</b> | ROBINSON HELICOPTER CO R66 | <b>Injuries:</b> | 2 Fatal |

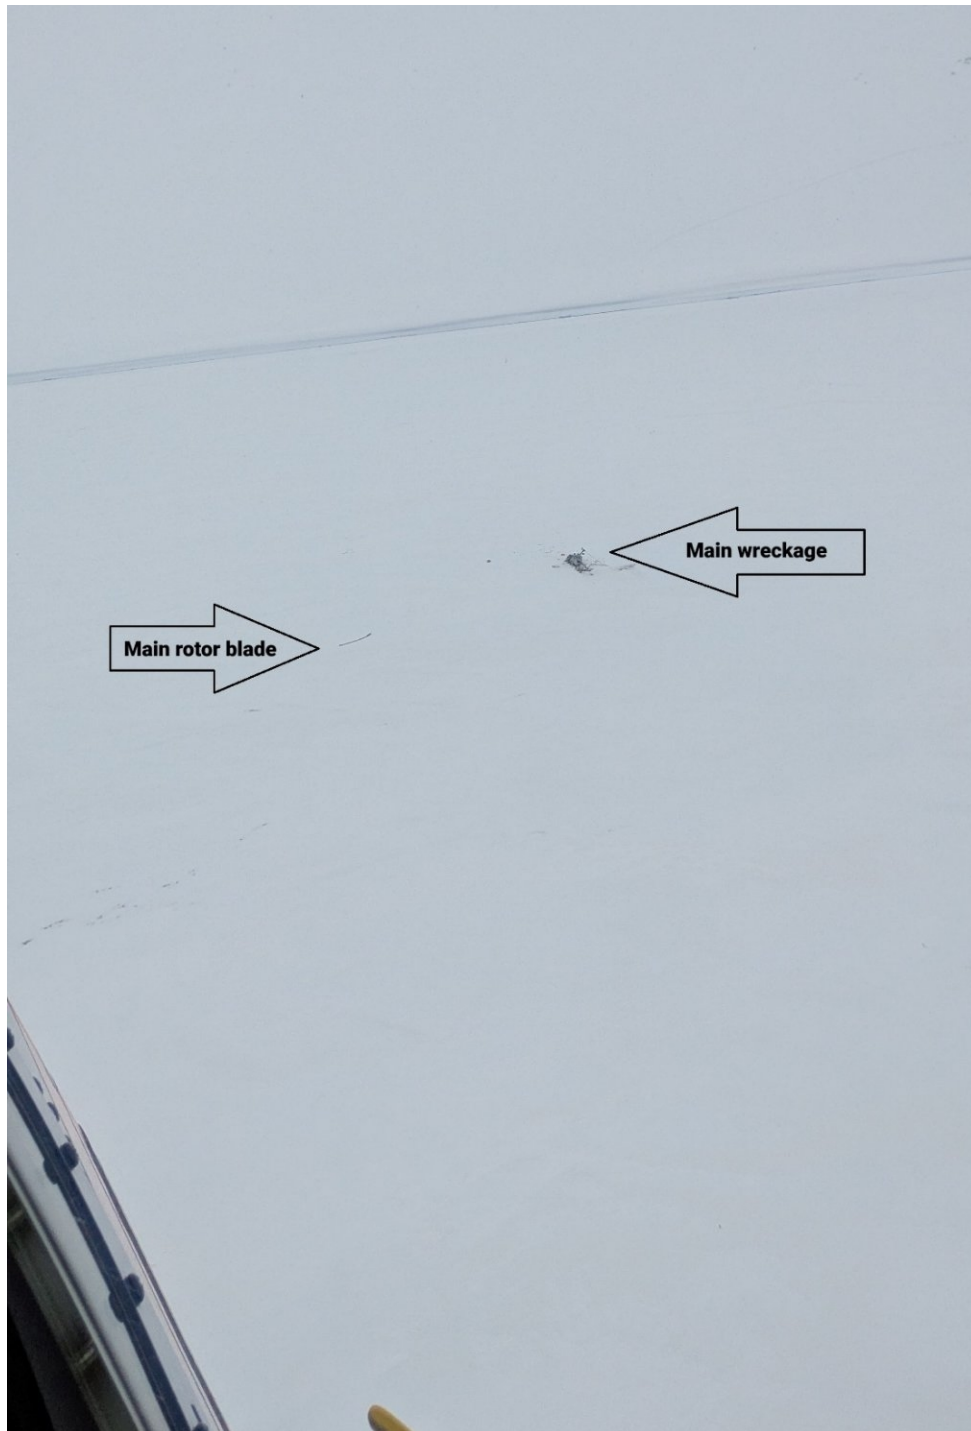
After an emergency locator transmitter (ELT) signal was received and attempts to reach the crew were unsuccessful, a North Slope Borough (NSB) Search and Rescue Sikorsky S-92 helicopter was dispatched from Utqiagvik (formerly Barrow), Alaska to search for the helicopter. NSB search and rescue crews found the helicopter wreckage about 25 miles west of Deadhorse in an area of flat, snow-covered, featureless terrain. See figure 1.

Figure 1. View of the wreckage from the search and rescue helicopter.

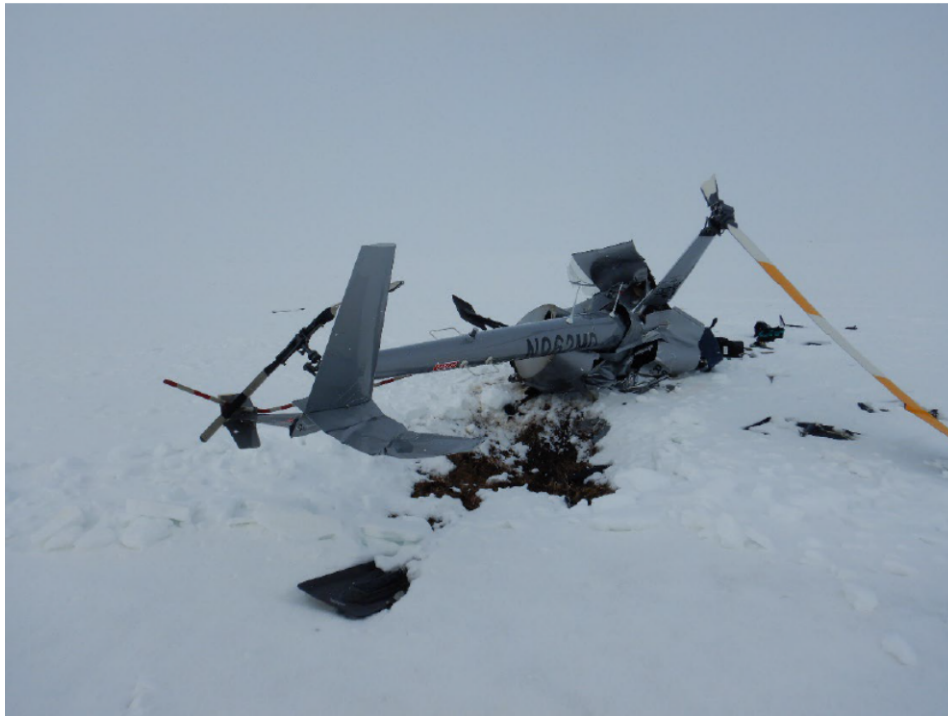
An initial examination of the helicopter wreckage revealed that all the helicopter's components were found at the accident site. The main wreckage came to rest about 11 feet from the initial impact point, and it showed significant down-stroking impact damage. One main rotor blade was found about 140 ft to the left of the main wreckage, and the other main rotor blade remained attached to the helicopter's main rotor hub. See figure 2

Figure 2. View of the wreckage at the accident site.
