# Aviation Investigation Final Report

| <b>Location:</b> | Oakdale, Illinois | <b>Accident Number:</b> | CEN23FA340 |
| <b>Date &amp; Time:</b> | July 31, 2023, 13:11 Local | <b>Registration:</b> | N567VF |
| <b>Aircraft:</b> | RICHARDS HEAVYLIFT HELO INC<br>UH-1H | <b>Aircraft Damage:</b> | Substantial |

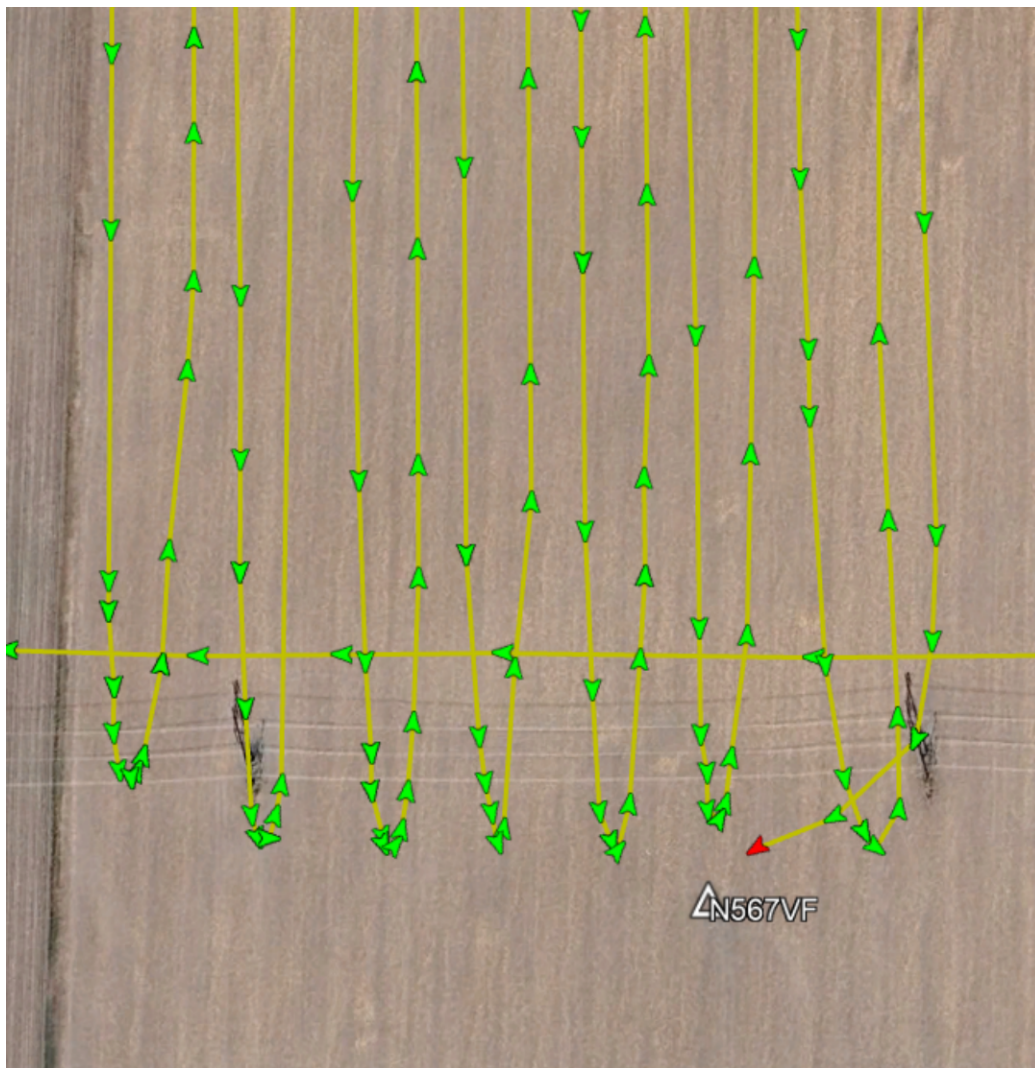
*Figure 1. ADS-B Data with Wreckage Location*

ADS-B data showed the helicopter departed the Mount Vernon Airport, Mount Vernon, Illinois, about 0714 CDT (all times CDT unless noted). After spraying several fields, the helicopter began to work the field closest to the accident site at 1305. The helicopter made several passes over the field from the north and south. Each pass appeared consistent with turns to the east to continue spraying the field. At 1310, the helicopter made a turn to the west over the powerlines and then impacted terrain.

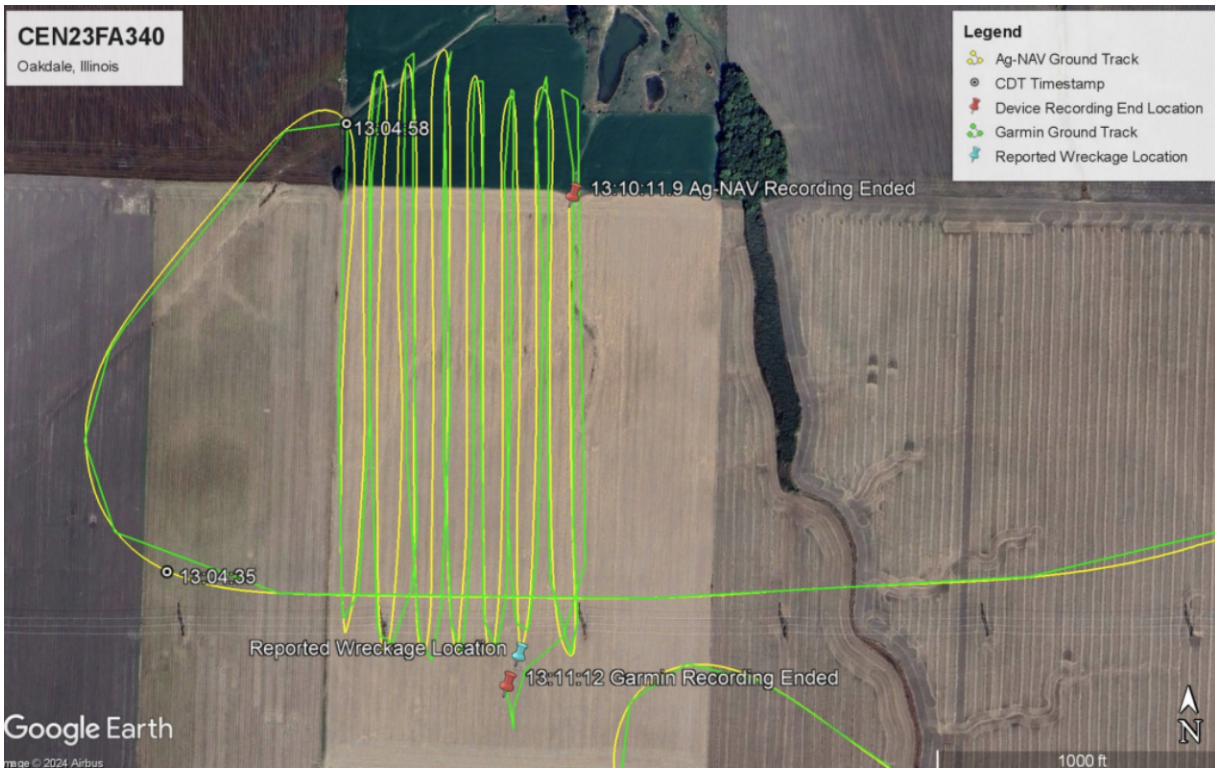
Figure 2. Charted Ag-Nav & Garmin GPS Data

Altitude data recorded by both devices were consistent with the pilot flying over the southern power lines for each turn to reverse course. The Ag-Nav did not record the helicopter's final climb.

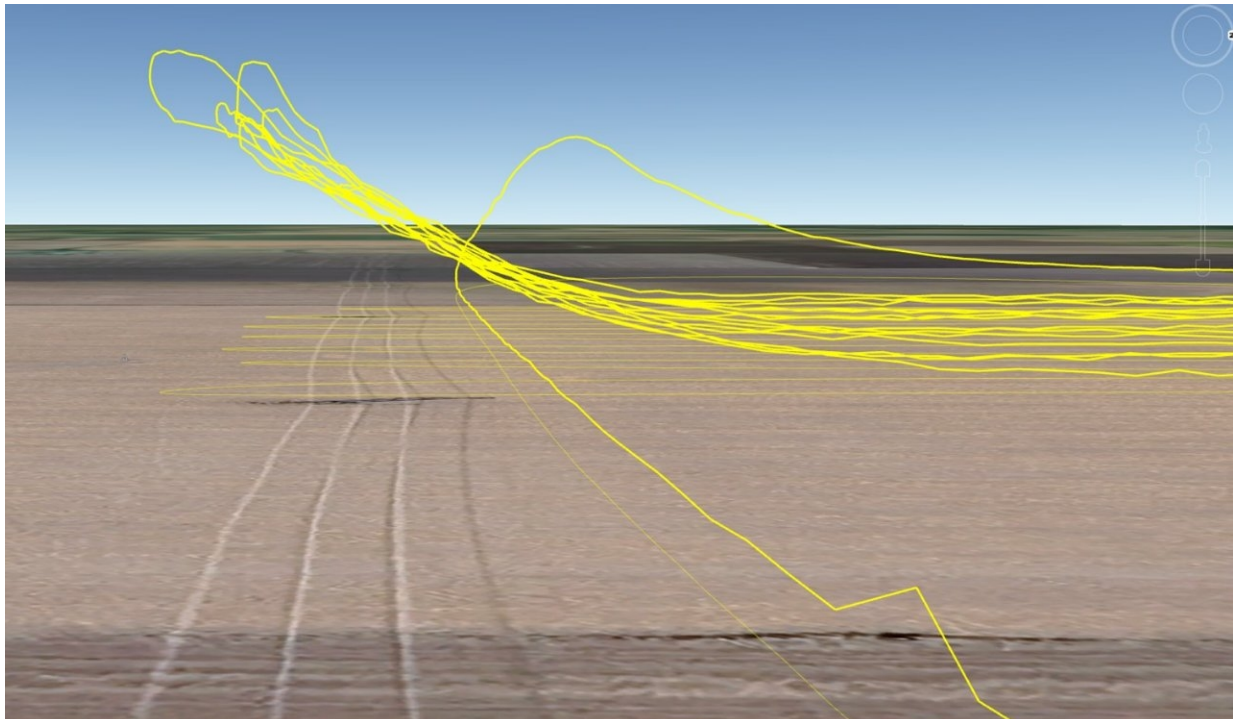
### *Figure 3. AgNav data plots*

The Garmin recorded the helicopter's climb and westerly turn and showed a close path near a power pole; however, no wire damage or signatures of arcing were observed on the power lines that were located about 45 yards north of the accident site. No electrical arcing or evidence of a wire strike was seen on the wreckage.
