Aviation Investigation Preliminary Report

Location:	West Alton, MO	Accident Number:	CEN25FA307
Date & Time:	August 7, 2025, 10:59 Local	Registration:	N173AL
Aircraft:	Hughes 369D	Injuries:	2 Fatal
Flight Conducted Under:	Part 133: Rotorcraft ext. load

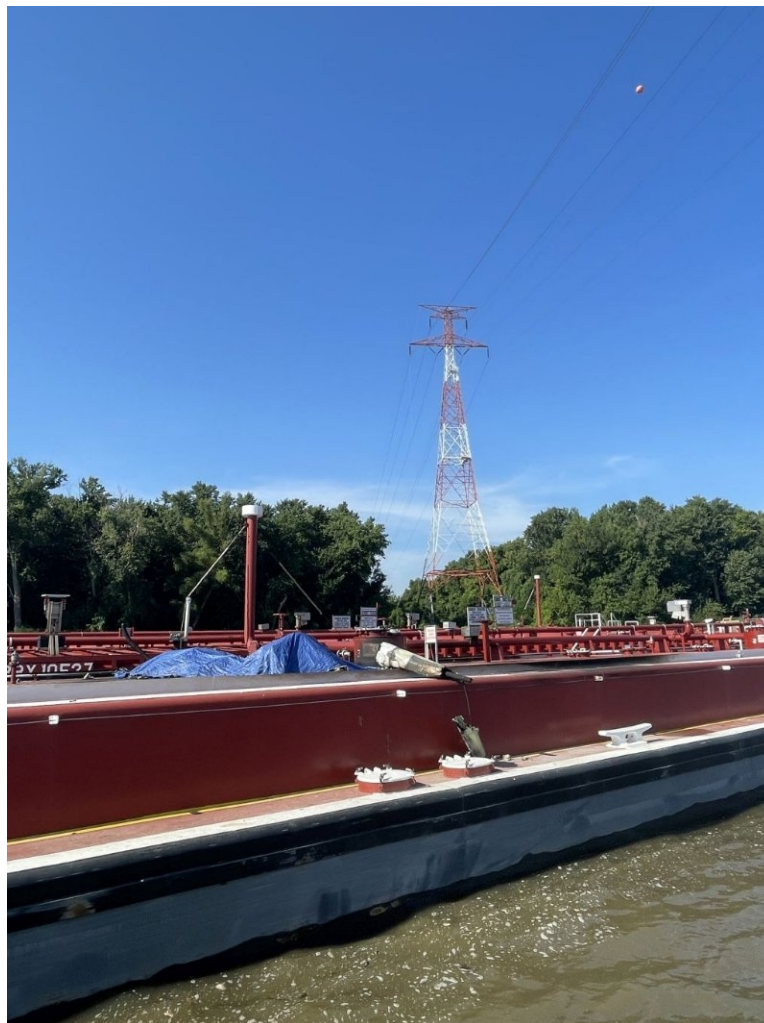
Figure 1 – Accident Site with Powerline Support Tower

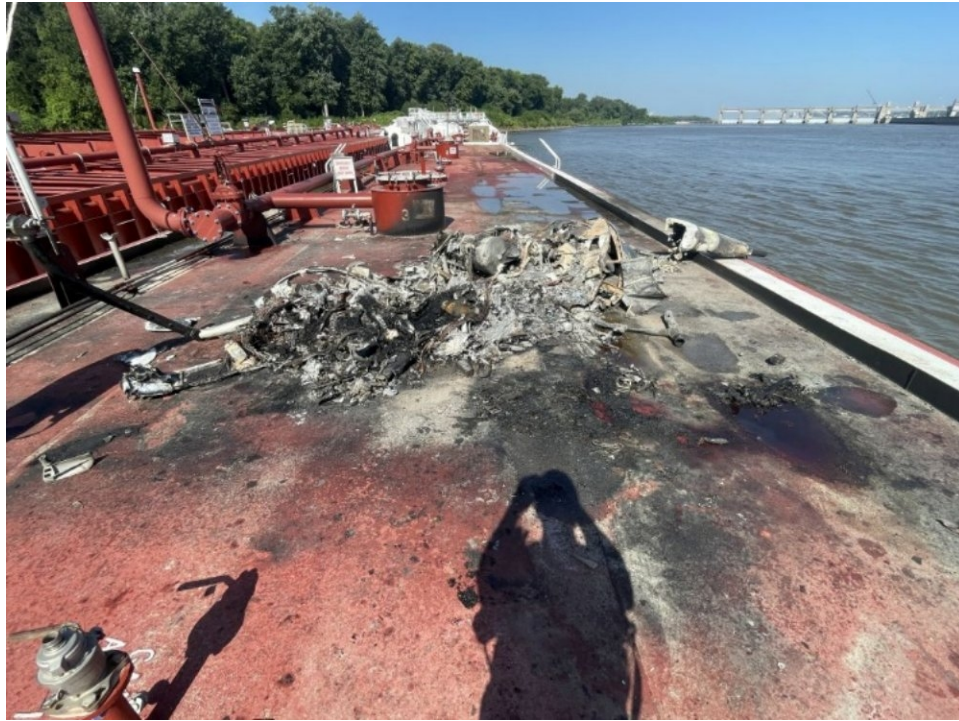
The helicopter main wreckage consisted of the fuselage, engine, main rotor transmission, main rotor hub, and forward portion of the tail boom (fragmented into two sections). One main rotor blade was located about 150 ft from the main wreckage. A 7-foot segment of a second main rotor blade was located about 176 ft from the main wreckage. Finally, a main rotor blade tip, about 6-inches in length, was located about 26 ft from the main wreckage. The remaining main rotor blades and the aft portion of the tail boom, including the tail rotor and horizontal stabilizer, were not present with the wreckage and presumed to have landed in the river.

Figure 2 – Main Wreckage on Barge Deck

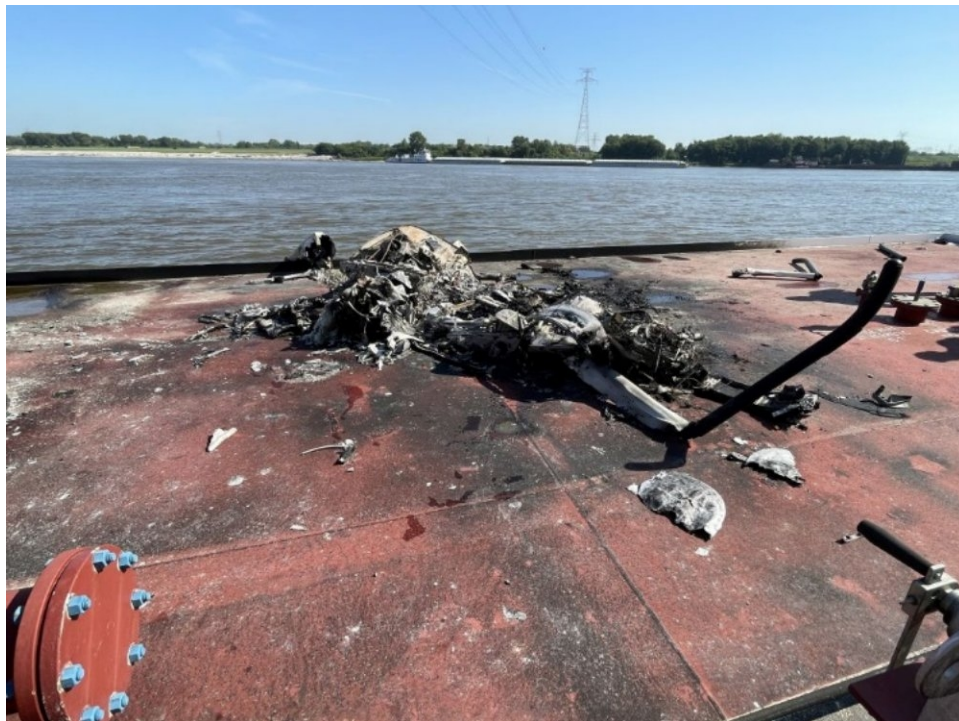
Figure 3 – Main Wreckage on Barge Deck
