Aviation Investigation Final Report

Location:	Garey, California	Accident Number:	WPR24LA093
Date & Time:	February 23, 2024, 07:40 Local	Registration:	N2618W
Aircraft:	Bell 47G-3B-1	Aircraft Damage:	Substantial
Defining Event:	Loss of engine power (total)	Injuries:	1 Minor
Flight Conducted Under:	Part 137: Agricultural

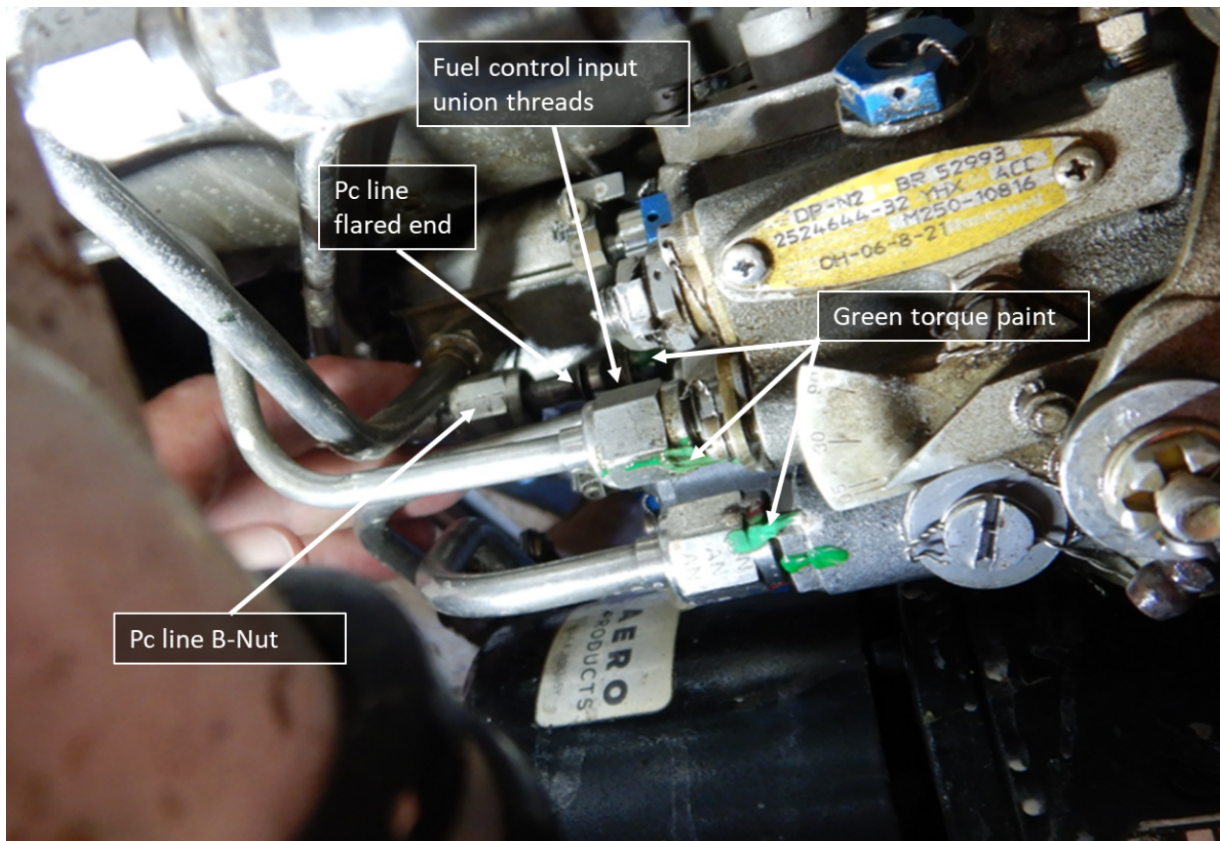
Postaccident examination of the pneumatic air lines revealed that there was a slight air leak at the accumulator and a large air leak at a pneumatic air line (Pc) between the power turbine governor (PTG) and the fuel control unit (FCU); the Pc line was not connected to the FCU. The B-nut connecting the Pc line to the FCU had backed off, allowing the Pc line to become disconnected. . This Pc line is one of several lines that use air pressure to communicate fuel scheduling commands between the PTG and the FCU. The security of this line is necessary for proper engine operation. Engine operation without the Pc line properly connected would result in the FCU reducing fuel to a sub-idle condition, preventing the engine from producing sufficient power for continued flight.

Maintenance was performed on the helicopter 15 days and 29.2 flight hours before the accident that included checking all B-nuts for torque paint to ensure adequate torque remained on the B-nuts. Maintenance personnel likely did not properly inspect the condition of the torque paint on the affected B-nut, which resulted in a disconnection of the B-nut from the FCU and a total loss of engine power.

Maintenance personnel’s failure to properly check the torque paint on a fuel control unit B-nut, which resulted in the loosening of the B-nut, a loss of engine power at a low altitude, and a subsequent impact with terrain.

A check of the pneumatic system by application of about 25 psi of air pressure at the Pc filter resulted in the detection of minor air leakage at both B-nuts on both ends of the accumulator and a large leak at the PTG to FCU Pc input line. Closer examination revealed the B-nut had no thread engagement and had slid aft down the Pc line, as shown in figure 1. The input union on the FCU exhibited evidence of green colored torque paint that was similar in color to the other B-nuts and inputs on the FCU.

Figure 1. Image of the accident fuel control, showing the B-nut, the flared end of the Pc line, and the threads of the attachment fitting of the fuel control.

According to Rolls-Royce, the engine manufacturer, the Pc line connecting the PTG to the FCU is the third of three Pc lines in the system. Pc air is the power supply or motive force that allows the fuel control to modulate fuel delivered to the engine fuel nozzle. With this line disconnected, the engine would reduce power to an unpowered static-state or sub-idle condition.

Rolls-Royce released commercial service letter (CSL) 2373 that addressed a special tool to access the subject B-nut. The CSL provides details on how to manufacture the tool locally and the tool is also available for purchase.
