## Airworthiness Directive

**AD No.:** 2022-0168R1

EC135, EC635 and MBB-BK117 helicopters  
H160-B helicopters

## ATA 42 – Integrated Modular Avionics – Ethernet Network – Inspection

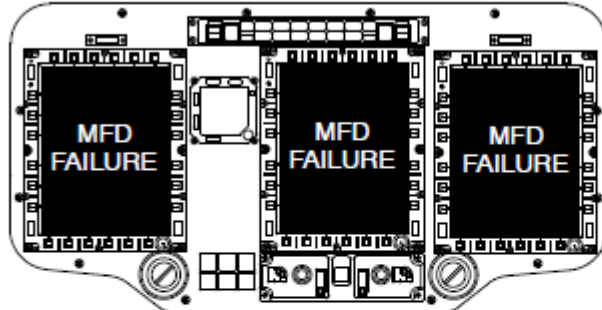
- MFD FAILURE displayed on all MFDs
- If autopilot upper modes were coupled, they may decouple after 10 seconds (indicated by an „autopilot decouple“ voice message).

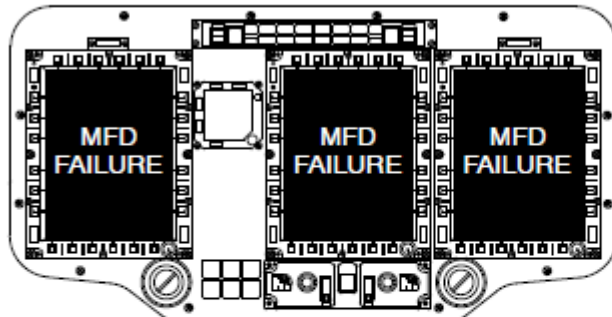
BAC2\_EUH\_0400\_R

- MFD FAILURE displayed on all MFDs
- If autopilot upper modes were coupled, they may decouple after 10 seconds (indicated by an „autopilot decouple“ voice message).
