Aviation Investigation Final Report

Location:	Edgemont, South Dakota	Accident Number:	CEN25LA105
Date & Time:	February 27, 2025, 07:45 Local	Registration:	N6555C
Aircraft:	ROBINSON HELICOPTER COMPANY R44 II	Aircraft Damage:	None
Defining Event:	Cabin safety event	Injuries:	1 Serious, 1 None
Flight Conducted Under:	Part 91: General aviation - Aerial observation

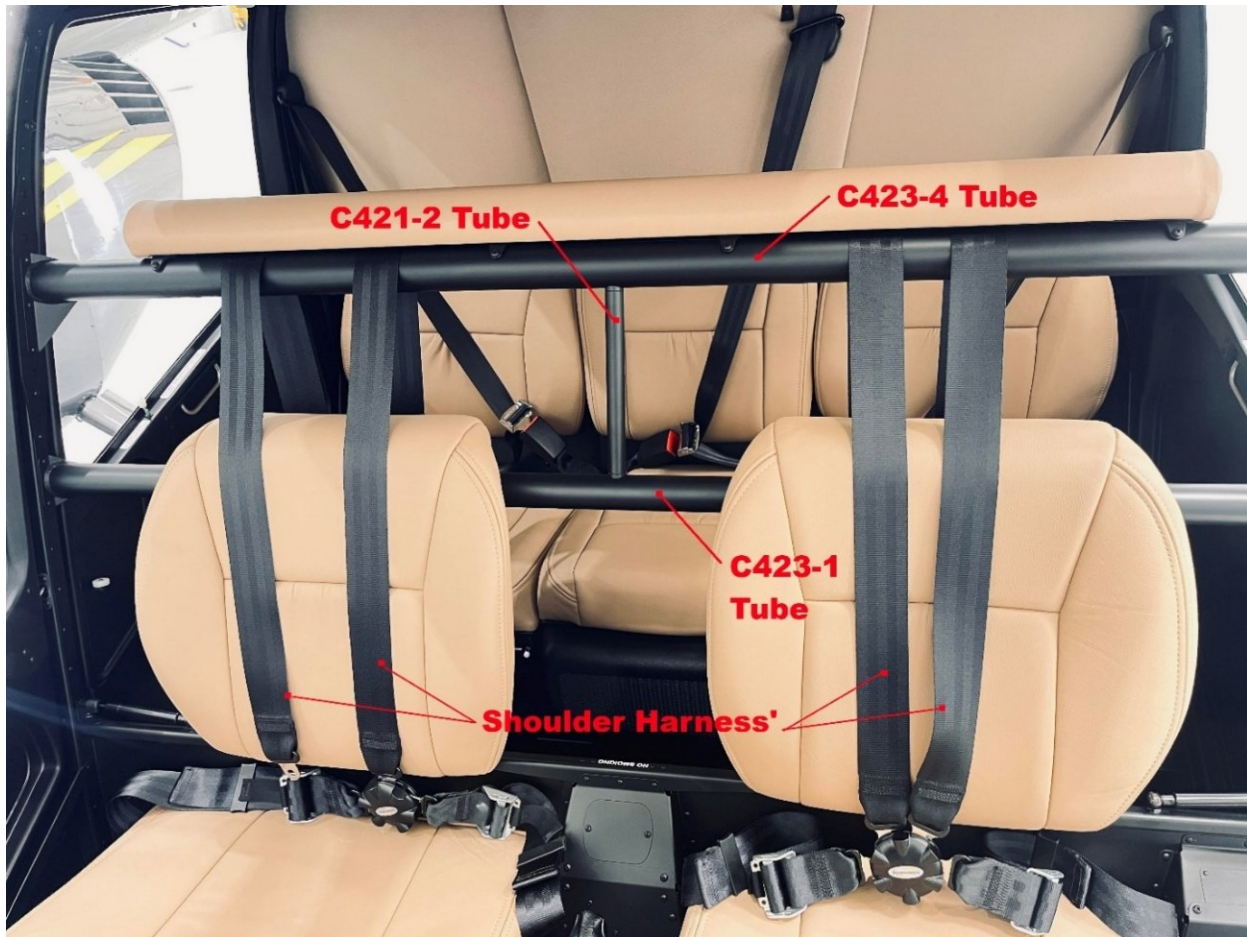
Figure 1. Airframe restraint system

According to the helicopter manufacturer, the C421-2 tube (vertical) and the C423-4 upper seatback support tube (horizontal) were part of the optional 5-point seat belt installation available for the front seats (Figure 1). The purpose of the C423-4 upper seatback support tube was to properly position and support the four shoulder harnesses for the front seat occupants. The purpose of the C421-2 tube was to transfer any downward loads applied to the upper seatback support tube to the C423-1 lower seatback support tube in the event of a hard landing. The manufacturer stated that it was not designed to sustain any side loads and does not require periodic maintenance or inspection other than overall condition.

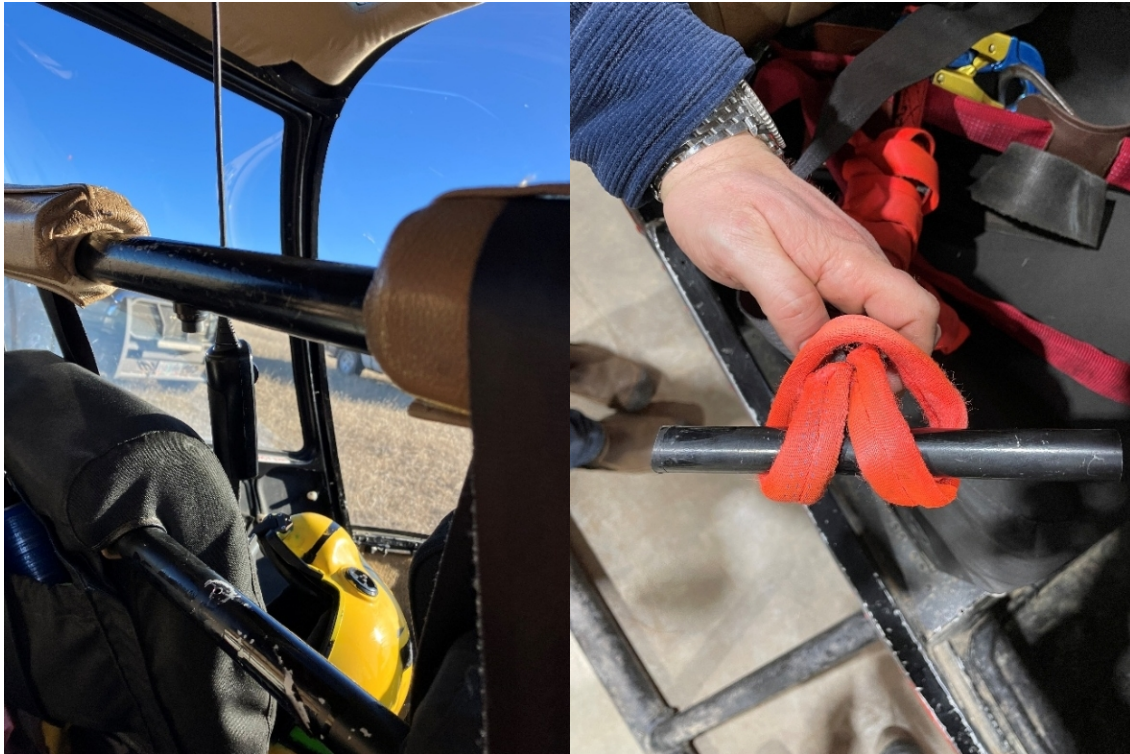
Figure 2. Separated vertical tube

A postaccident examination of the helicopter revealed that the anchor point for the front passenger seat restraint system separated and was still attached to the gunner's harness. Examination of the separation surfaces revealed deformation along the circumference of each end of the tubing.

According to the helicopter manufacturer, the anchor point utilized for the harness was not designed to sustain side loads, which resulted in its separation and the gunner falling out of the helicopter.

Post-flight examination of the helicopter revealed that the anchor point (vertical tube, C421-2) used to secure the supplemental restraint system to the helicopter separated from the surrounding structure (Figure 2). The hollow vertical tube remained intact but exhibited deformation on the outer circumference of one of its ends. The other end exhibited less deformation to the tube, its plastic cap, and hardware.
