# Aviation Investigation Final Report

| <b>Location:</b> | Cabazon, California | <b>Accident Number:</b> | WPR23FA302 |
| <b>Date &amp; Time:</b> | August 6, 2023, 18:44 Local | <b>Registration:</b> | N555AS (A1); N4037S (A2) |
| <b>Aircraft:</b> | Bell 407 (A1); Sikorsky S-64E (A2) | <b>Aircraft Damage:</b> | Substantial (A1); Minor (A2) |

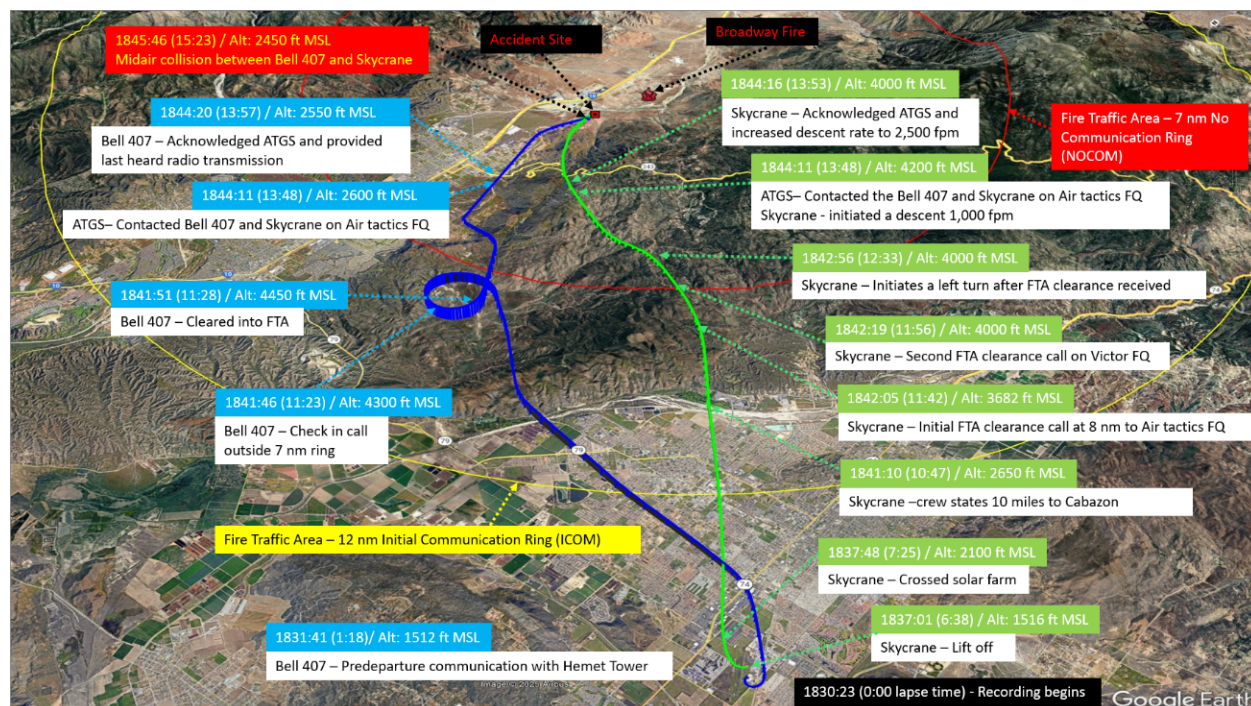
Review of the communication recording from within the Skycrane shows that the recording started at 0:00 lapse time (refer to figure 1).

Figure 1. Recorded ADS-B data with select communications annotated.

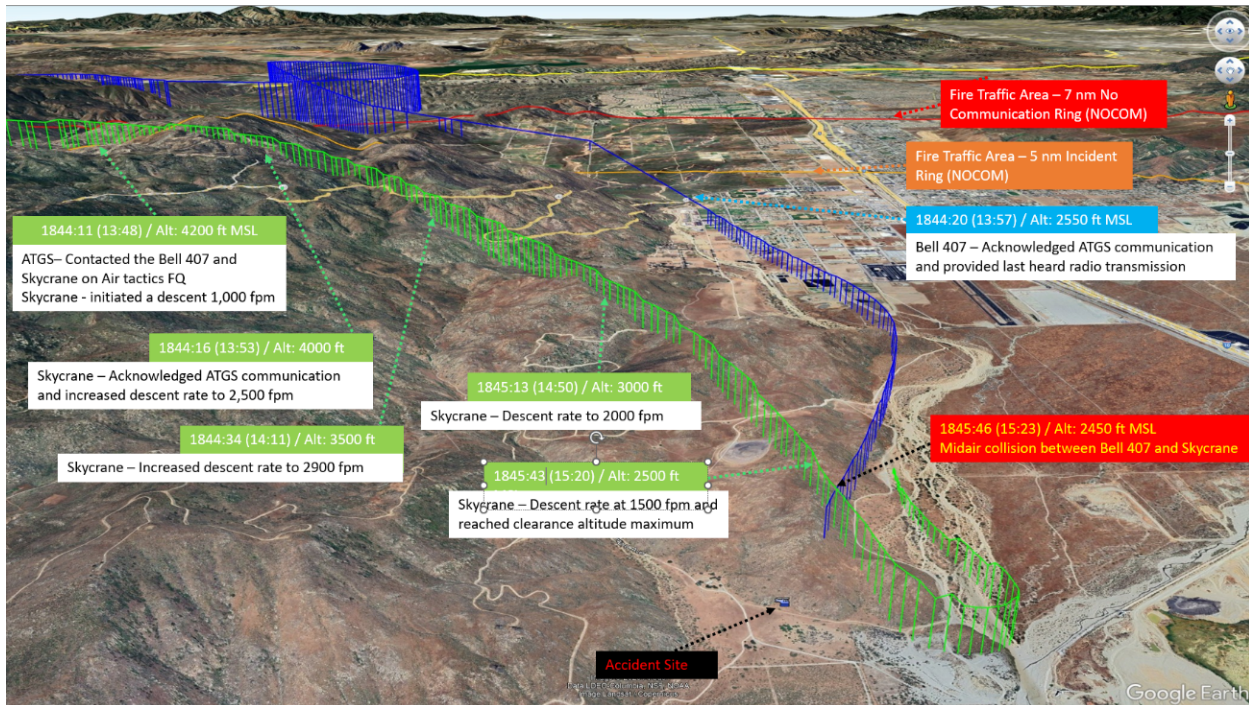
At 13:58, ATGS responded back to both helicopters and stated, "Ok, you have high tension power lines just south of the incident paralyzing...paralleling in front of the road and you got windmills off the east, those'll be your hazards." At 14:11, the Skycrane acknowledged ATGS and simultaneously descended at 3,000 fpm through 3,550 ft msl. At 14:22, the Skycrane continued its descent at 2,900 fpm through 3,350 ft. At 14:50, the Skycrane initiated a descending right turn at 2,000 fpm passing through 3,000 ft at 95 knots indicated. At 15:03, the Skycrane crew scanned the instrument gauges and configured the water tanks. At 15:06, the Skycrane continued its descent at 2,000 fpm, through 2,600 ft, at 100 knots. At 15:16, the Skycrane descended at 1,800 fpm through 2,550 ft at 100 knots. At 15:20, the Skycrane descended at 1,500 fpm through 2,500 ft at 100 knots. At 15:23, the Skycrane descended at 1,500 fpm through 2,450 ft at 100 knots. The recording showed that the right side collective control moved down, up, and then down again while the cyclic moved right and aft, before it swung back to a neutral position. Immediately after, the SIC asked, "oh ...what was that?" At 15:25, the PIC asked if the Bell 407 struck the Skycrane, which the SIC confirmed. ADS-B data showed that Skycrane was on a descending right turn to the east while the Bell 407 was in level flight headed southeast. Both helicopters converged over descending terrain on the way to the fire. At 15:42, the Skycrane crew decided to initiate a precautionary landing onto a nearby field, where they landed without further incident. See figure 2.

Figure 2. ADS-B data during later part of flight with select communications annotated.

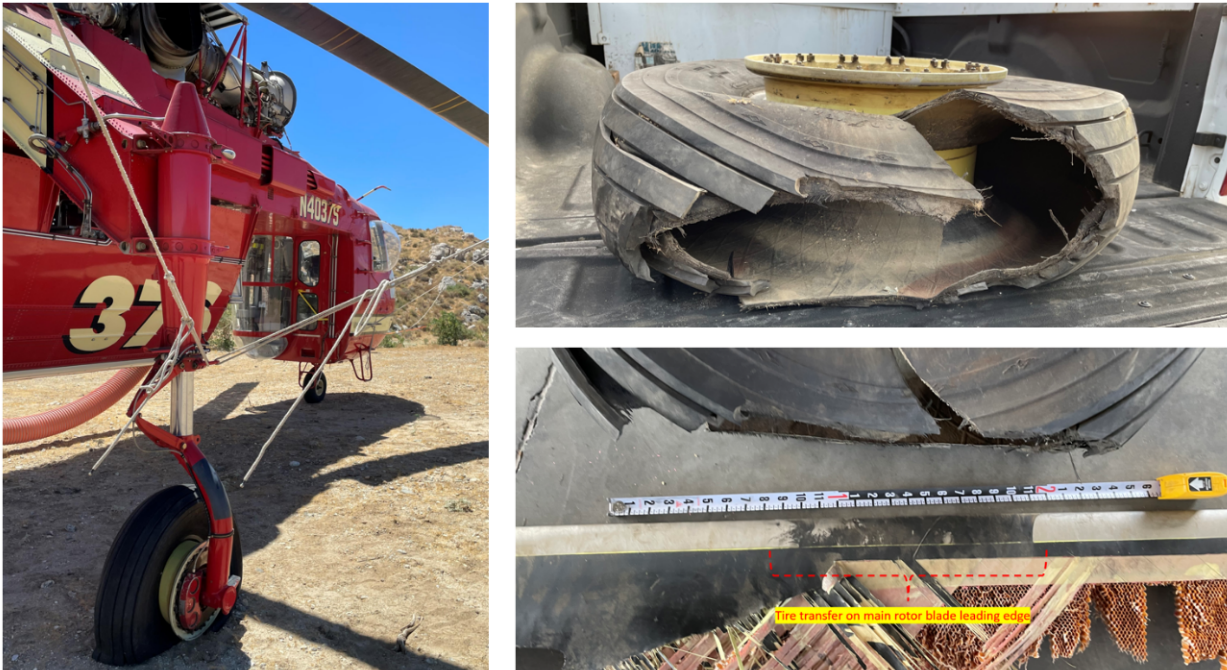
A postaccident examination of the Sikorsky tire revealed that the right main landing gear tire had about a 24-inch-wide cut; however, the cut section of the rubber tire was not located. A rubber transfer mark was found on a 12-inch section on the leading edge of the Bell 407's main rotor blade. See figure 3.

Figure 3. Left photo - view of damaged tire on helicopter. Upper right photo - view of removed damaged tire. Lower right photo - view of damaged tire next to main rotor blade showing transfer mark.

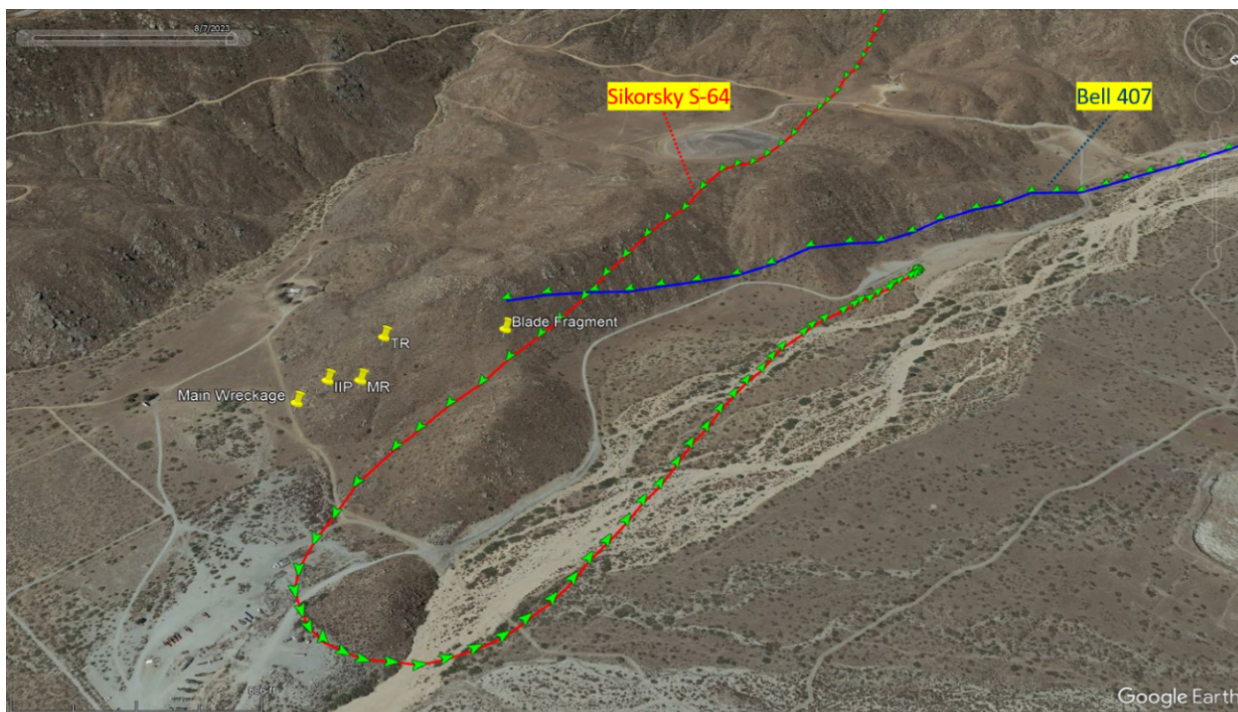
Examination of the accident site revealed that the Bell 407 came to rest on a steep and rocky hillside about 1,050 ft from the last recorded ADS-B data point. See figure 4.

Figure 4. ADS-B flight plots with wreckage location markers.

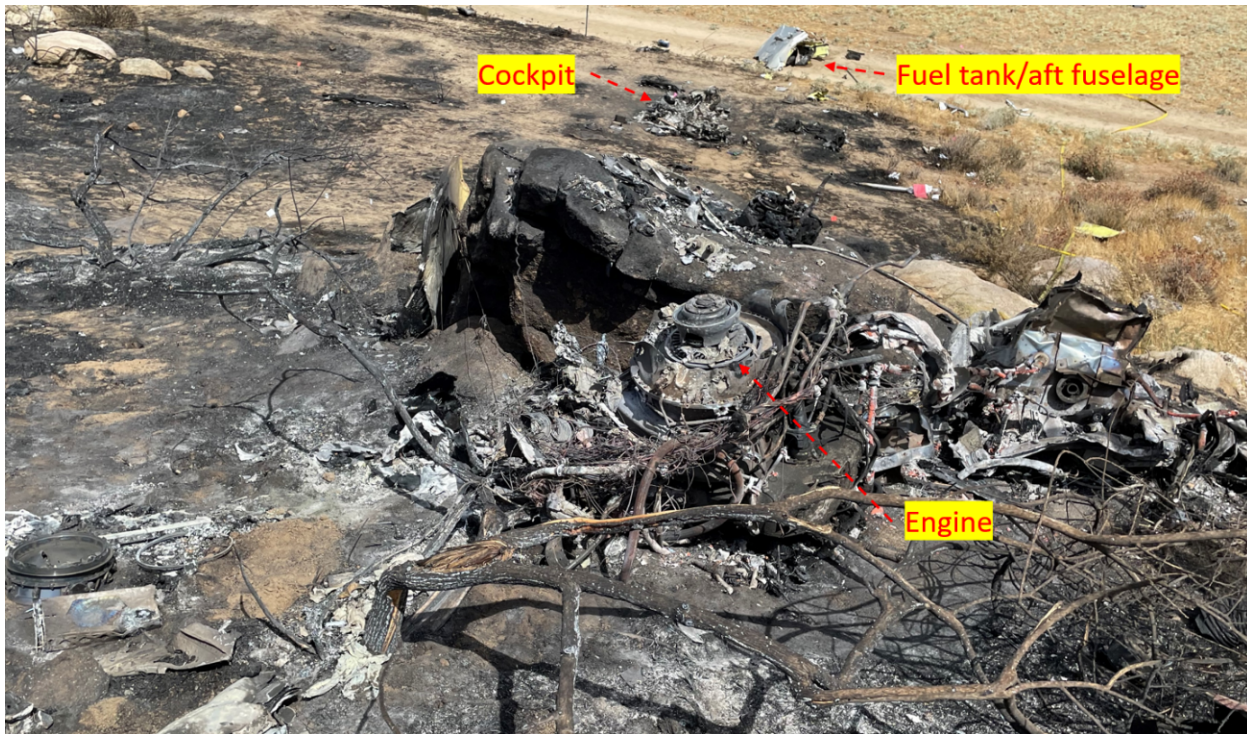
A post-crash fire ensued after impact and consumed the fuselage of the Bell 407. The debris path was about 950 ft by 550 ft and contained all major components of the helicopter. The beginning of the debris path was identified by a piece of main rotor blade, which was about 560 feet east of the approximate collision area. Subsequent fragments of the main rotor blade were identified within a 100 ft span to the east. A displaced skid and crosstube came to rest about 195 ft east of the main wreckage and were the easternmost pieces of debris. About 830 ft southeast of the first blade component, a ground scar was consistent with the fuselage's first identified point of contact (FIPC). It was followed by a 20-foot-long ground scar, oriented on a 098° magnetic heading, that extended to the engine, which was displaced and located adjacent to rock boulders. See figure 5.

Figure 5. View of main wreckage.

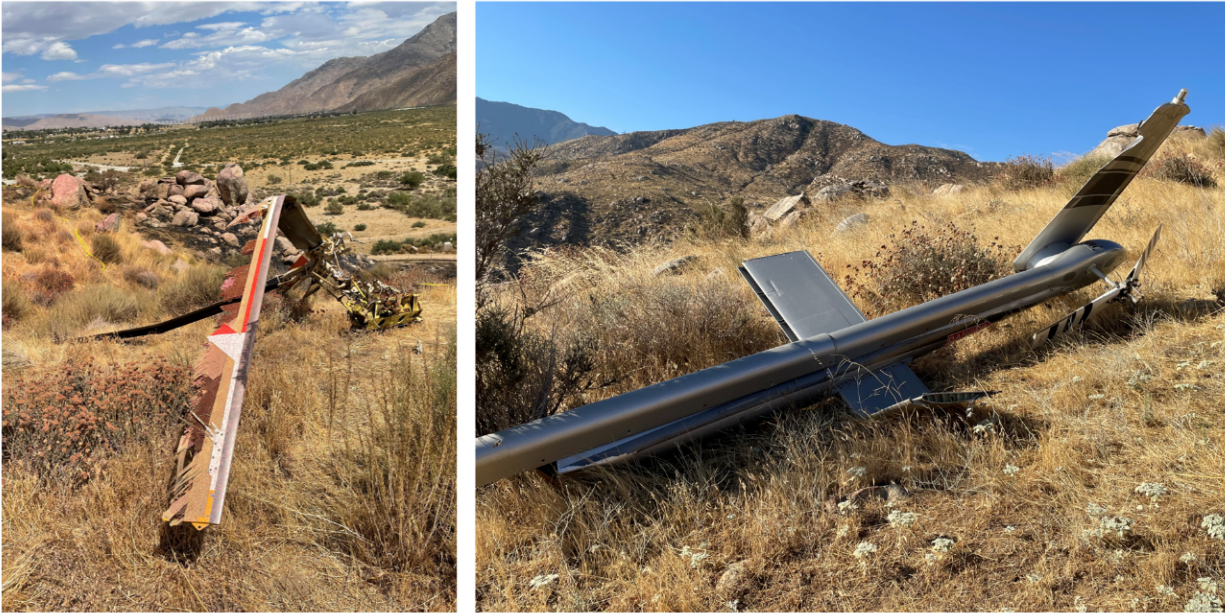
The main wreckage was found about 45 ft east of the engine. The main rotor blades, mast, and transmission came to rest about 285 ft northwest of the main wreckage, upslope from the FIPC. The tail cone and tail rotor blade assembly came to rest about 470 ft west of the main wreckage. See figure 6.

Figure 6. Left photo - view of main rotor and transmission assembly. Right photo - view of separated tail boom.
