Aviation Investigation Final Report

Location:	Mogadore, Ohio	Accident Number:	ERA25LA144
Date & Time:	March 14, 2025, 07:08 Local	Registration:	N262LH
Aircraft:	Schweizer 269C	Aircraft Damage:	Substantial
Defining Event:	Low altitude operation/event	Injuries:	1 Fatal
Flight Conducted Under:	Part 91: General aviation - Personal

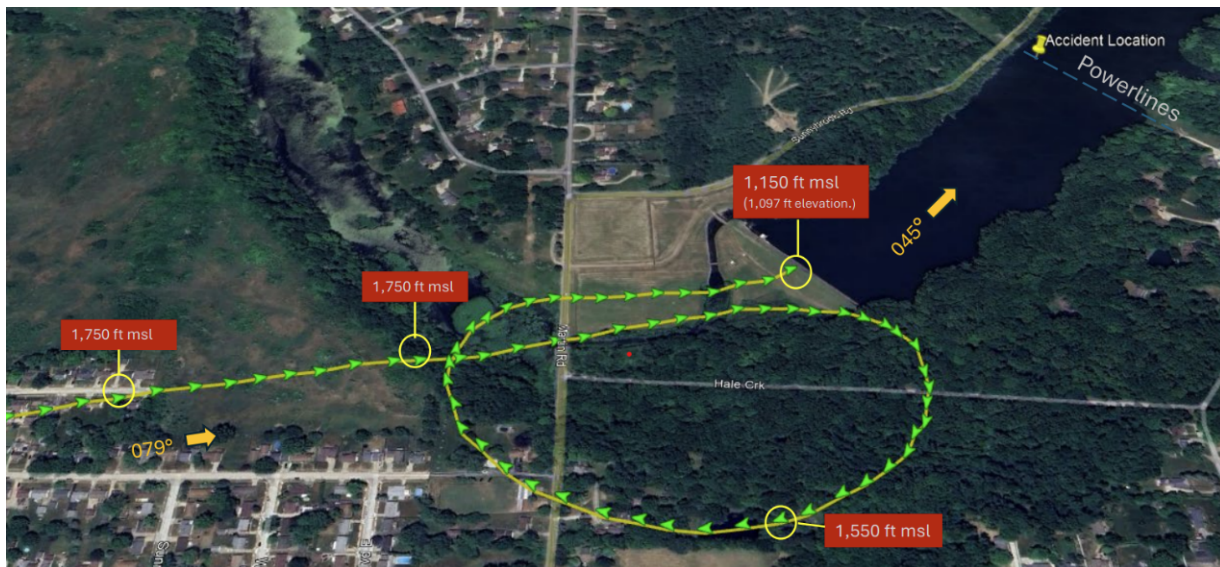
ADS-B data indicated that after takeoff from 3G3, the helicopter climbed to about 1,700 ft msl and turned left on a track of about 070° for 15 nautical miles. As the helicopter approached a reservoir, it began a right 360° descending turn, leveled off, and reestablished a northeast track before the data ended (see the figure).

Figure. Final part of the flight path as the helicopter approached the reservoir.
