Aviation Investigation Preliminary Report

Location:	Superior, AZ	Accident Number:	WPR26FA074
Date & Time:	January 2, 2026, 11:00 Local	Registration:	N3502P
Aircraft:	MD HELICOPTERS LLC 369FF	Injuries:	4 Fatal
Flight Conducted Under:		Part 91: General aviation - Personal

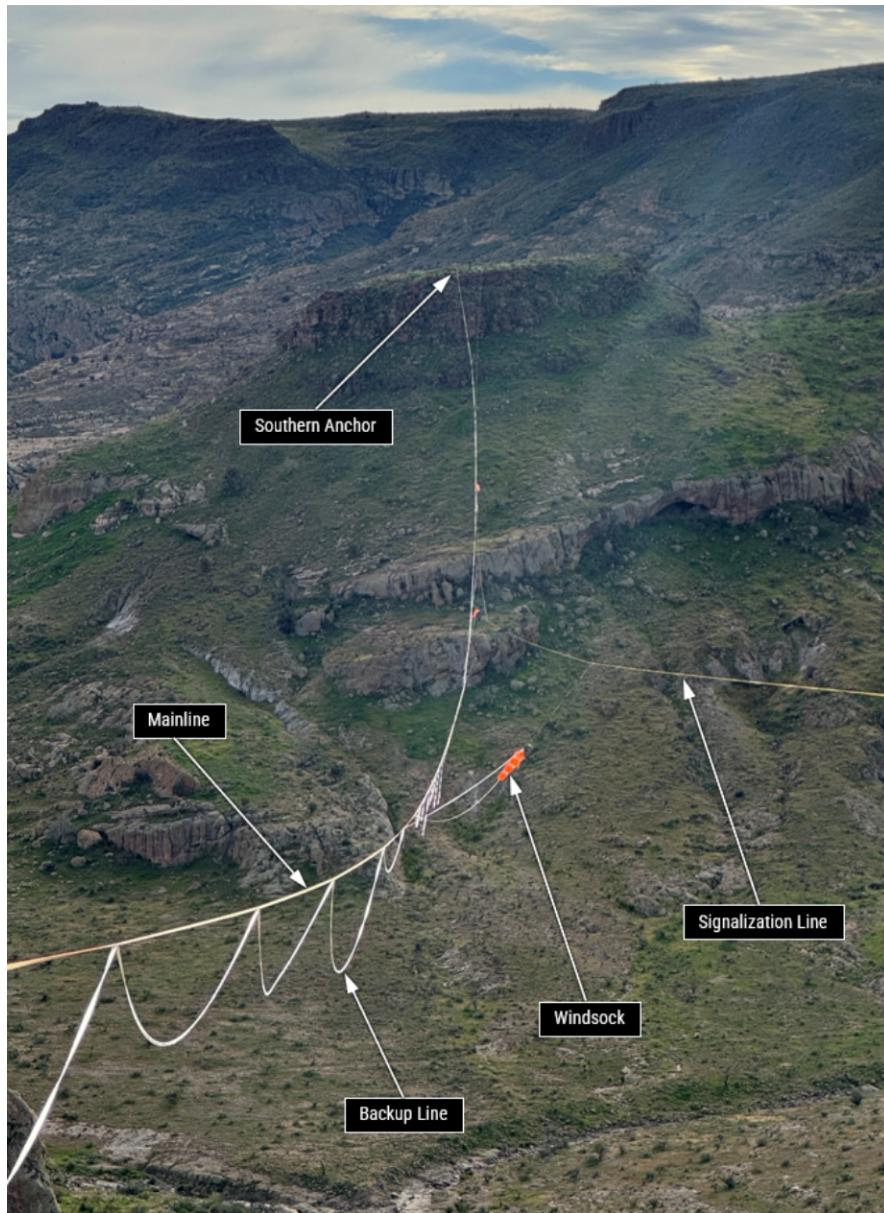
According to a witness, on or around December 26, 2025, he and a group of friends traveled to the area near the accident site, which consisted of a valley with terrain elevations that ranged between 2,600-3,500 ft mean sea level (msl). Using two anchors spaced on bluffs about 0.74 mile apart, they raised a signalization line that carried five windsocks and about ten LED lights. After the signalization line was raised, they used additional nylon lines to draw the mainline and backup lines between the anchors. (See Figure 1.) The lines were oriented in a generally north/south direction and were estimated to be about 600 ft above the ground at their highest point.

Figure 1: The series of lines between the anchors, as viewed from the northern bluff (photo courtesy of witnesses).

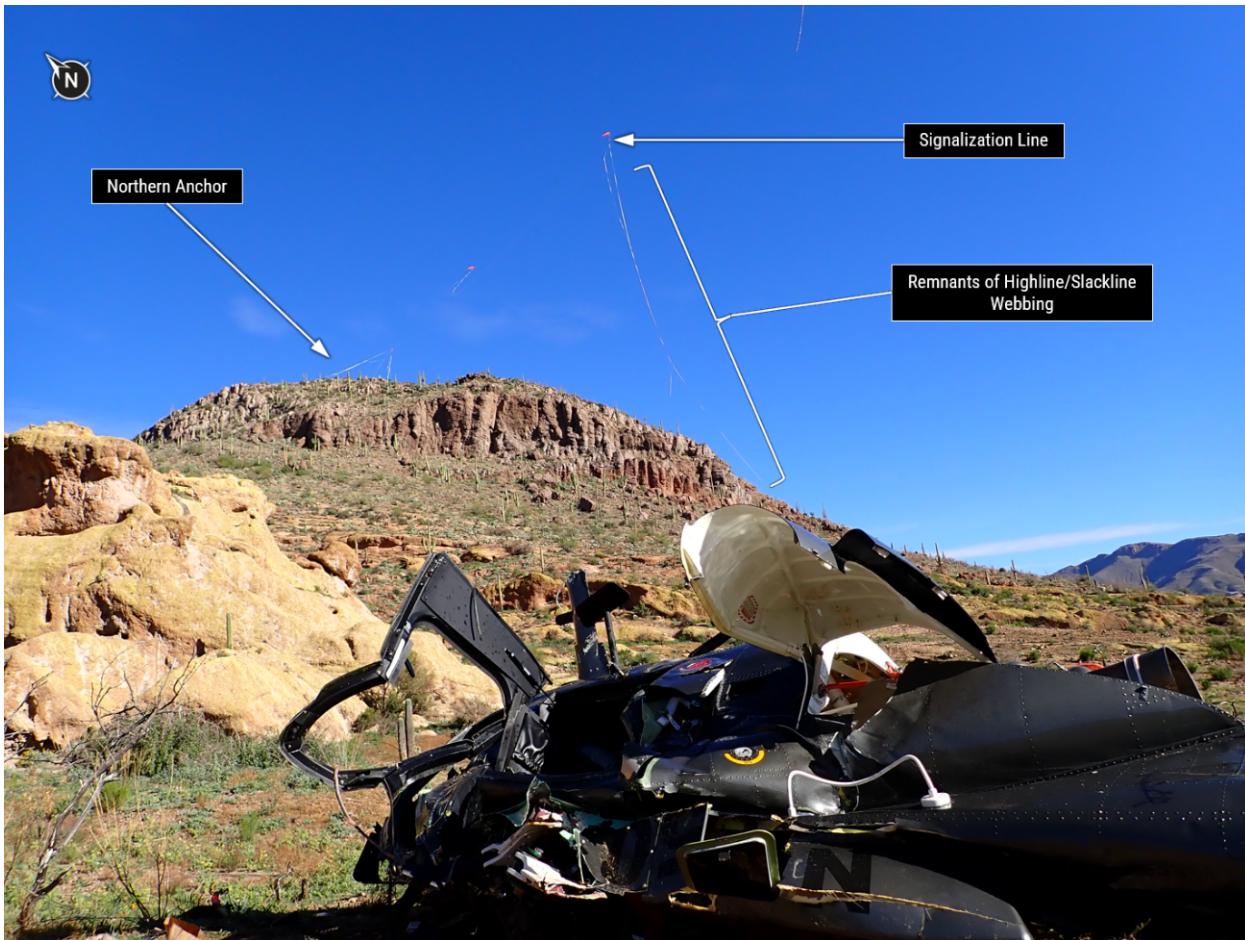
The witness reported that the helicopter impacted the lines and appeared to slow or even reverse direction. The helicopter pitched nose up and yawed to the right, after which its tailboom separated. The fuselage became inverted, and the tailboom and fuselage subsequently impacted terrain about 150 and 350 ft from the lines. (See Figure 2.)

Figure 2: The helicopter fuselage. The northern bluff, signalization line, and sections of the highline/slackline are visible in the background.

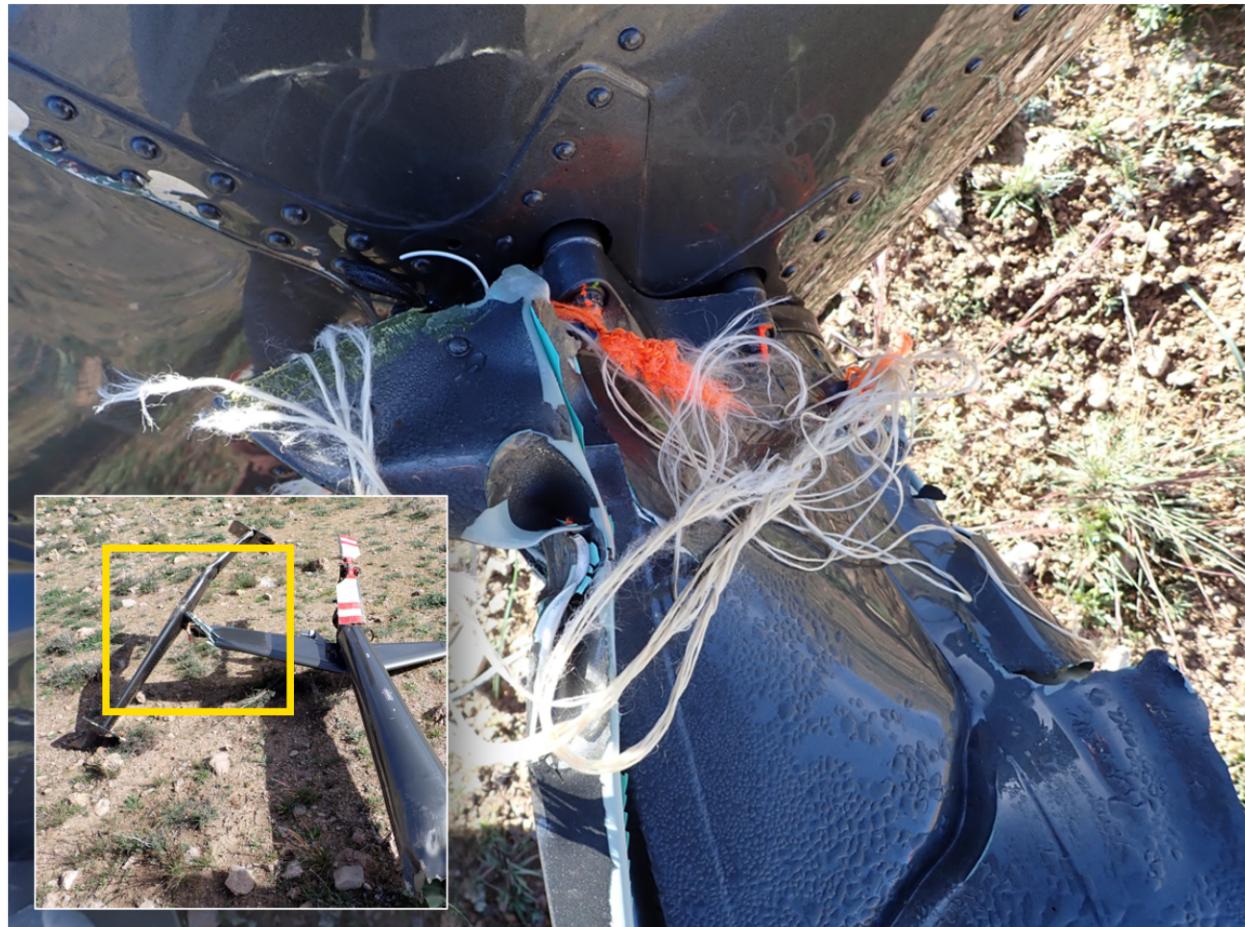
Examination of the helicopter revealed material consistent in appearance to highline/slackline webbing imbedded in the upper part of the vertical stabilizer. (See Figure 3.) The lower ends of the horizontal stabilizer end caps were sheared off, and striations similar to the webbing weave pattern were visible on the paint on the vertical and horizontal stabilizers. Additional striations were found on two of the main rotor blades. The helicopter was equipped with a wire

strike protection system that consisted of cutters on the top and bottom of the forward fuselage. The cutting surfaces did not show any striations or disturbed paint.

Figure 3: Highline/slackline webbing imbedded in the vertical stabilizer.
