Aviation Investigation Final Report

Location:	Durkee, Oregon	Accident Number:	WPR25LA034
Date & Time:	November 7, 2024, 08:37 Local	Registration:	N4361R
Aircraft:	ROBINSON HELICOPTER COMPANY R44 II	Aircraft Damage:	Substantial
Defining Event:	External load event (Rotorcraft)	Injuries:	1 None
Flight Conducted Under:	Part 133: Rotorcraft ext. load

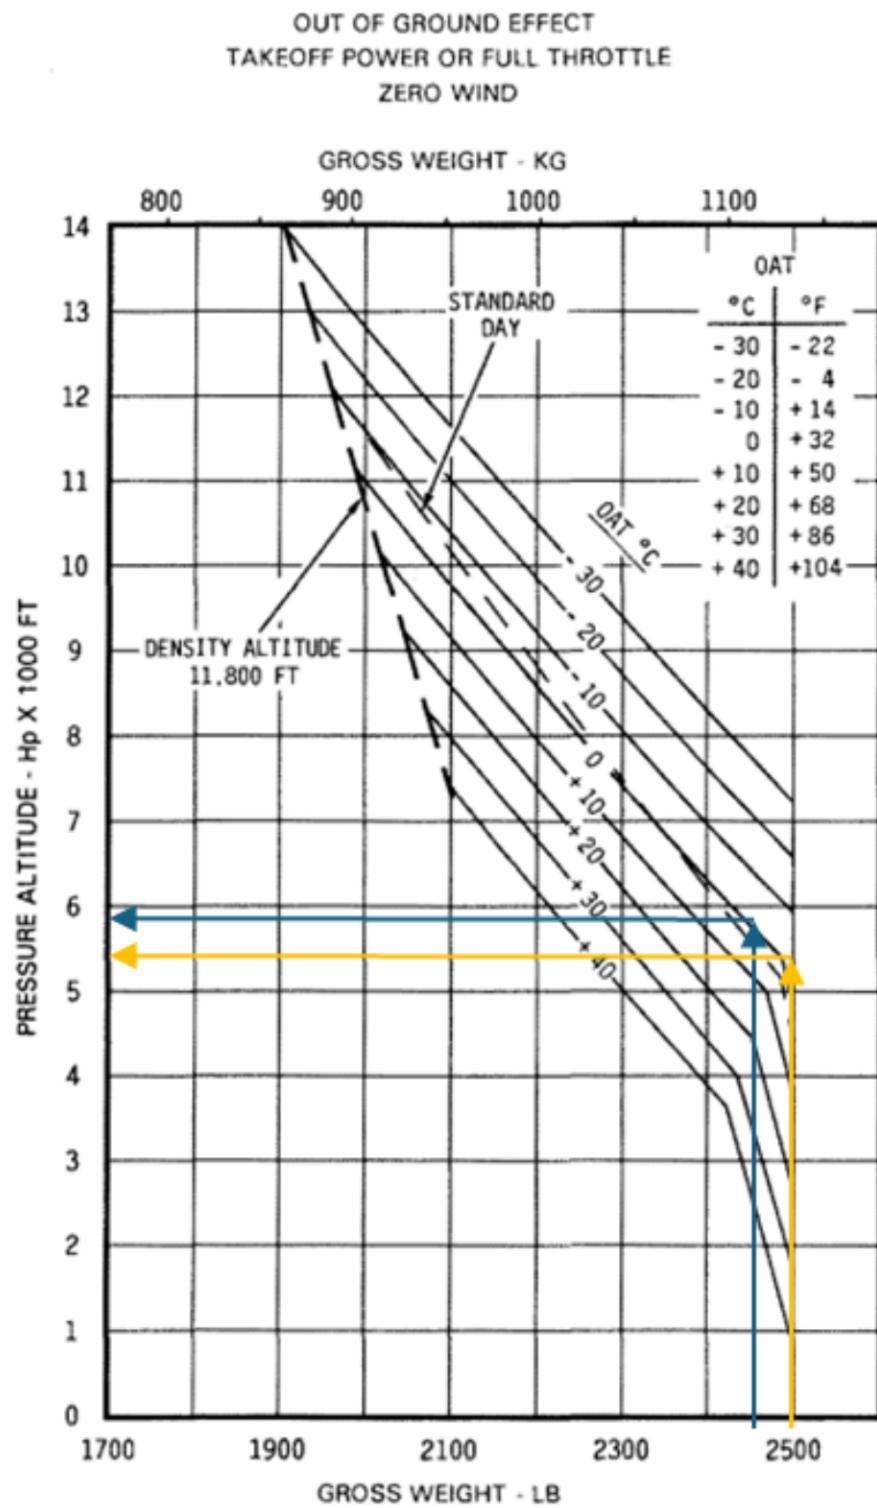
0GE HOVER CEILING VS. GROSS WEIGHT

Performance calculations revealed that, given the environmental conditions at the accident site around the accident time, the helicopter would have been marginally capable of an OGE hover at 2,450 lbs. The pilot conducted multiple power checks and assessed the conditions as acceptable; however, once the pilot transitioned the helicopter to an OGE hover with the external load, the power required to hover OGE likely exceeded the available engine power. Given the fact that the engine test run revealed no anomalies, the density altitude, the weight of

the cargo, or both were likely higher than the pilot estimated, which would have reduced the helicopter's OGE hover performance.

The pilot estimated the weight of the helicopter at the time of the accident to be about 2,450 lbs, 50 lbs less than its maximum gross weight. Performance calculations revealed that, at 2,450 lbs, along with the estimated environmental conditions of the accident site, the helicopter was capable of a hover OGE up to 5,800 ft msl. The helicopter's chart for hover OGE performance also showed that engine performance is reduced at gross weights above 2,480 lbs. The chart showed that a helicopter that, at 2,500 lbs gross weight under the same environmental conditions, the helicopter could hover OGE up to 5,300 ft msl (see figure 1).

Figure 1. Out of ground effect hover chart for the R44 II helicopter, showing OGE hover capability for 2,450 pounds (blue arrows) and 2,500 pounds (orange arrows).
