# Notification of a Proposal to issue an Airworthiness Directive

**PAD No.:** 26-038

AIRBUS HELICOPTERS DEUTSCHLAND GmbH MBB-BK117 helicopters

## ATA 42 – Integrated Modular Avionics – Ethernet Network – Inspection / Modification

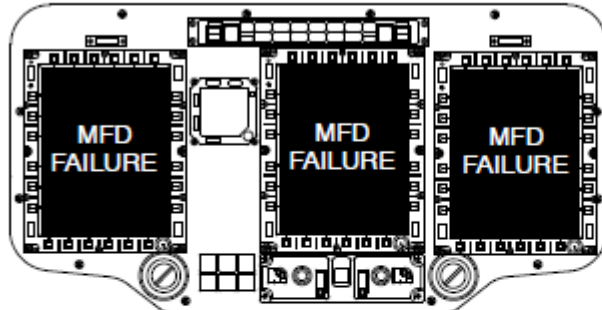
- MFDs:

- MFD FAILURE displayed on all MFDs
- If autopilot upper modes were coupled, they may decouple after 10 seconds (indicated by an „autopilot decouple“ voice message).
