Federal
Aviation
Administration

Airworthiness Concern Sheet

<p>Reply to: Name: Jacob Fitch Title: Continued Operational Safety, Program Manager Office: Operational Safety Branch Street Address: 10101 Hillwood Parkway City, State, ZIP: Fort Worth, TX 76177 Telephone: 817-222-4130 Electronic Mail: Jacob.Fitch@faa.gov</p>	<p>Make: Leonardo S.p.A. Model / Series: AW139 Serial Numbers: All Reason for Airworthiness Concern: Cracked Main Rotor Tension Links</p>
--	---

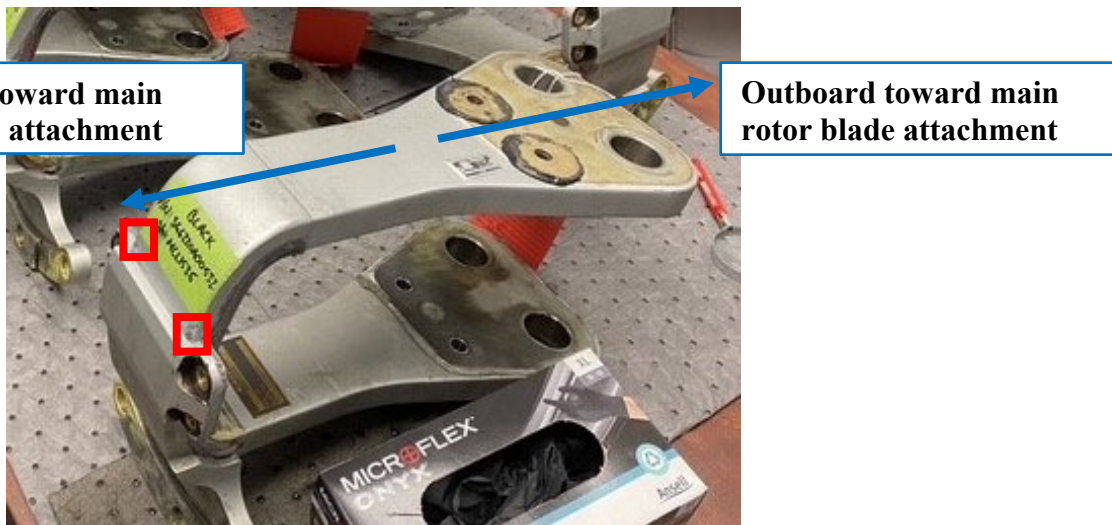
The FAA recently received three separate Service Difficulty Reports (SDRs) from a U.S. repair station regarding cracked main rotor tension links on the Leonardo AW139. There are five tension links on the AW139, one for each main rotor blade. The inboard end of each tension link is attached to the main rotor hub while the outboard end is attached to the main rotor blade, as depicted in Figure 1.

Figure 1. Leonardo AW139, Cracked Main Rotor Tension Link (side view)
 Cracked areas are within the red boxes.

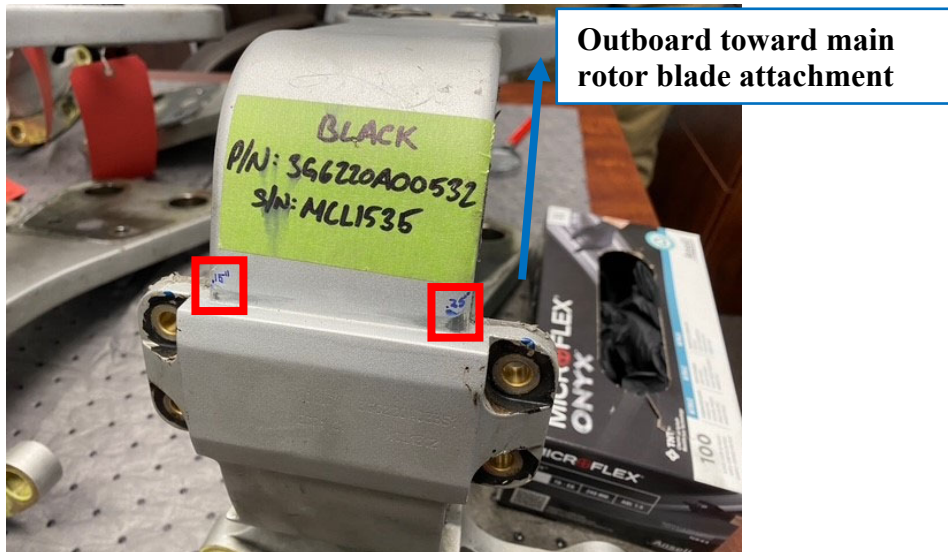
Figure 2 depicts an example of one of the cracked tension links that were associated with the SDRs the FAA received in March 2026. The repair station provided pictures of other cracked tension links from recent SDRs. Each had cracks in similar locations. Figure 3 provides an example of one of the SDRs received.

Figure 2. Leonardo AW139, Cracked Main Rotor Tension Link
 Cracked areas are within the red boxes.
