Aviation Investigation Final Report

Location:	Glacier View, Alaska	Accident Number:	ANC24LA013
Date & Time:	February 11, 2024, 11:30 Local	Registration:	N74868
Aircraft:	ROBINSON HELICOPTER COMPANY R44 II	Aircraft Damage:	Substantial
Defining Event:	Sys/Comp malf/fail (non-power)	Injuries:	1 None
Flight Conducted Under:	Part 91: General aviation - Business

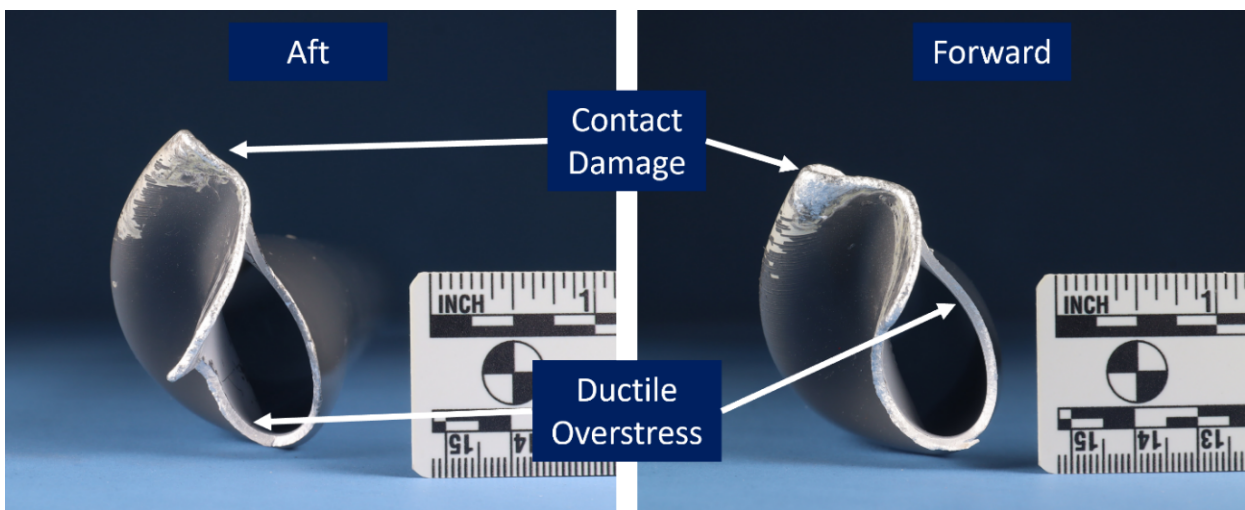
The torsional twisting of the fractured surfaces of the tail rotor driveshaft is consistent with a sudden binding of the tail rotor gearbox, or a rapid deceleration of the tail rotor blades. There was no damage evident to the tail rotor assembly from a bird strike or impact with a hard object.

A sudden stoppage of the tail rotor for unknown reasons, which resulted in the torsional overload failure of the tail rotor driveshaft.

The fractured pieces of the tail rotor driveshaft were sent to the NTSB Materials Laboratory for further examination. The examination revealed the fractures were consistent with ductile torsion overload. There was no evidence of pre-existing cracks or other damage to the driveshaft surfaces. The tail rotor blades were not damaged.

Figure 1. View of the tail rotor driveshaft fracture surfaces
