Aviation Investigation Final Report

Location:	Anaconda, Montana	Accident Number:	WPR24FA132
Date & Time:	April 26, 2024, 06:59 Local	Registration:	N988B
Aircraft:	Bell 206-L4	Aircraft Damage:	Destroyed
Defining Event:	Loss of engine power (total)	Injuries:	1 Fatal
Flight Conducted Under:	Part 133: Rotorcraft ext. load

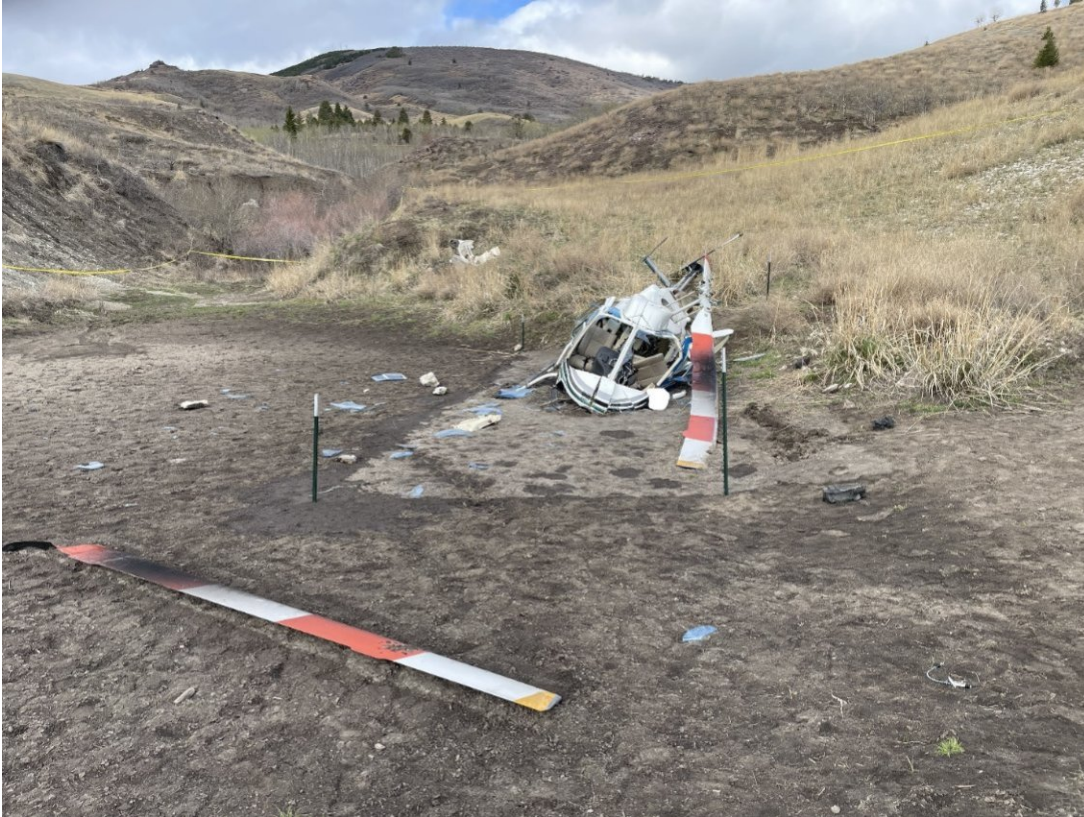
Figure 1. Helicopter Wreckage

Examination of the accident site revealed that the helicopter came to rest in a mostly upright position immediately adjacent to a flat and dry pond area in a gully about 855 ft southwest of the load truck (see figure 1). The fuselage came to rest oriented on a heading of about 060°. The bottom of the fuselage exhibited crushing deformation and the left skid was splayed outward. One main rotor blade was fracture-separated about 3 ft from the rotor attachment point just outboard of the blade doubler and the fracture surfaces exhibited downward deformation. The remainder of the blade was located about 15 ft forward of the helicopter. The second rotor blade remained attached to the rotor mast and exhibited some bending opposite of rotation. The spreader and 25-ft long line were located about 30 ft aft of the helicopter and were not attached to the helicopter, consistent with separation prior to impact. The long-line attachment shackle was unmarred and showed no visible damage. Fuel was observed leaking from the wreckage following the accident.

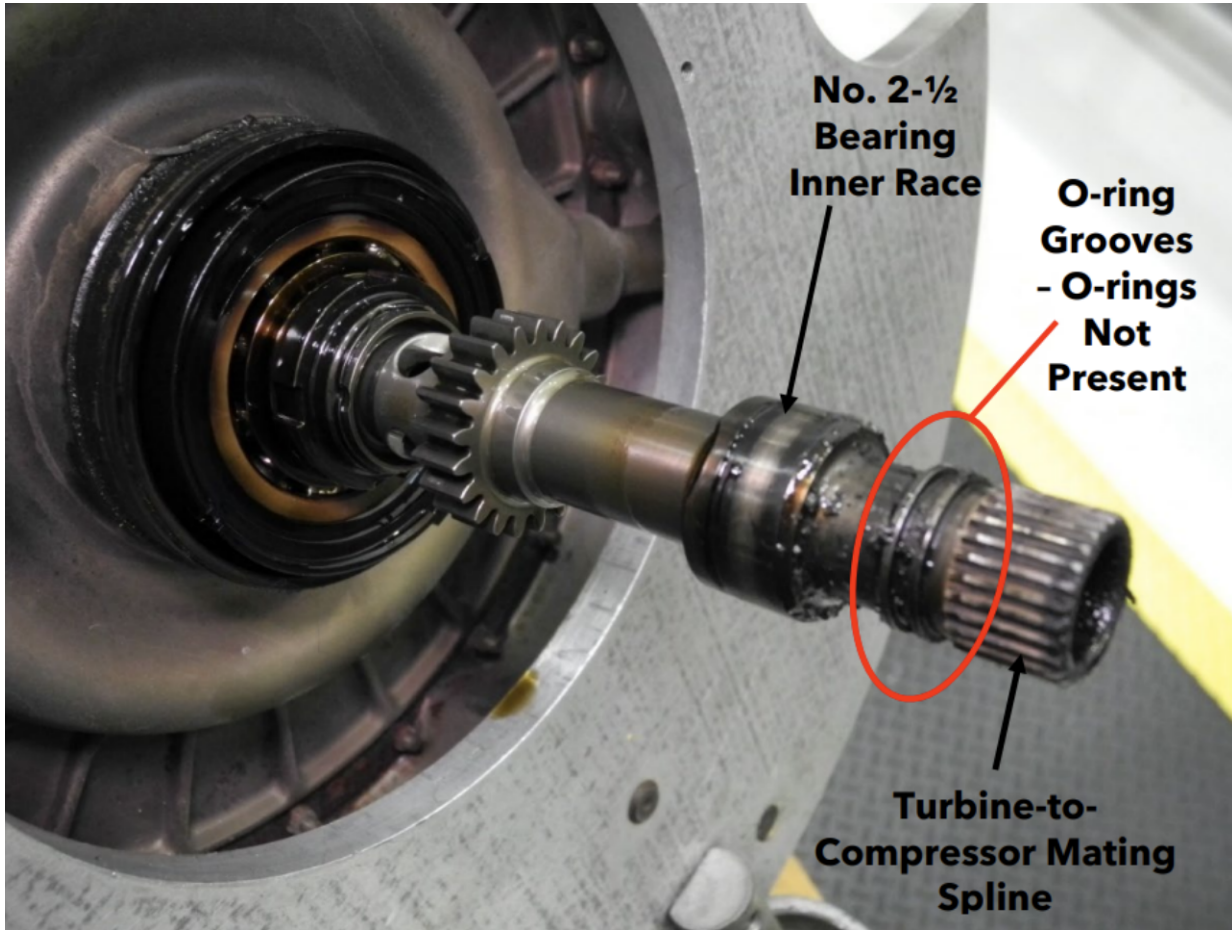
Figure 2. Spur Adapter Gearshaft

Coked material was found that restricted oil flow in one orifice of the piccolo tube and blocked a second orifice of the oil jet to the No. 3 bearing. Analysis of the coked material revealed fluorocarbon rubber signatures consistent with O-ring material. The engine manufacturer stated they were not aware of any previous instances of O-rings disintegrating. The initiating event for the disintegration of the O-rings could not be determined.

Maintenance records indicated that the spur adapter gearshaft, where the O-rings would normally be located, was last accessible when the engine was overhauled about 5 years (1,414.1 flight hours) before the accident. According to the engine manufacturer, a damaged or wrong part number O-ring (or a missing O-ring) may allow cooling oil flow to leak back into the gearbox rather than flow between the concentric shafts. The reduced oil flow between the shafts is not sufficient to cool the shafting below oil carboning temperatures, as evidenced by the finding of coked carbon material in the area of the fractured compressor coupling shaft. Carbon deposits on the outside diameter of the turbine-to-compressor coupling and the inside diameter of the power turbine inner shaft and turbine-to-compressor coupling can build up until rub occurs, causing interference between the shafts, resulting in frictional heating and ultimate failure, which subsequently resulted in a total loss of engine power.

The engine was removed from the wreckage and transported to a manufacturer facility for further examination. The engine was disassembled and the spur adapter gearshaft (SAG) O-rings were not present in either the forward or aft O-ring grooves during engine disassembly (see figure 2).

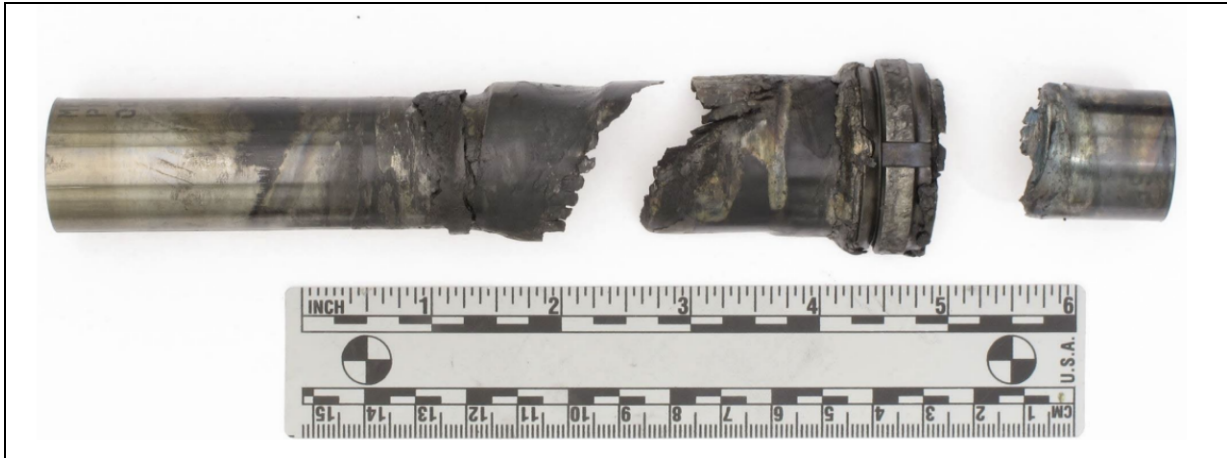
The turbine-to-compressor coupling shaft was found fractured into three pieces as shown in figure 3.

Figure 3. Turbine-to-compressor coupling shaft fractured. Photo courtesy Rolls-Royce.

Heavy coking was observed in the forward and aft spline locations of the turbine-to-compressor coupling shaft. Coking was noted between the coupling shaft and the power turbine outer shaft. Extensive coking was noted upon removal of the power-turbine-to-pinion-gear coupling shaft. No evidence of coked oil was observed in the aft O-ring groove. Analysis of the coked material revealed fluorocarbon rubber signatures consistent with O-ring material. A computer tomography (CT) scan of the piccolo tube revealed coked material sufficient to restrict oil flow in one orifice and block the other orifice of the oil jet to the No. 3 bearing (see figure 4).

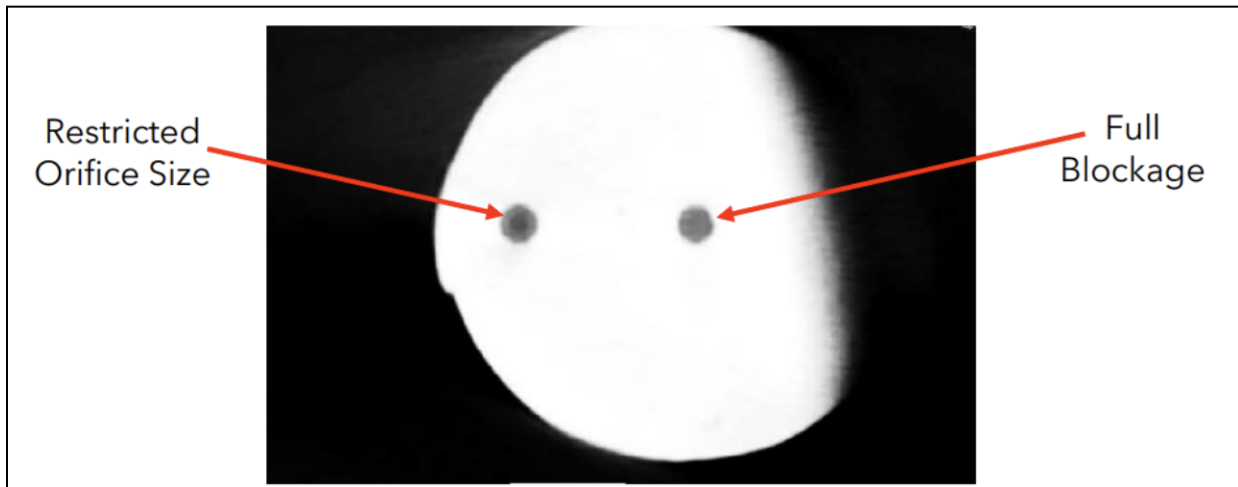
It is likely that the carbon buildup in the piccolo tube screen and nozzles reduced cooling oil flow to the turbine-to-compressor coupling and the turbine inner shaft that caused the shafts to operate at a higher temperature than the carboning limits of the oil, allowing coke to build up between the shafts. The reason for the carbon accumulation in the piccolo tube screen and nozzles was not determined.

Figure 4. Restricted oil jet orifices in piccolo tube. Photo courtesy Rolls-Royce.
