Airworthiness Concern Sheet

<p>Reply to: Name: Eduardo Orozco Title: Aviation Safety Engineer Office: AIR-772 Street Address: 3960 Paramount Blvd, Suite 100 City, State, ZIP: Lakewood, CA 90712 Telephone: 562-627-5264 Electronic Mail: Eduardo.Orozco-Duran@faa.gov</p>	<p>Make: Robinson Helicopter Company Model / Series: R44/R44 II/R66 Serial Numbers: All Reason for Airworthiness Concern: Separated Push-Pull Tube</p>
--	---

Federal Aviation Administration (FAA) Description of Airworthiness Concern

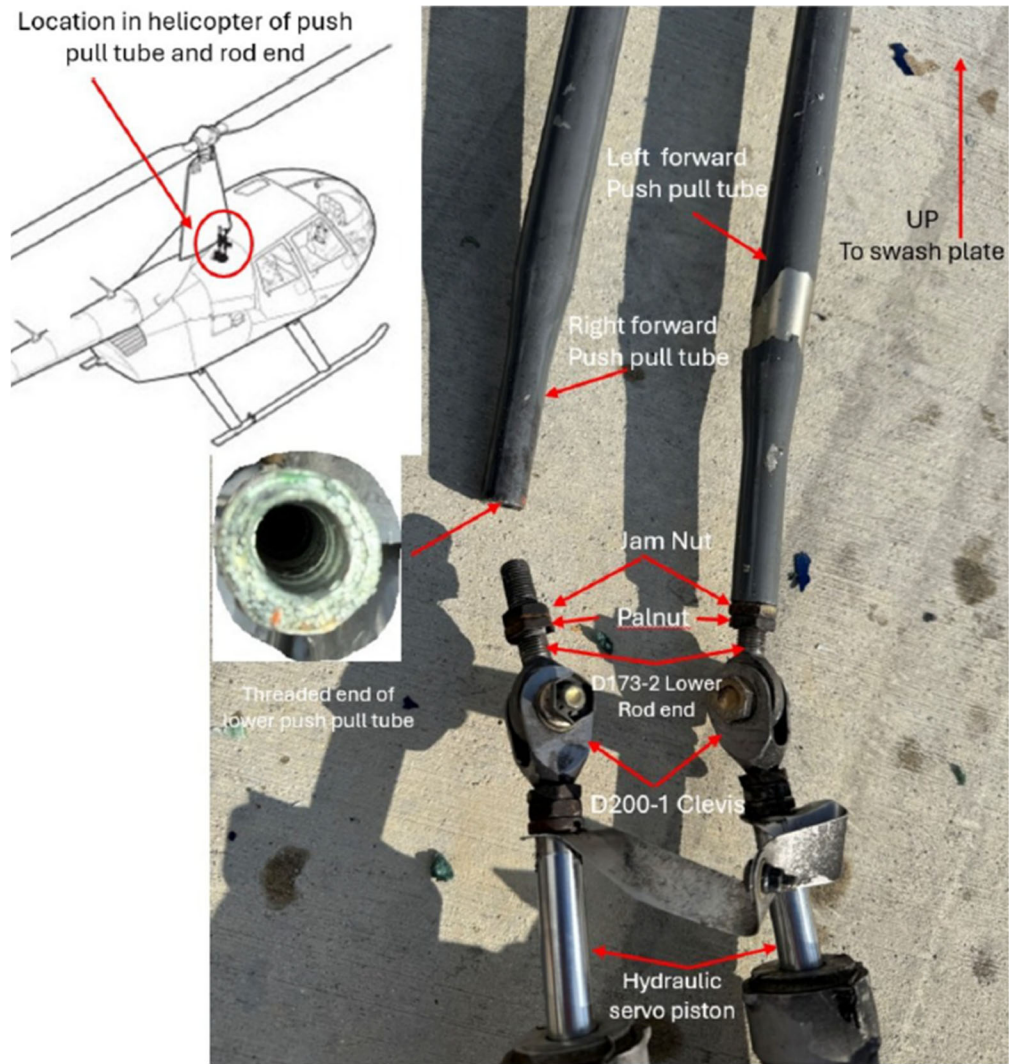
Figure 1. Upper Right and Left Push-Pull Tubes and Rod Ends.

On March 23, 2026, a Robinson Helicopter R44 rotorcraft (N478AT) impacted the roof of a warehouse facility in Boynton Beach, Florida. During the NTSB’s on-site examination of the main rotor flight controls, the upper right push-pull tube was found separated from the lower rod end (part number D173-2), which remained attached to the upper hydraulic servo piston shaft at the clevis (part number D200-1).

The palnut and jam nut that secure the upper right push-pull tube to the rod end could not be rotated by hand on the rod end threads. The upper right push-pull tube was observed to be elongated at the threaded end (see figure 1). Remnants of torque stripe paint were present on the push-pull tube, palnut, and jam nut. The palnuts and jam nuts on the left and aft lower rod ends and below the hydraulic servo clevis were found to be finger tight. Reference NTSB preliminary report ANC26FA021 for more information.

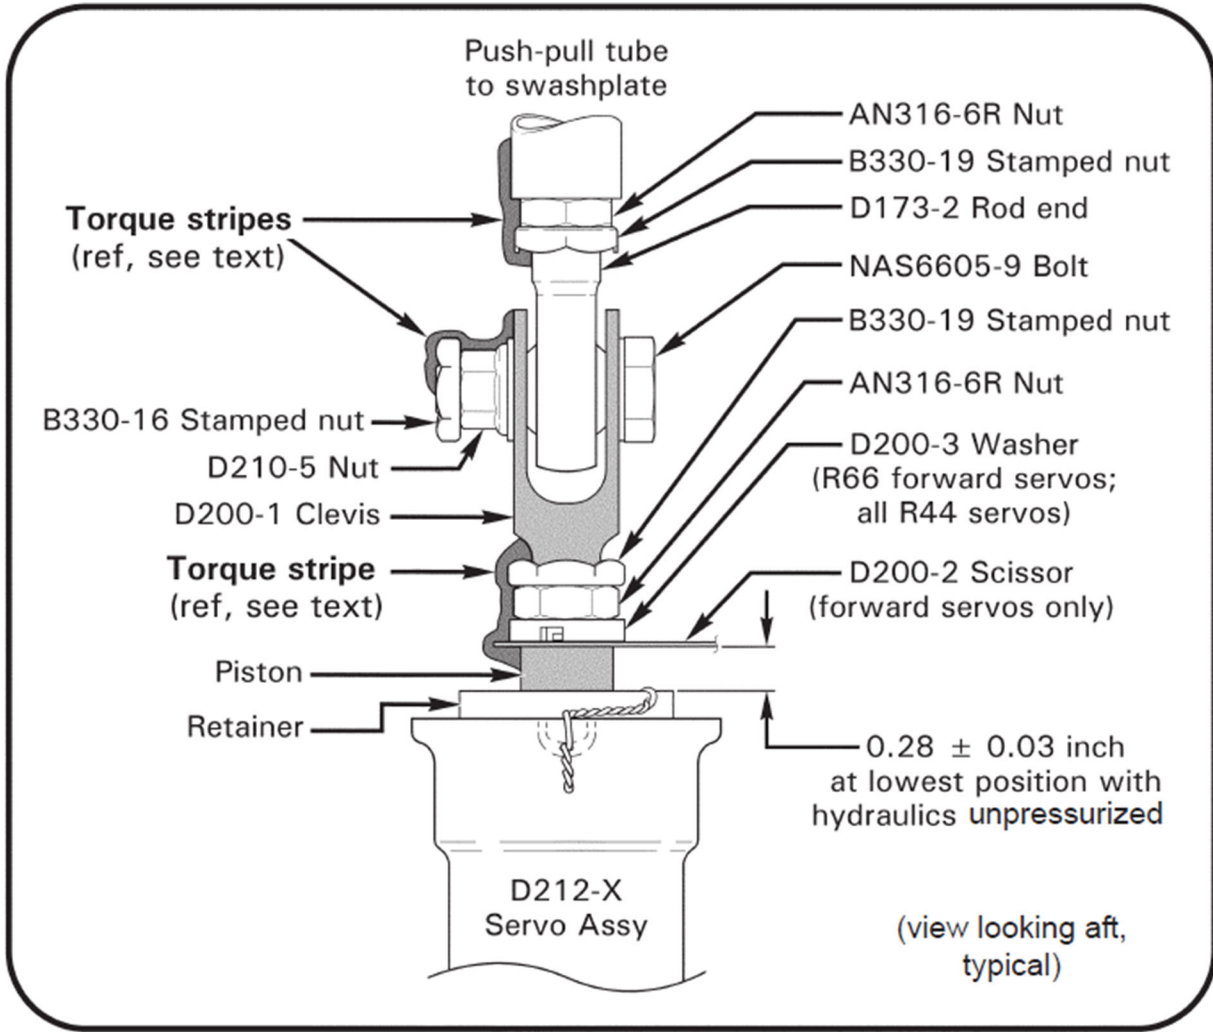
Figure 2. Hydraulic Servo-to-Swashplate Push-Pull Connection (3 Places).

The FAA is interested in receiving information of abnormal damage around the hydraulic servo-to-swashplate push-pull tube connection (see figure 2), including but not limited to:

- loosening hardware
- broken, missing, or inadequate torque striping
- palnut or jam nut damage
- corrosion
- fretting dust or damage to the internal threads of the servo clevis or push-pull tube

We recommend operators perform Robinson R44 Service Bulletin SB-119 and R66 Service Bulletin SB-45 dated May 11, 2026 or later revisions. If completed, please provide the information requested in Step 12 of the bulletin to the FAA.
