Aviation Investigation Final Report

Location:	Kekaha, Hawaii	Accident Number:	ANC24LA017
Date & Time:	February 27, 2024, 13:40 Local	Registration:	N633JH
Aircraft:	MD Helicopter 369E/500E	Aircraft Damage:	Substantial
Defining Event:	Powerplant sys/comp malf/fail	Injuries:	1 Serious, 4 Minor
Flight Conducted Under:	Part 135: Air taxi & commuter - Non-scheduled - Sightseeing

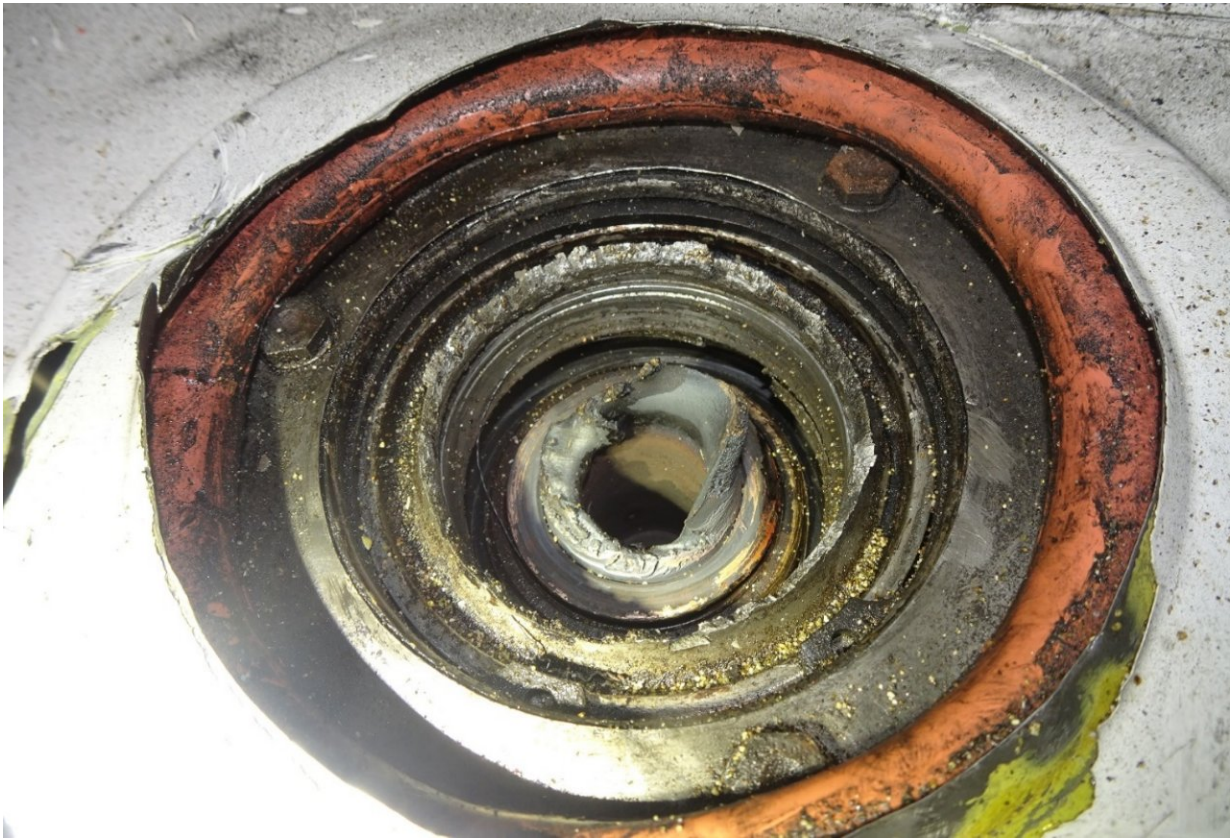
An initial examination revealed that the overrunning clutch and engine-to-transmission driveshaft were fractured. The overrunning clutch was found to have failed at its output (forward) end, with significant thermal damage to the clutch inner race and output bearing. The overrunning clutch assembly, Kaflex driveshaft, and the grease sample from the engine power output pad were collected and sent to the NTSB Materials Laboratory. Further examination of the overrunning clutch found the thermal damage was consistent with frictional heating of the output bearing, leading to the output bearing’s failure, causing the clutch inner race to become very hot and degrade its material strength.

The majority of the overrunning clutch subassembly and the clutch housing remained installed on the engine gearbox housing, but the clutch inner race splined shaft had fractured aft of the splines, with the fracture exhibiting a spiral and partially melted appearance (figure 1).

Figure 1. The fractured and thermally deformed clutch inner race.

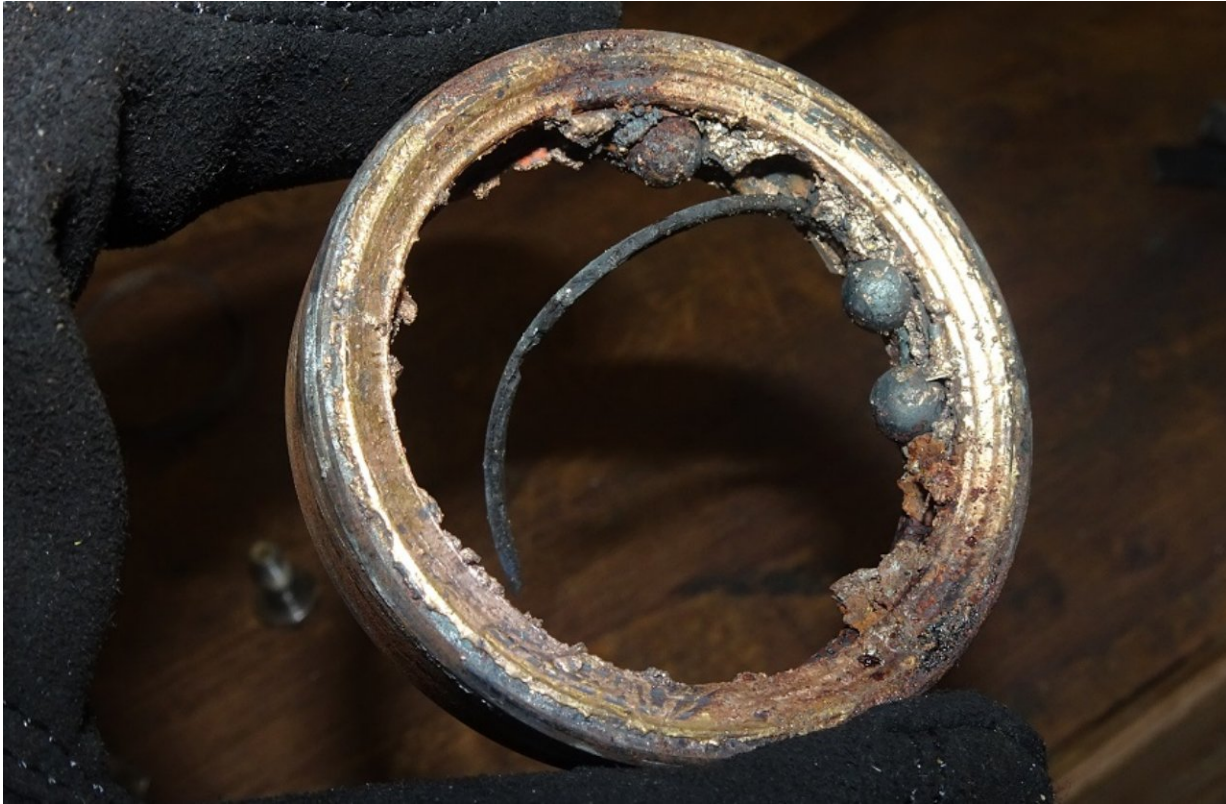
A portion of the clutch output bearing, normally installed immediately adjacent to the clutch inner race's splines, was found in its normally installed location but had separated from the clutch. However, the clutch output bearing found was composed only of the bearing outer race with three roller (ball) elements adhered to the outer race and exhibited thermal damage

(figure 2). A circular metal piece, which exhibited thermal damage and deformation, was found with the output bearing.

Figure 2. The clutch output bearing outer race with the three roller elements adhered.

heat tinting, oxidation, and deformation consistent with high heat exposure. The output bearing outer race contained remnant balls (roller elements) and cage pieces that had melted and resolidified to the outer race.
