# Aviation Investigation Final Report

| <b>Location:</b> | Andale, Kansas | <b>Accident Number:</b> | CEN24FA248 |
| <b>Aircraft:</b> | Rotorway Scorpion 133 | <b>Aircraft Damage:</b> | Destroyed |
| <b>Defining Event:</b> | Mast bumping | <b>Injuries:</b> | 1 Fatal |

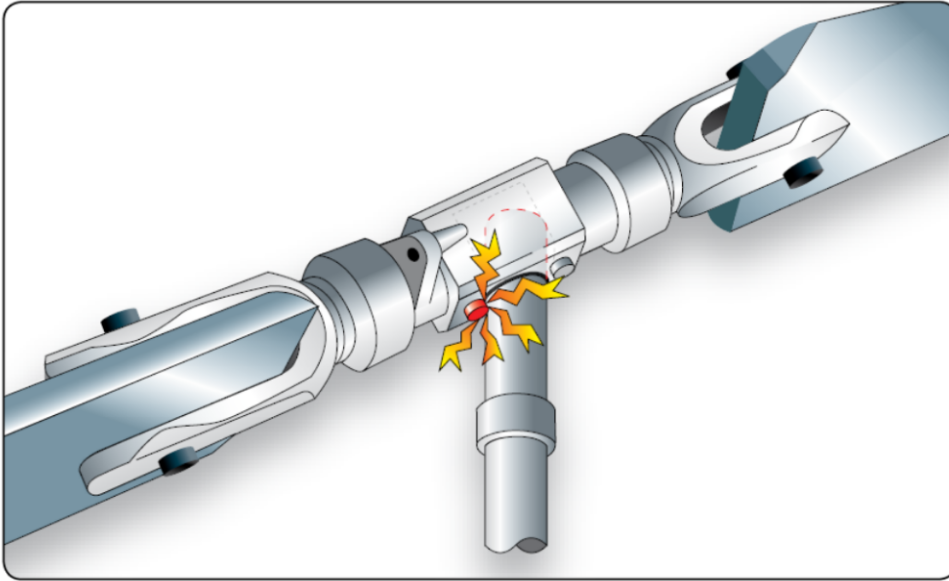
**Figure.** Mast bumping

The handbook includes an illustration that depicts the main rotor hub contacting the main rotor mast, as a result of improper corrective action in a low-G condition (see figure).

illustration. (Source: FAA)
