# Airworthiness Concern Sheet

| <b>Reply to:</b><br><b>Name:</b> Ramanpreet Singh<br><b>Title:</b> Aviation Safety Engineer<br><b>Office:</b> AIR-755<br><b>Street Address:</b> 1701 Columbia Ave<br><b>City, State, ZIP:</b> College Park, GA 30337<br><b>Telephone:</b> (516) 228-7300<br><b>Electronic Mail:</b> ecb-cos@faa.gov | <b>Make:</b> Tempest Aero Group<br><b>Model / Series:</b> N/A<br><b>Serial Numbers:</b> N/A<br><b>Reason for Airworthiness Concern:</b><br><br>Cracking of Tempest Spark Plugs at Hot lock Assembly |

**SERVICE BULLETIN SB-012****August 7<sup>th</sup>, 2026**

This Service Bulletin describes a potential cracking problem in specific lot numbers of Tempest® Spark Plugs manufactured between May 5, 2026 and July 29, 2026. It recommends immediate inspection of the affected spark plugs prior to your next flight and replacement of any cracked spark plugs. No action is required for Tempest® Spark Plugs purchased prior to May 5, 2026.

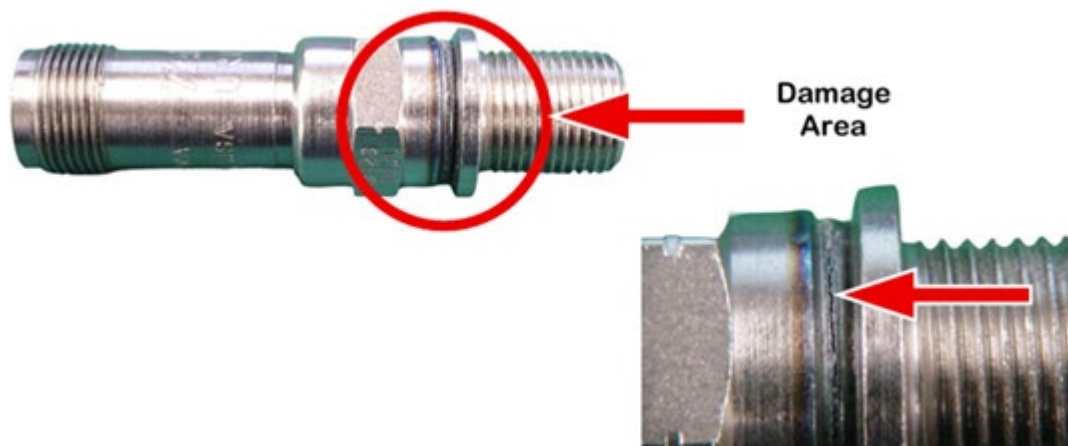
| <b>Federal Aviation Administration (FAA) Description of Airworthiness Concern</b><br><p>On July 27, 2026, the FAA received notification of a failed Tempest spark plug, part number (PN) UREM38E, which was discovered following an event of engine roughness and subsequent partial loss of power. Service Difficulty Report (SDR) ECPR20260731001 is enclosed for reference. Further inspection by the operator revealed full separation between the spark plug's seat and hexagonal nut, also known as the hot lock assembly. The FAA identified similar SDRs which were recently submitted to report circumferential cracking on new or low time Tempest spark plugs.</p> <p>Upon notification of the issue, Tempest released <a href="#">Service Bulletin (SB)-012</a> dated August 7, 2026, which is also provided as an enclosure. The service bulletin recommends immediate visual inspection before further flight of Tempest spark plugs manufactured between May 5, 2026 through July 29, 2026, and provides a list of suspect part and lot numbers. The service bulletin also provides illustrations of the suspect area to inspect for cracking, which is also shown in Figure 1.</p> <p>Failed spark plugs may lead to damage to the engine, possible loss of power, and subsequent loss of control of the aircraft. The FAA is currently investigating this concern.</p> | |

Figure 1: The suspected area of damage on the spark plugs
