# Aviation Investigation Final Report

| <b>Location:</b> | Fern Prairie, Washington | <b>Accident Number:</b> | WPR24LA319 |
| <b>Date &amp; Time:</b> | September 26, 2024, 15:50 Local | <b>Registration:</b> | N9984K |
| <b>Aircraft:</b> | Bell 206L | <b>Aircraft Damage:</b> | Substantial |

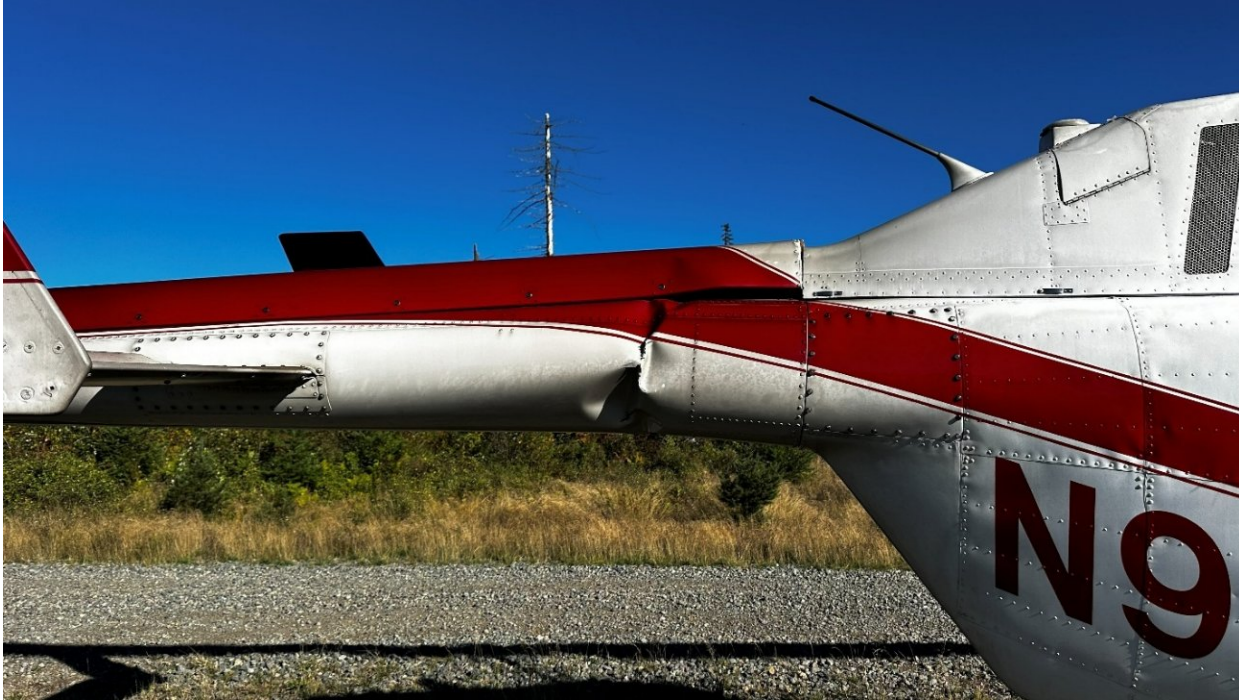
Postaccident examination revealed the helicopter’s tailboom was buckled around its entire circumference. The tailboom buckling was likely the direct result of abnormally high structural loads imposed on the airframe during the vertical hop. This violent oscillation generated dynamic loads exceeding the normal structural design limits of the tailboom, resulting in it buckling about 13 inches aft of the intercostal support, and displacing it downward about 15° and to the right. The full monocoque construction of the tailboom, while robust under normal flight loads, can sustain damage when under the sudden, cyclically-amplified bending forces associated with this type of resonant vibration event.

An aeroelastic interaction between the helicopter's main rotor blades and nodal beam system, which resulted in oscillations that exceeded the design limits of the tailboom. Contributing to the accident was the failure of the main rotor blade manufacturer to adequately publish the appropriate recovery technique for a known flight dynamics issue.

Figure. Damage to the helicopter's tailboom (Source: JL Aviation).

The helicopter was recovered and subsequently examined at the operator's facility. Examination revealed the tailboom, of full monocoque construction, was buckled around its entire circumference about 13 inches aft of the intercostal support; it was displaced downward about 15° and to the right. The upper aft fuselage adjacent to the engine deck displayed areas of wrinkling and paint flaking. The skids did not appear to be deformed or splayed outward.

The recovery method prescribed by the SB stated that pilots should “immediately reduce speed and load the rotor by increasing collective,” with the caution, “DO NOT lower the collective or enter an autorotation. The vibration will only continue throughout the descent and can potentially result in damage to the aircraft.” An engineer at VHA stated that, although banking had been shown to be effective as a recovery technique, reducing the helicopter’s airspeed had been shown to eliminate the oscillations more quickly.
