# Aviation Investigation Final Report

| <b>Location:</b> | Potrero, California | <b>Accident Number:</b> | WPR25FA062 |
| <b>Date &amp; Time:</b> | December 16, 2024, 10:30 Local | <b>Registration:</b> | N617GC |
| <b>Aircraft:</b> | AMERICAN EUROCOPTER LLC<br>AS350B3 | <b>Aircraft Damage:</b> | Substantial |

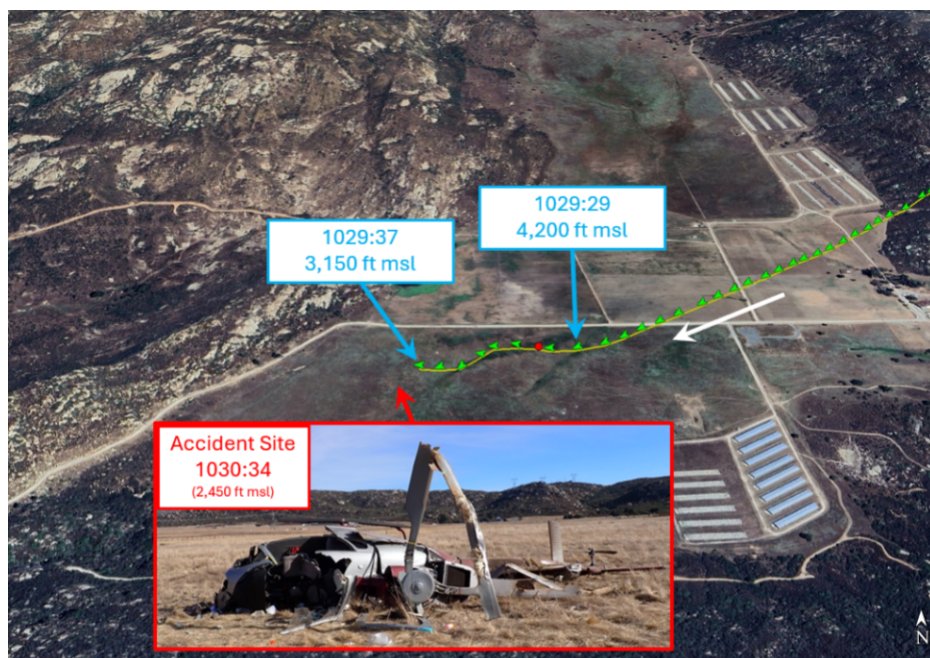
At 1007:52, the helicopter made an extended left 360° turn, descended to about 4,600 ft msl, and then climbed again to about 5,600 ft msl. At 1021:58, the helicopter turned southwest and leveled off 4 minutes later at 4,300 ft msl. Beginning at 1029:26, over the next 49 seconds the helicopter made two S-turns while descending from 4,200 ft to 3,100 ft msl. The final data point, recorded at 1029:37, was about 820 ft above ground level and 280 ft northeast of the accident site (see figure).

*Figure: ADS-B flight track and accident site.*
