# **Aviation Investigation Final Report**

Location:	Brady, Texas	Incident Number:	CEN23FA183
Date & Time:	May 14, 2023, 00:00 Local	Registration:	N40506
Aircraft:	Robinson R22 Beta	Aircraft Damage:	Substantial
Defining Event:	Loss of control on ground	Injuries:	1 Fatal
Flight Conducted Under:	Part 91: General aviation - Personal

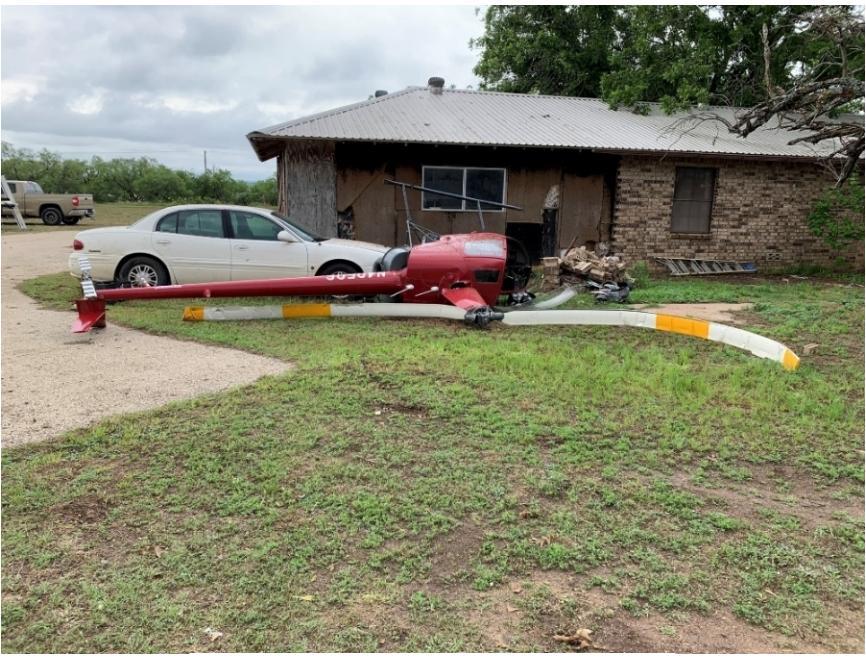
The helicopter was found on its right side, facing west, about 15 ft from the north wall of the house, as shown in figure 1. The helicopter was about 70 ft southwest from a concrete pad that the pilot used during ground operations, as shown in figure 2. The helicopter's ground handling wheels and a hand truck associated with a battery charger were found beside the concrete pad, as shown in figure 3. The battery charger and its integrated jumper cables were

Figure 1. Main wreckage overview

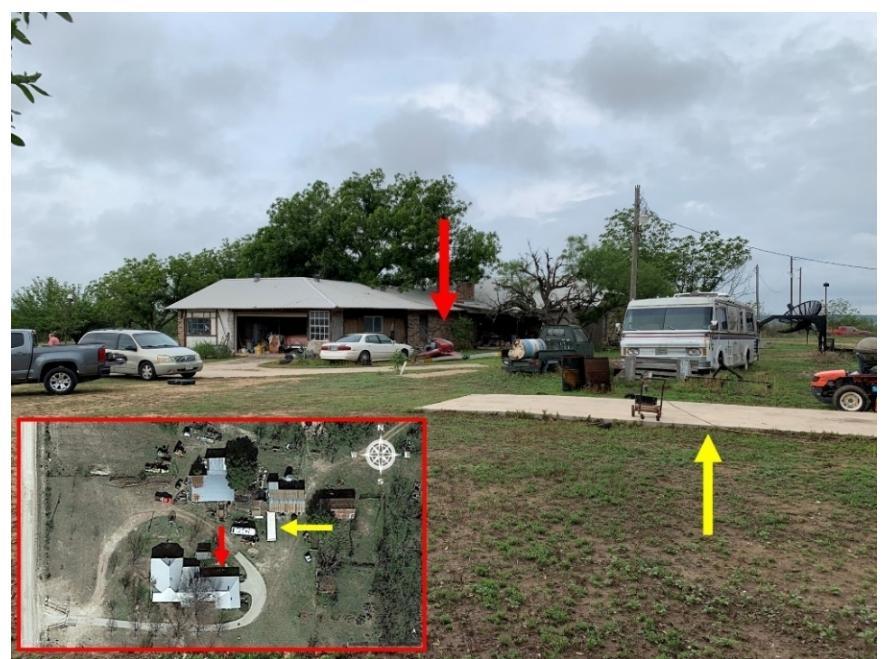
**Figure 2.** Location of main wreckage in north side yard of house (red arrows) and concrete pad (yellow arrows) with inset aerial photo depicting property layout.

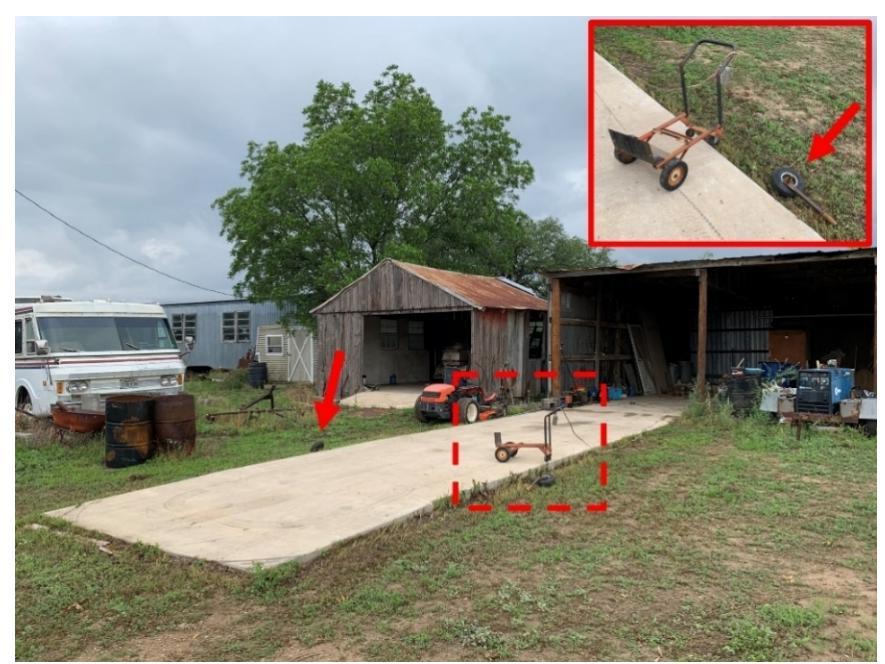
**Figure 3.** Concrete pad, hand truck used with battery charger (red boxes), and ground handling wheels (red arrows).

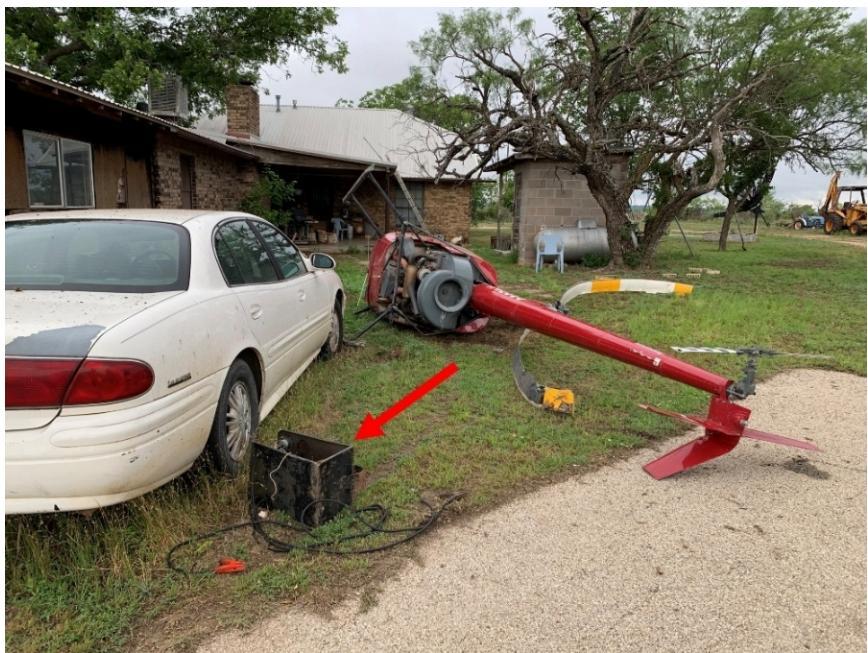
found about 60 ft from the concrete pad against the rear right tire of a white sedan parked beside the helicopter wreckage, as shown in figure 4. The hood and roof of the white sedan exhibited fresh dirt deposits.

Figure 4. Main wreckage, sedan, and battery charger with jumper cables (red arrow).

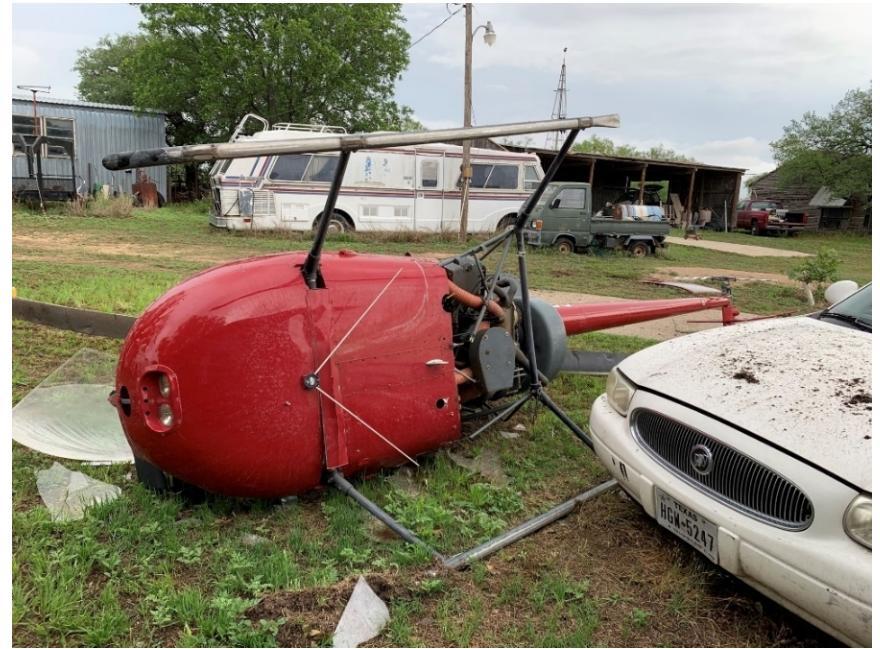
There was a small truck, full-sized recreational vehicle, and two steel drums located between the concrete pad and the helicopter wreckage, as shown in figure 5. Based on ground impact marks and the overall wreckage distribution, the helicopter ascended at least 7 ft to clear the obstacles before it impacted the ground near the house.

Figure 5. Main wreckage with obstacles along projected flight path.

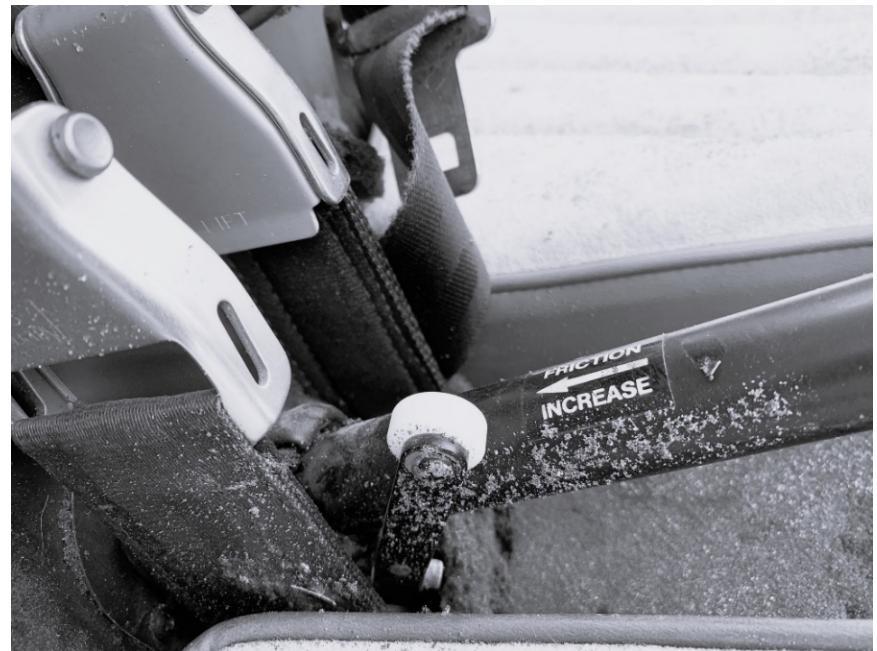
The non-certificated pilot's failure to ensure the collective friction control was adequately engaged during an on-ground engine run, which resulted in the helicopter inadvertently becoming airborne. Contributing to the crash were the pilot's various physical and mental conditions and his use of potentially impairing medications.

Flight control continuity was confirmed from the cyclic and collective to the swashplate assembly where both ears exhibited fracture features consistent with overstress. Both blade pitch control links remained intact. The cyclic friction was on and, as shown in figure 6, the collective friction control was off. Tail rotor flight control continuity was confirmed from the anti-torque pedals to the tail rotor blades.

Figure 6. Collective friction in off position.

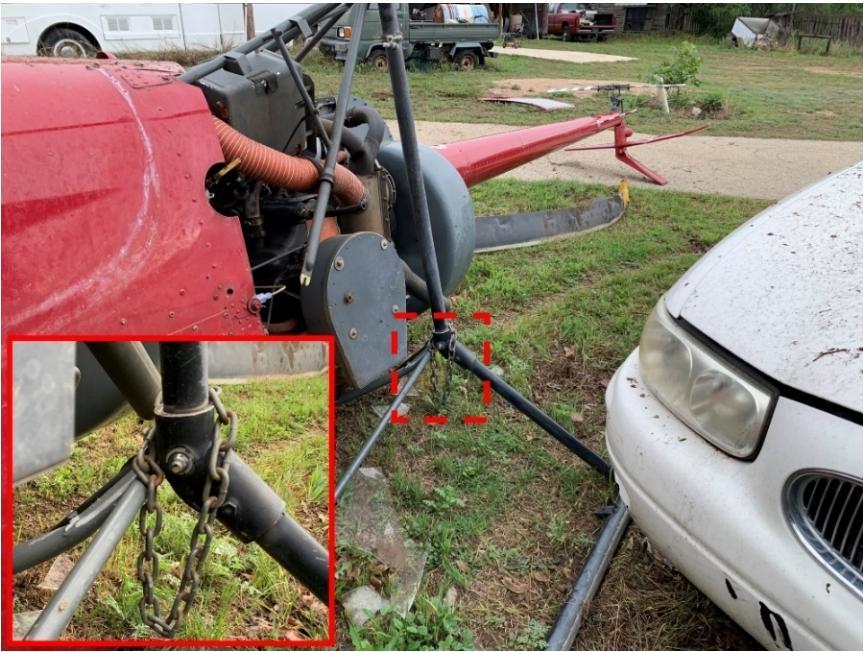
There was a short chain loop installed on the landing skid aft cross tube, as shown in figure 7. According to the pilot's family, to move the helicopter while on the ground, the pilot would connect an electric winch cable to a short chain loop on the helicopter's landing skid aft cross tube. The electric winch motor was located at the rear of the shed where the helicopter was normally stored. However, if he intended to fly, the pilot would remove the short chain loop before the flight. The winch cable was not connected to the chain loop at the time of the crash and was found on the floor of the shed undamaged.

Figure 7. Chain loop around the landing gear skid aft cross tube.
