## **Aviation Investigation Preliminary Report**

Location:	Miami, TX	Accident Number:	CEN25FA183
Date & Time:	May 23, 2025, 07:18 Local	Registration:	N1195P
Aircraft:	ROBINSON HELICOPTER COMPANY R44 II	Injuries:	1 Fatal
Flight Conducted Under:	Part 91: General aviation - Personal

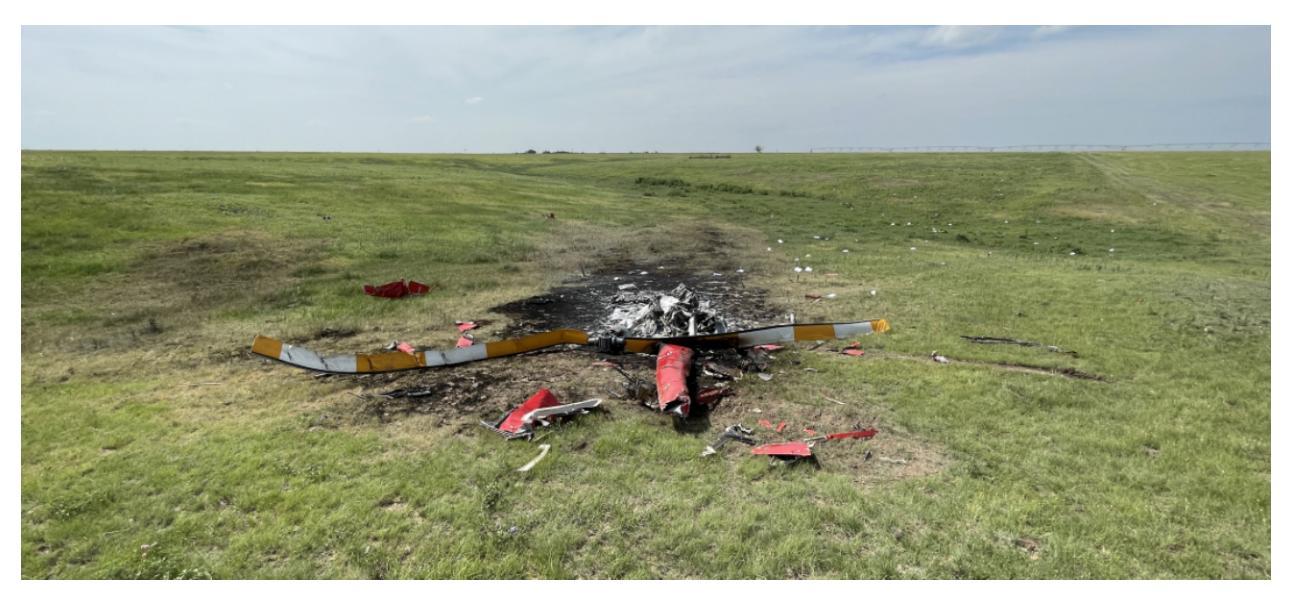
Figure 1. Accident site.

A witness near the accident site stated that he was outside when he heard the helicopter approaching from the east. The weather conditions were foggy with low clouds and mist. He could not determine the exact altitude of the cloud layer because the fog was so low. Due to the fog and low clouds, he could not discern the color of the helicopter, and it just looked like a dark silhouette, but it was flying very low and appeared to be having trouble maintaining control. The helicopter was flying west when it descended below the terrain in a small valley, then climbed up with the nose low and appeared to climb backwards. After the backwards climb, it leveled off very briefly, then made a rapid forward descent toward terrain, in a relatively level attitude. The helicopter was headed back to the east during the rapid descent. He did not notice any parts depart from the helicopter during the accident sequence. The helicopter impacted the ground hard and exploded. The accident site was located about 4.5 nm southwest of the departure location in a cattle pasture (figure 1). The helicopter impacted the ground facing east, then rotated left about 120° where it came to rest. A postimpact fire consumed a majority of the fuselage and part of the tailcone. The initial impact mark featured a round impression in the dirt surrounded by pieces of the windshield and door frames. On either side of the impression were parallel impact marks and fragments of the skid tubes. One of the main rotor blades impacted the ground near the initial impact mark. Before ground impact, the main rotor blades struck the aft portion of the tailboom, which separated the empennage and tail rotor assembly. All major helicopter components were identified at the accident site. On-scene examination of the airframe and engine did not reveal any evidence of preimpact malfunctions or failures that would have precluded normal operation of the helicopter.
