Loss of control and collision with terrain involving Robinson R44 II, registration VH-HOB

near Clare, South Australia, on 22 December 2020

ATSB Transport Safety Report

AO-2020-064

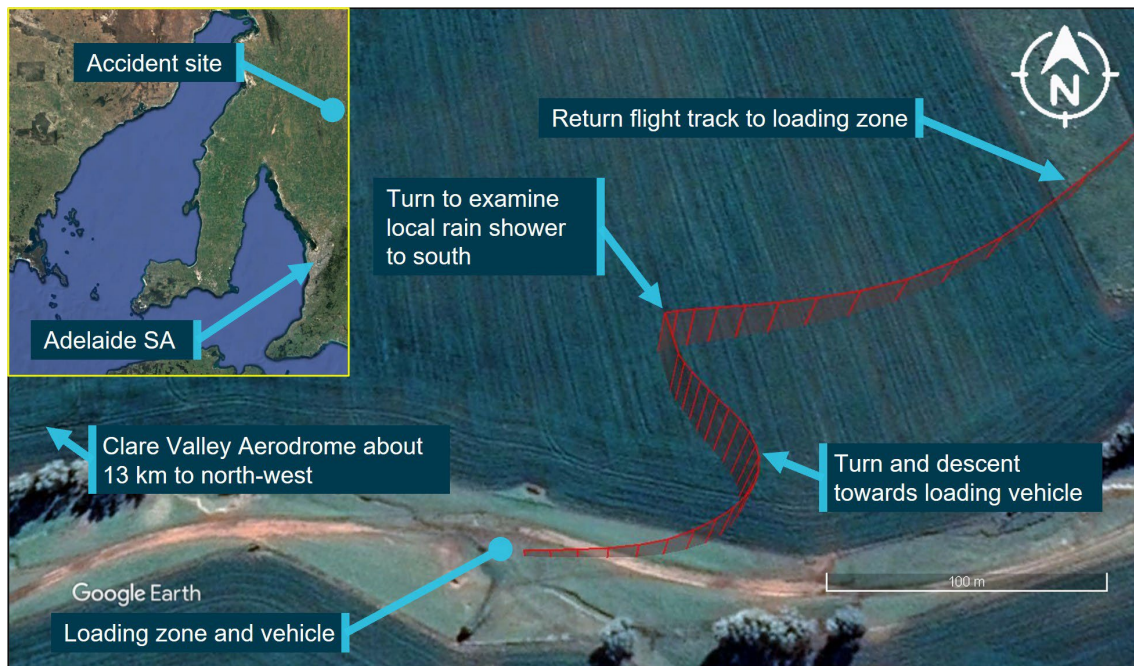
Figure 1: VH-HOB flight path showing return to loading zone and descent and inset providing accident location

About 10 seconds into the turn, at 0926:30, a loud bang from the rear of the helicopter was heard, followed by vibrations from the rotor systems. The ground crewman recalled looking up and seeing that the tail rotor had stopped turning. The pilot reported that the cockpit flight controls appeared to have jammed and of not being able to move the tail rotor pedals. The helicopter's rate

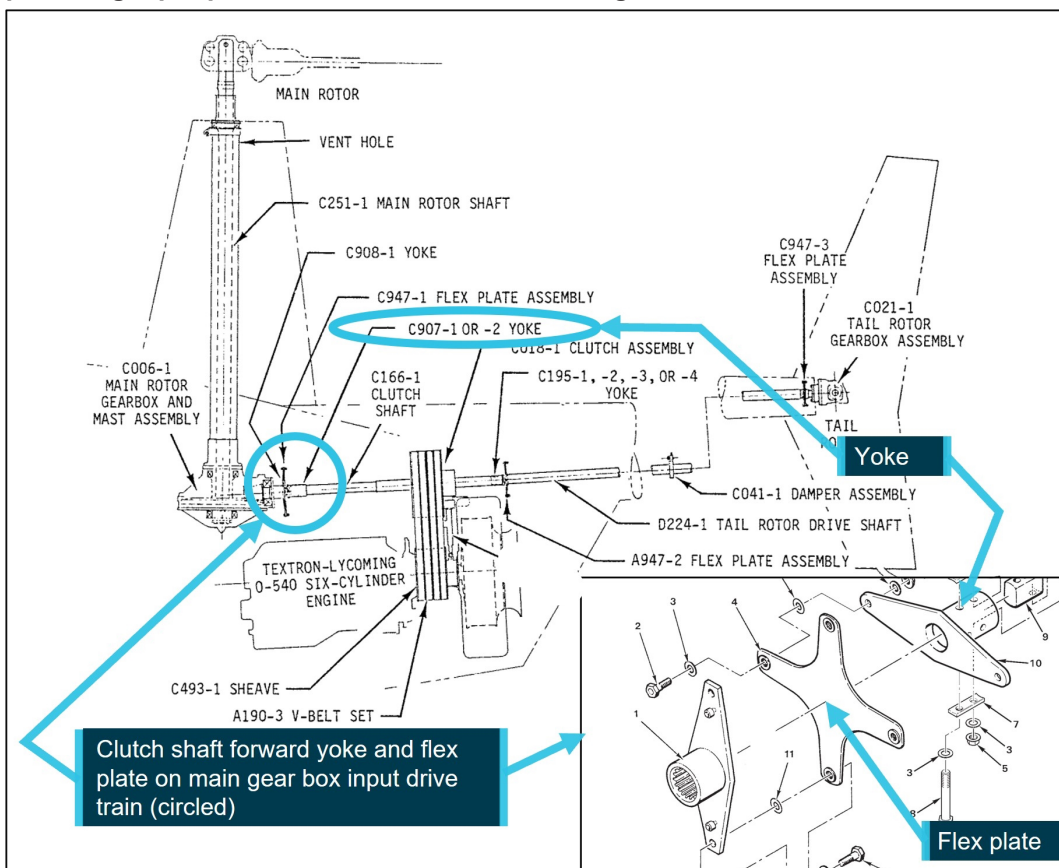
Figure 3: R44 drive train with inset showing clutch shaft forward yoke and flex plate providing input power to the main and tail rotor gearboxes

Other than for unscheduled maintenance, the yoke was only separated from the forward flex plate (see Figure 3 insert) when parts were replaced at their assigned 2,200/2,400-hour service interval. The yoke was treated as an 'on-condition' item and was not assigned an operating time-in-service, fatigue, or calendar life-limit.

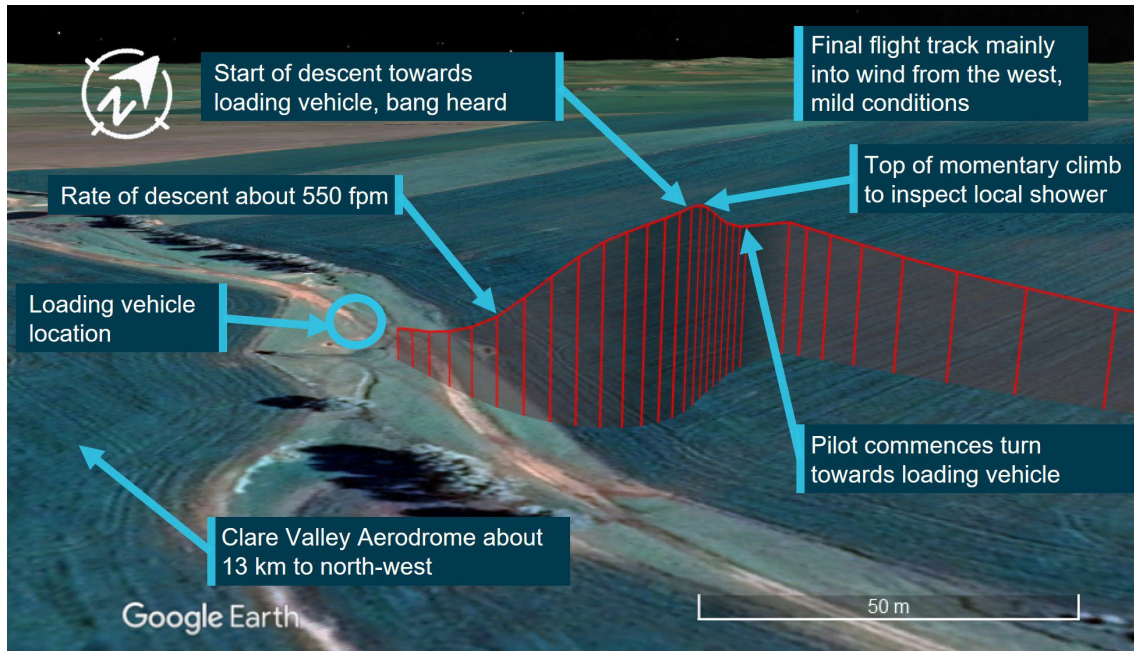
From 09:26:40 to collision at 09:26:46, the aircraft track varied by about 4 degrees. In the last two seconds of flight, the track varied by less than one degree, and aligned the helicopter’s movement with the position of the stationary ground vehicle (Figure 10).

Figure 10: VH-HOB flight path showing landing approach with momentary climb and descent towards ground vehicle
