AIR TRANSPORTATION SAFETY INVESTIGATION REPORT A23W0082

ENGINE POWER LOSS AND COLLISION WITH TERRAIN

Valhalla Helicopters Inc.
Bell Textron Inc. 205A-1 (helicopter), C-GRUV
Peace River Aerodrome, Alberta, 55 NM NE
19 July 2023

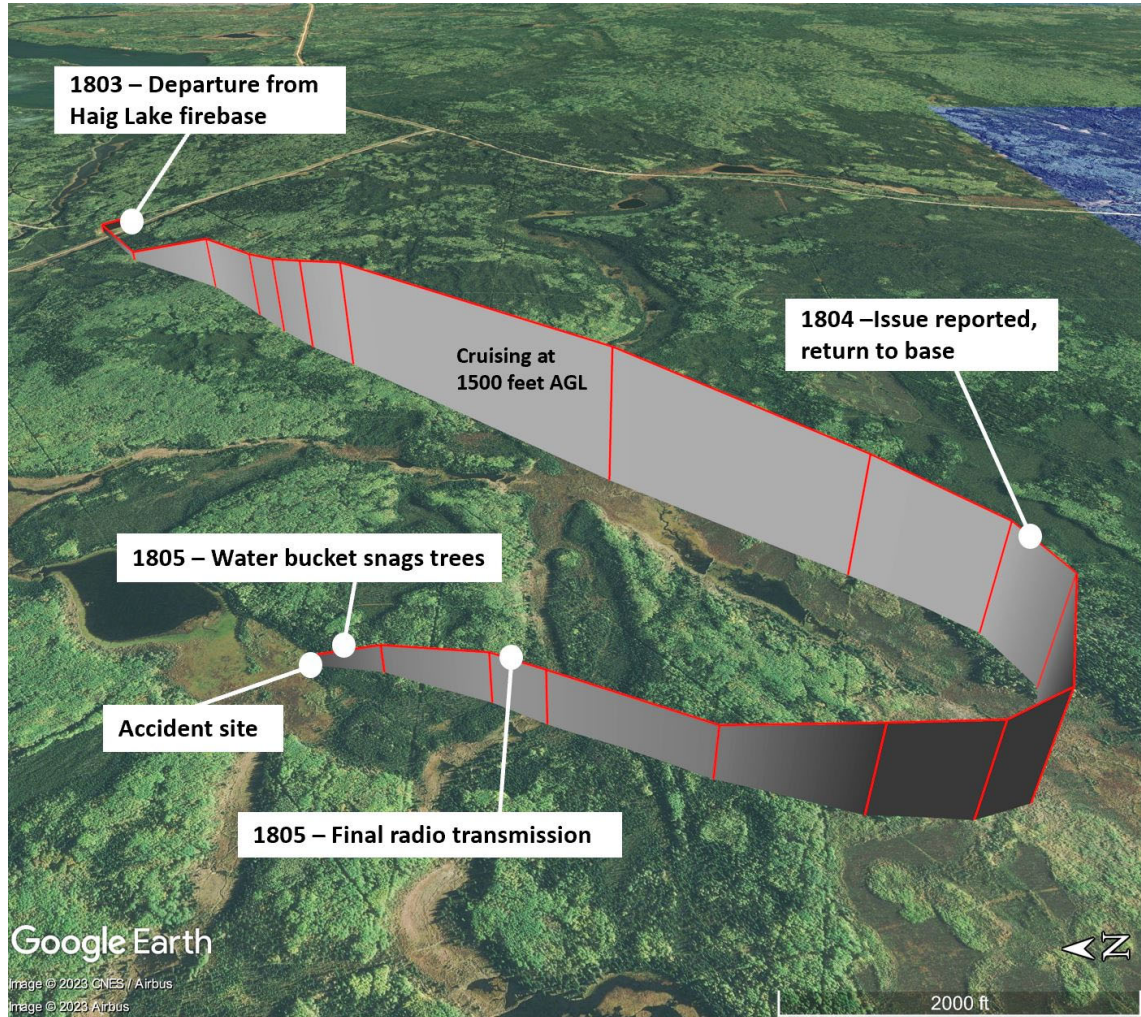
Shortly thereafter, the water bucket contacted trees and then became entangled in a tree. The pilot released the longline using the manual release (also known as the mechanical release) and, shortly thereafter, the helicopter impacted the ground in a nose-down, left-banked attitude (Figure 1).

Figure 1. Occurrence aircraft’s flight path leading to the accident site (Source: Google Earth, with TSB annotations)

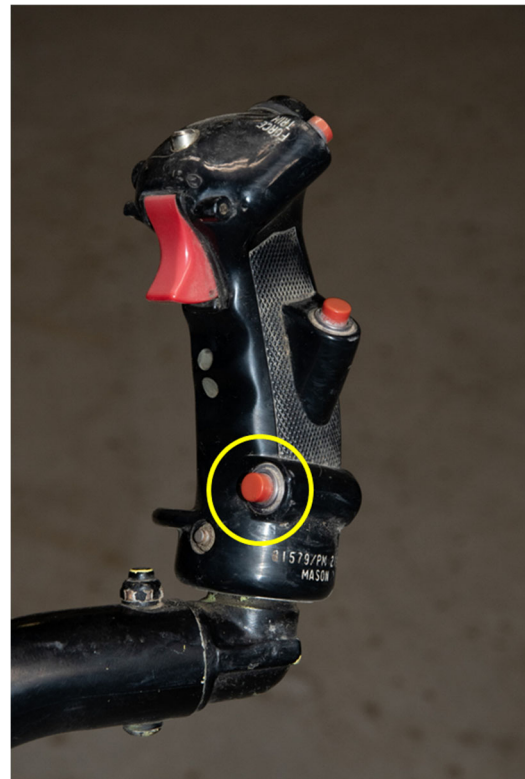
Figure 10. Electric cargo release push button on the cyclic from the occurrence aircraft (Source: TSB)

In the occurrence aircraft, the CARGO REL switch was found in the OFF position. The investigation determined that it was common for pilots at Valhalla Helicopters Inc. to conduct external cargo⁸ operations with the CARGO REL switch in the OFF position.

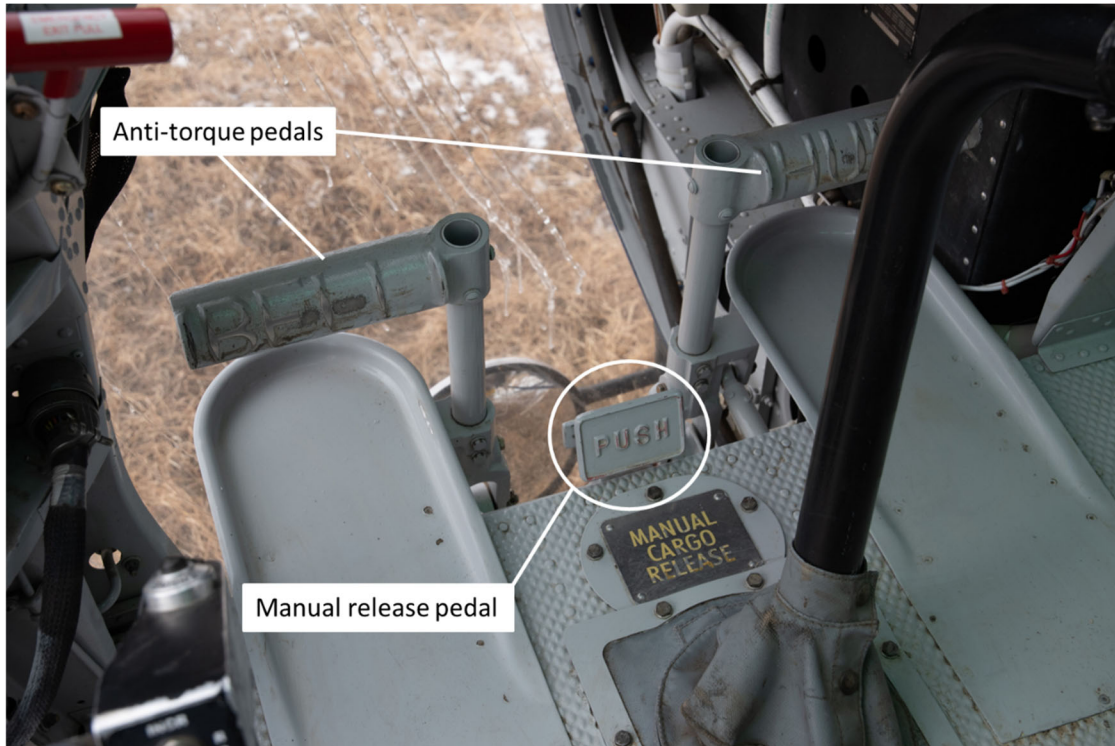
The manual release pedal is located on the floor between the anti-torque pedals (Figure 12) on both the left and right pilot's seats. Pressing the pedal applies tension to a metal cable that releases the internal mechanism of the cargo hook and allows it to open. Pilots remove their foot from an anti-torque pedal to depress the manual release pedal.

Figure 12. Manual release pedal and anti-torque pedals of a typical Bell 205A -1 (Source: TSB)
